Your Airport Report

SEASIDE MUNICIPAL AIRPORT

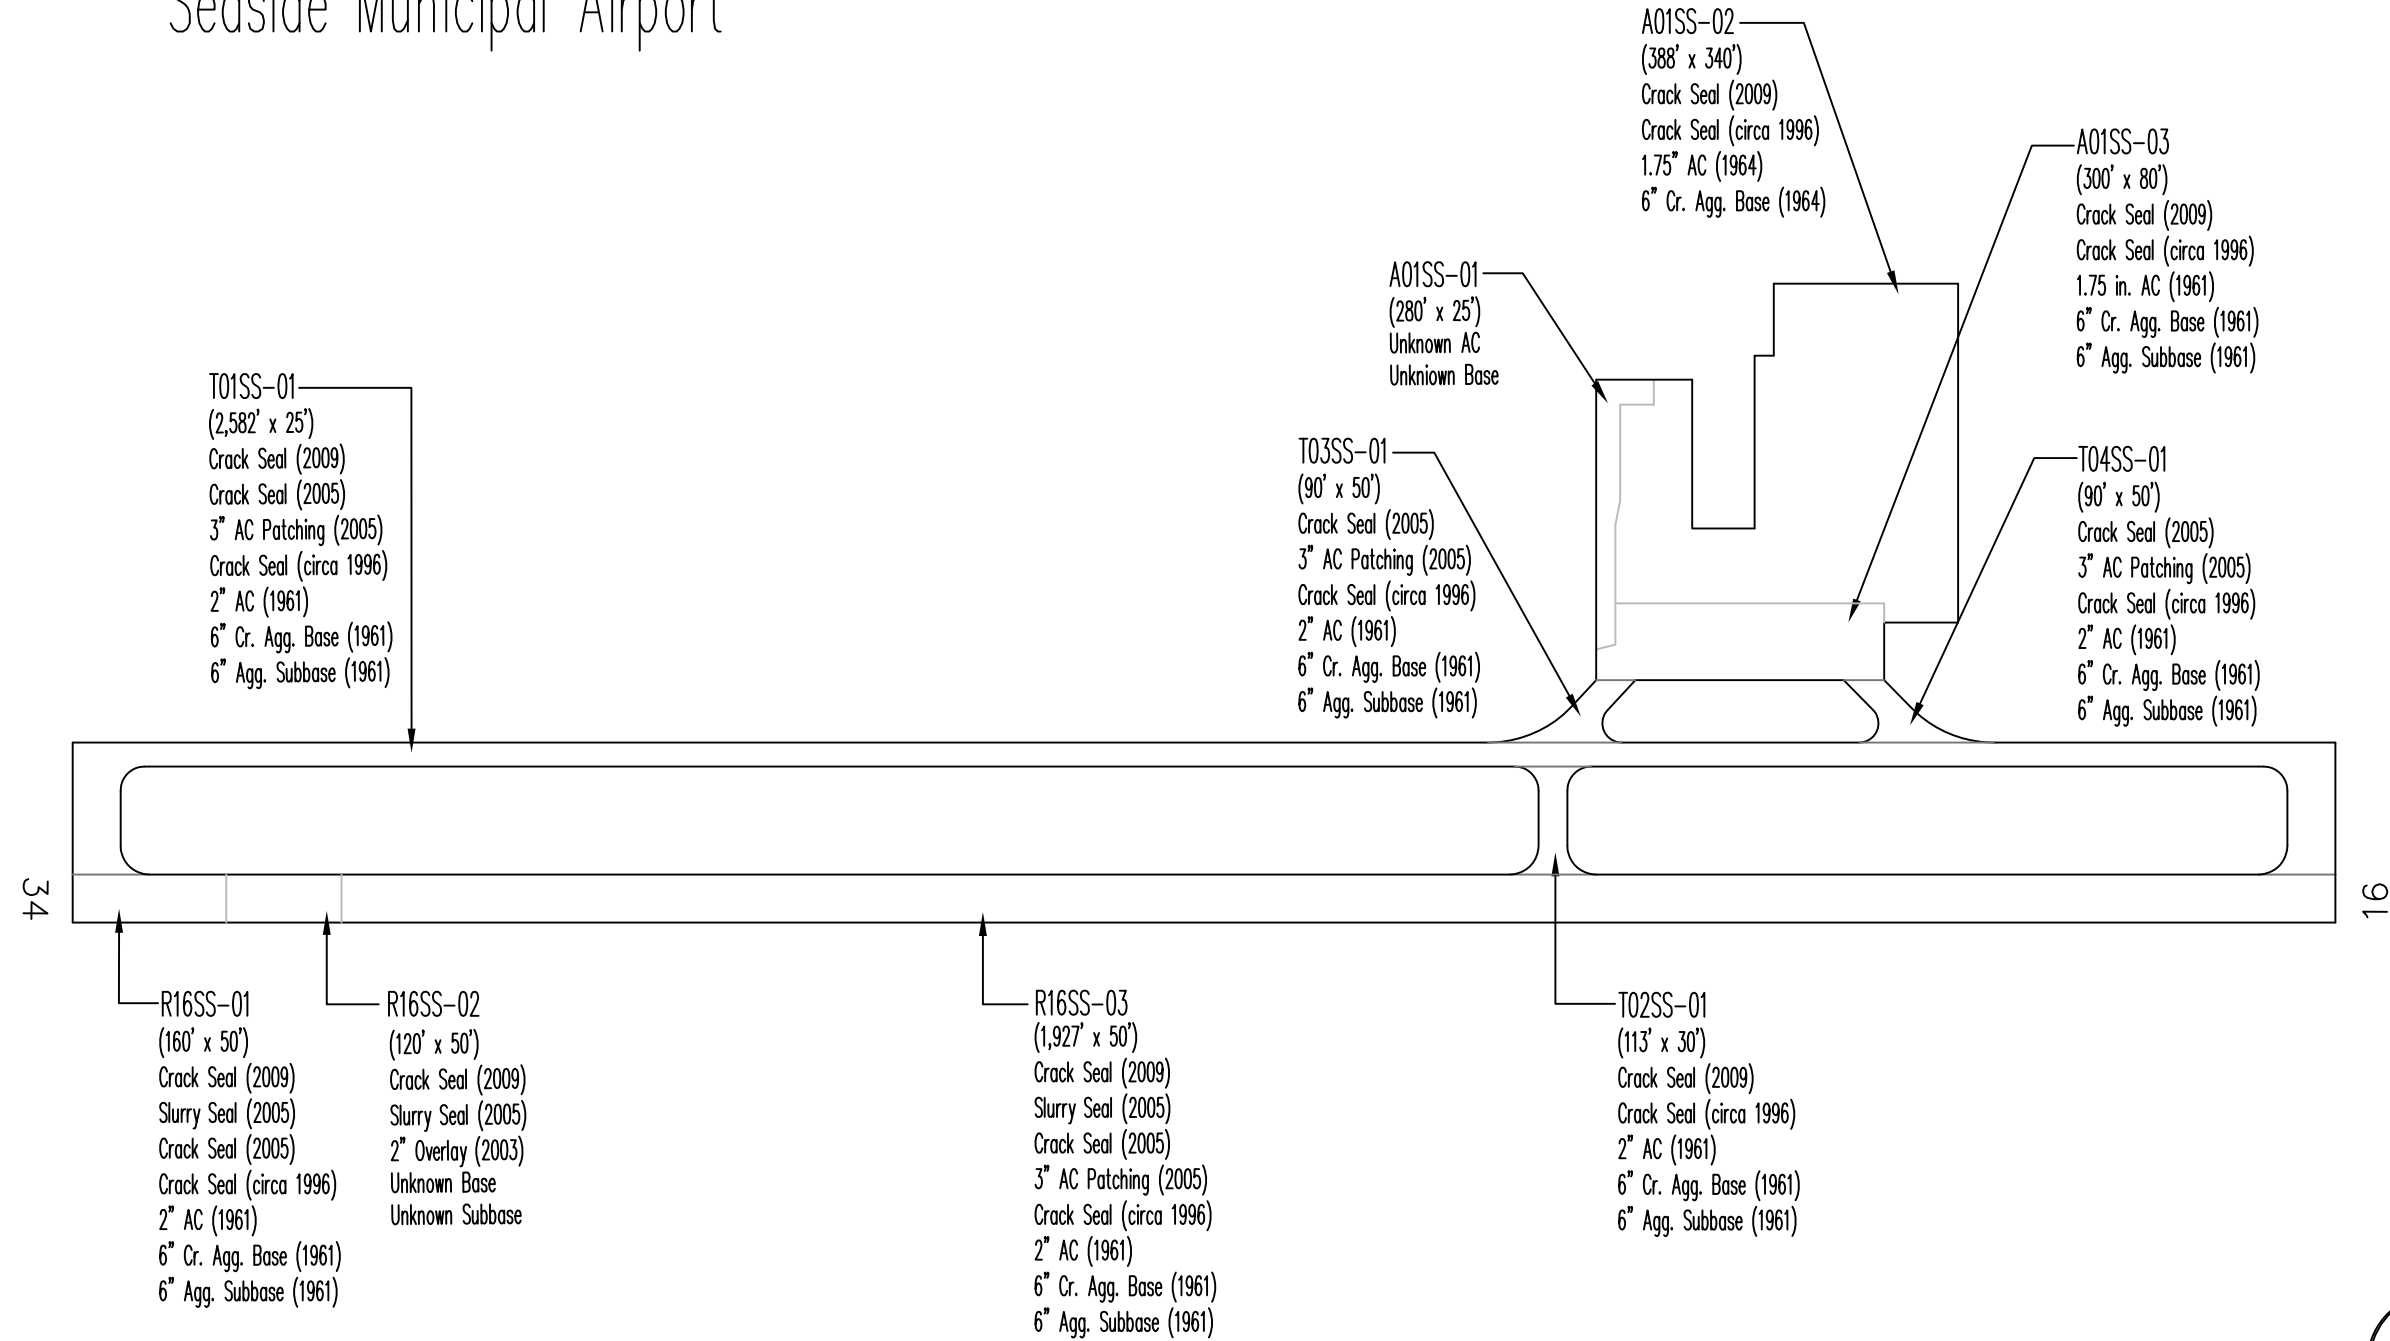
Figure SS-1. Airport Layout, Dimensions and Pavement Cross-Sections.
Seaside Municipal Airport

To determine how your pavements were constructed and their age, a records review was conducted. Figure SS-1 shows the records review results. This figure identifies pavement boundaries, dimensions, pavement layer types, thicknesses and dates of construction. The most recent construction date for each pavement can also be found in the Section Condition Report in Appendix 2. Figure SS-1 and the information contained in Appendices 1, 2 and 4 ensure that your airport complies with the “pavement inventory” requirement of FAA’s PMMP guidelines.

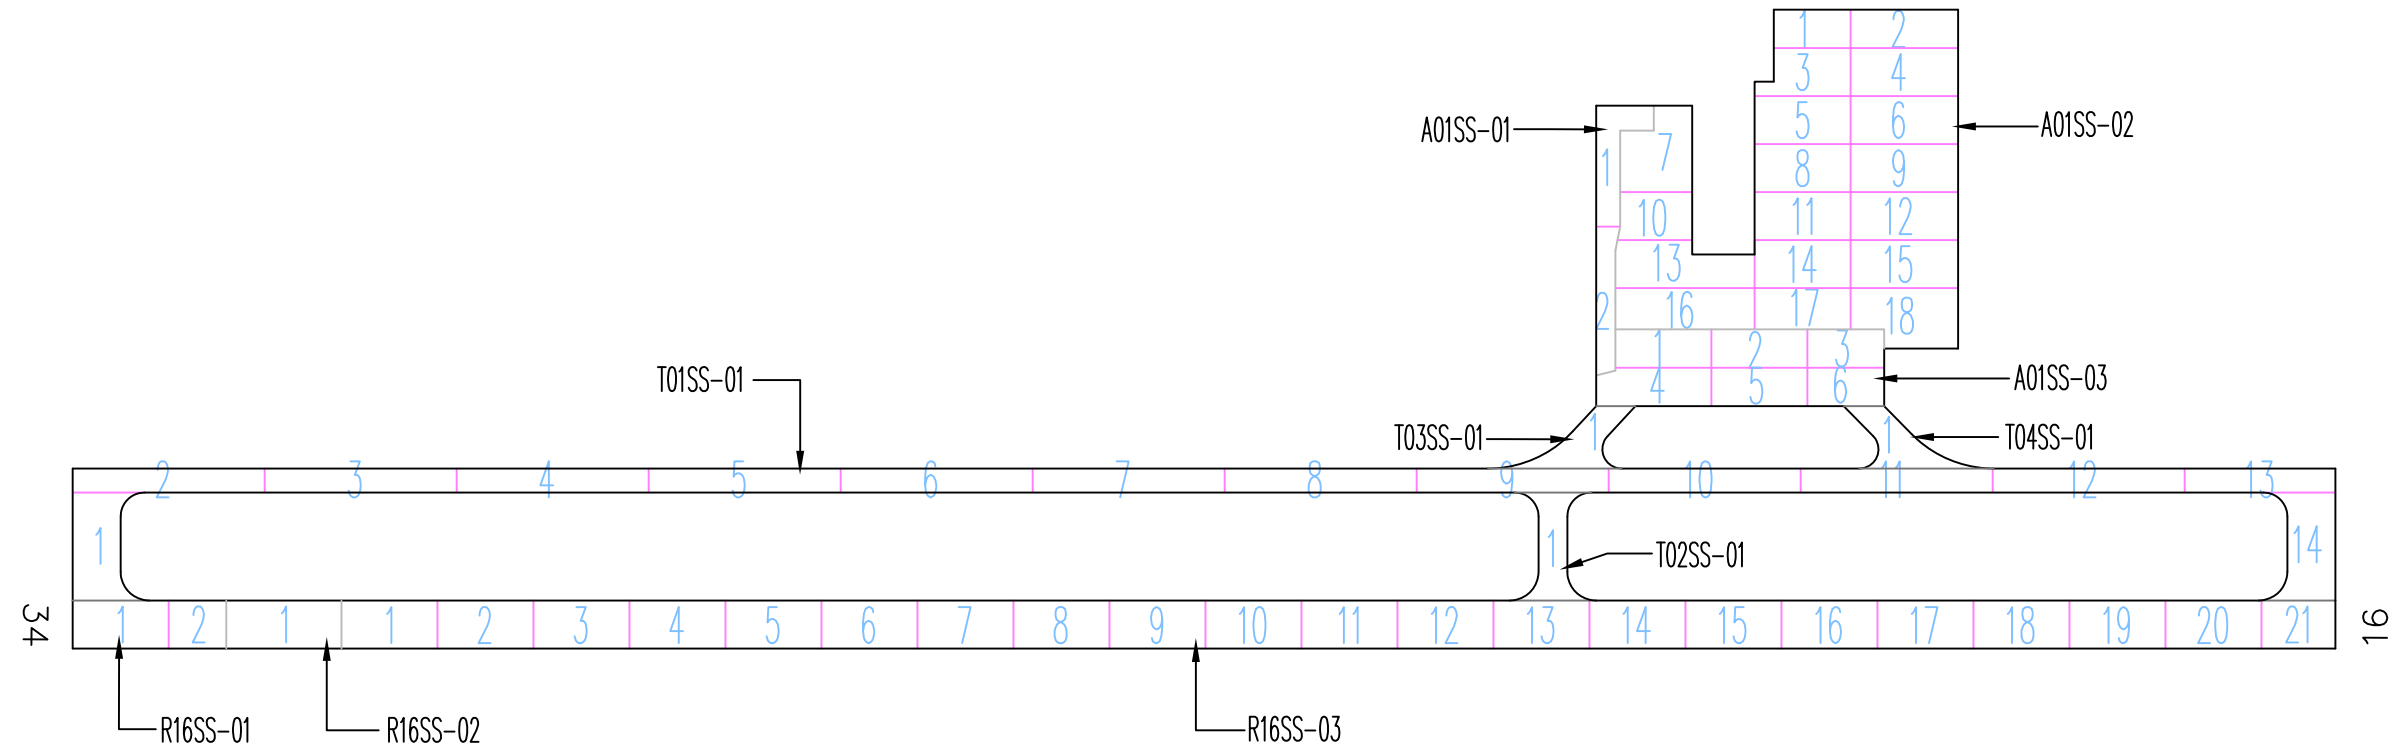
Figure SS-2. Pavement Branch, Section and Sample Unit Layout.
Seaside Municipal Airport

The pavements at your airport were divided into branches, sections and sample units in accordance with the methodology outlined in the current edition of ASTM D5430, *Standard Test Method for Airport Condition Index Surveys*. The branches, sections and sample units established at your airport are shown in Figure SS-2. A Branch Condition Report showing all branches, their associated areas, and their area-weighted average condition is provided in Appendix 1. Additionally, the Appendix 2 Section Condition Report provides information used to define each branch and section in the Micro PAVER database.
