Your Airport Report

SPORTSMAN AIRPARK

This report describes how your Pavement Maintenance Management Program (PMMP) was developed. Your Program was developed as part of the Oregon Continuous Aviation System Plan sponsored in part by the Oregon Department of Aviation and the Federal Aviation Administration (FAA). The information and data contained in this report ensures you are in compliance with the requirements of FAA Grant Assurance Number 11 which states that any airport requesting federal funds for pavement improvement projects must have implemented a pavement maintenance management program.

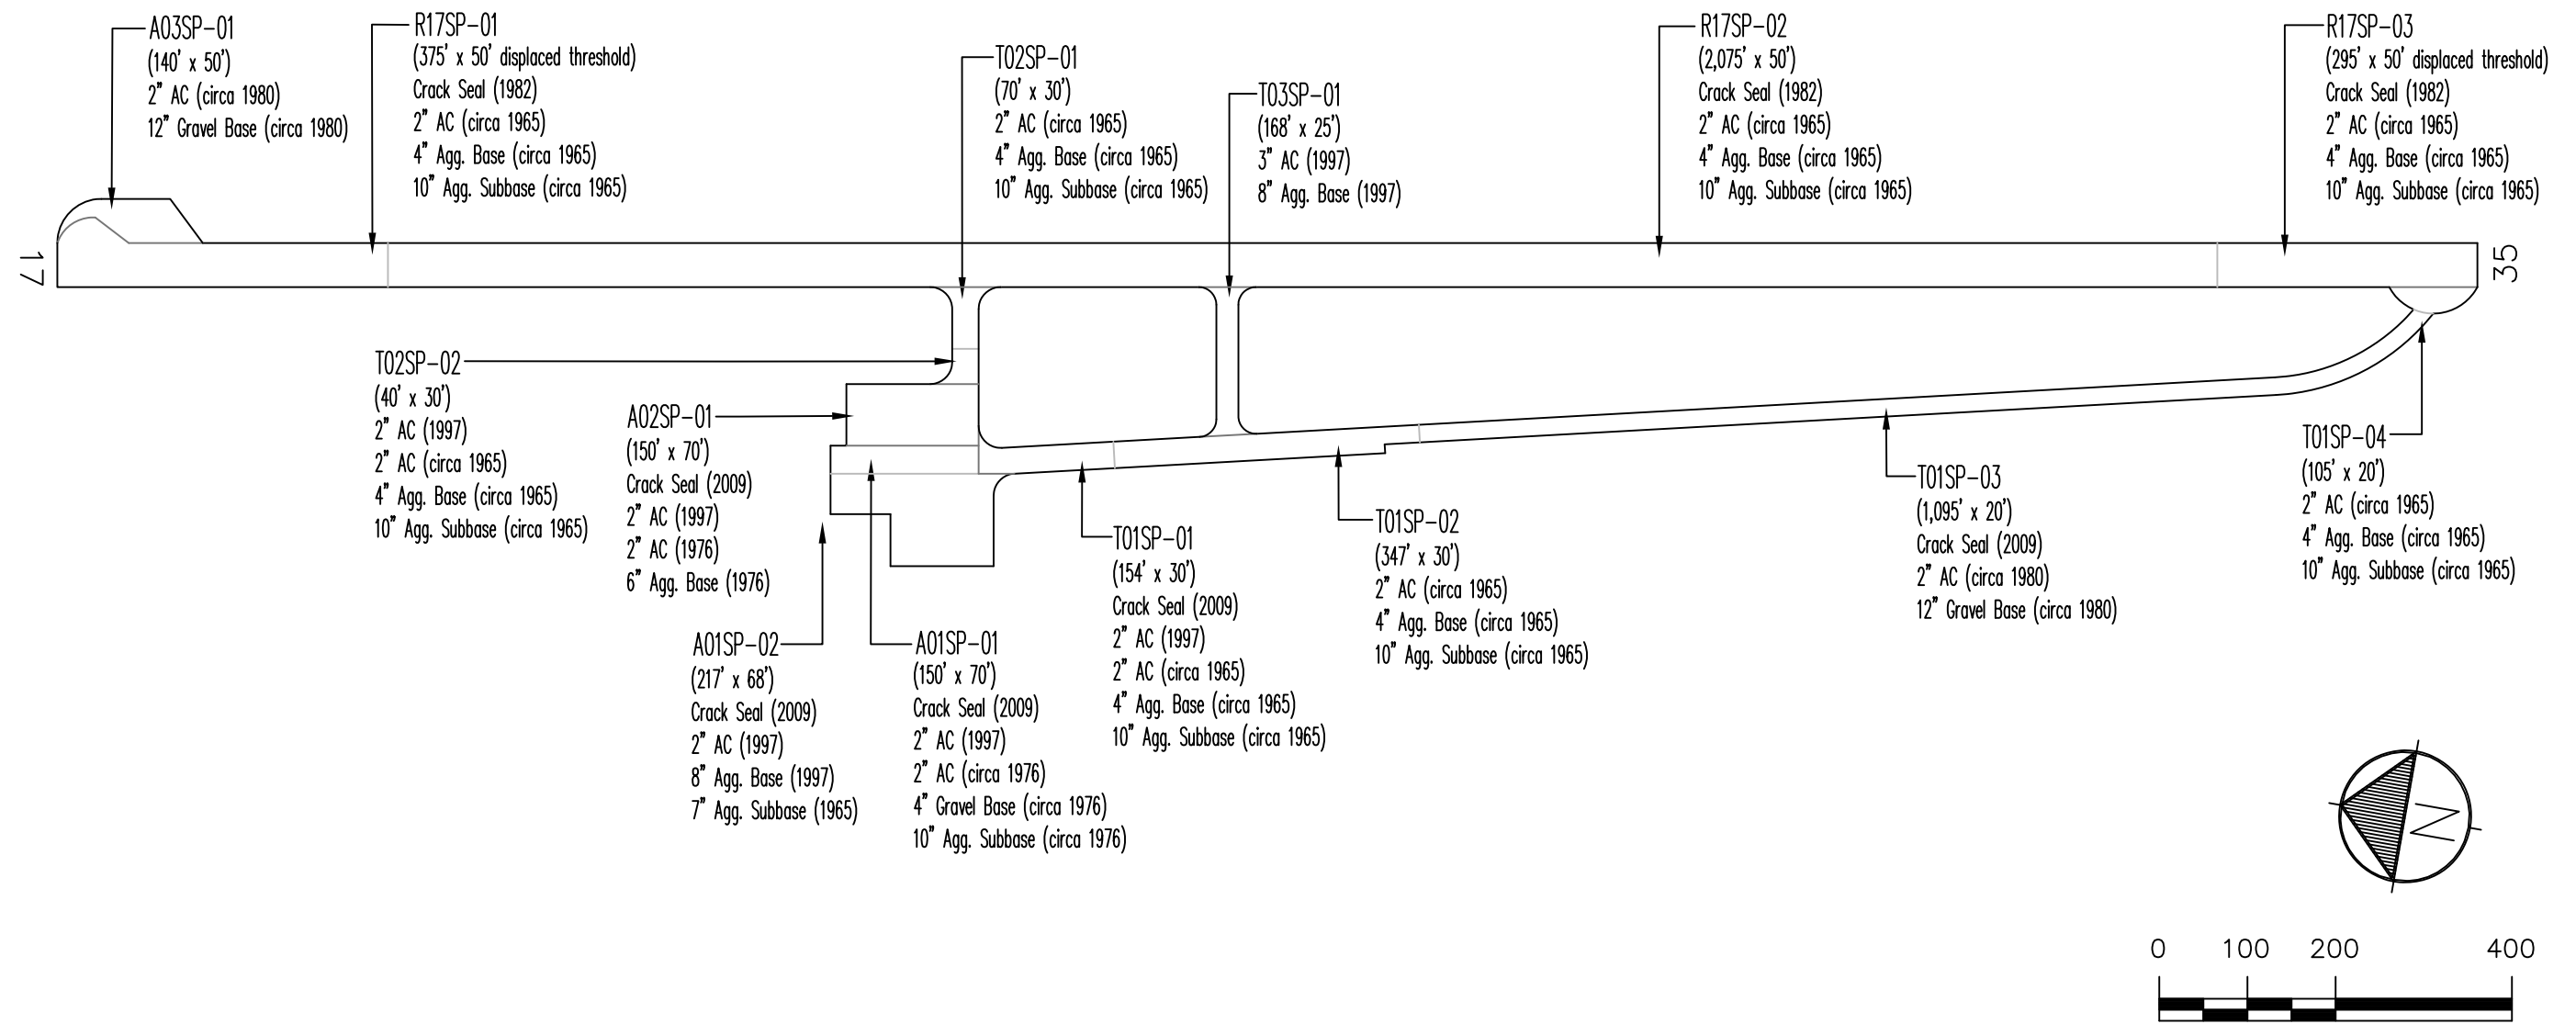
Figure SP-1. Airport Layout, Dimensions and Pavement Cross-Sections.
Sportsman Airpark

To determine how your pavements were constructed and their age, a records review was conducted. Figure SP-1 shows the records review results. This figure identifies pavement boundaries, dimensions, pavement layer types, thicknesses and dates of construction. The most recent construction date for each pavement can also be found in the Section Condition Report in Appendix 2. Figure SP-1 and the information contained in Appendices 1, 2 and 4 ensure that your airport complies with the “pavement inventory” requirement of FAA’s PMMP guidelines.

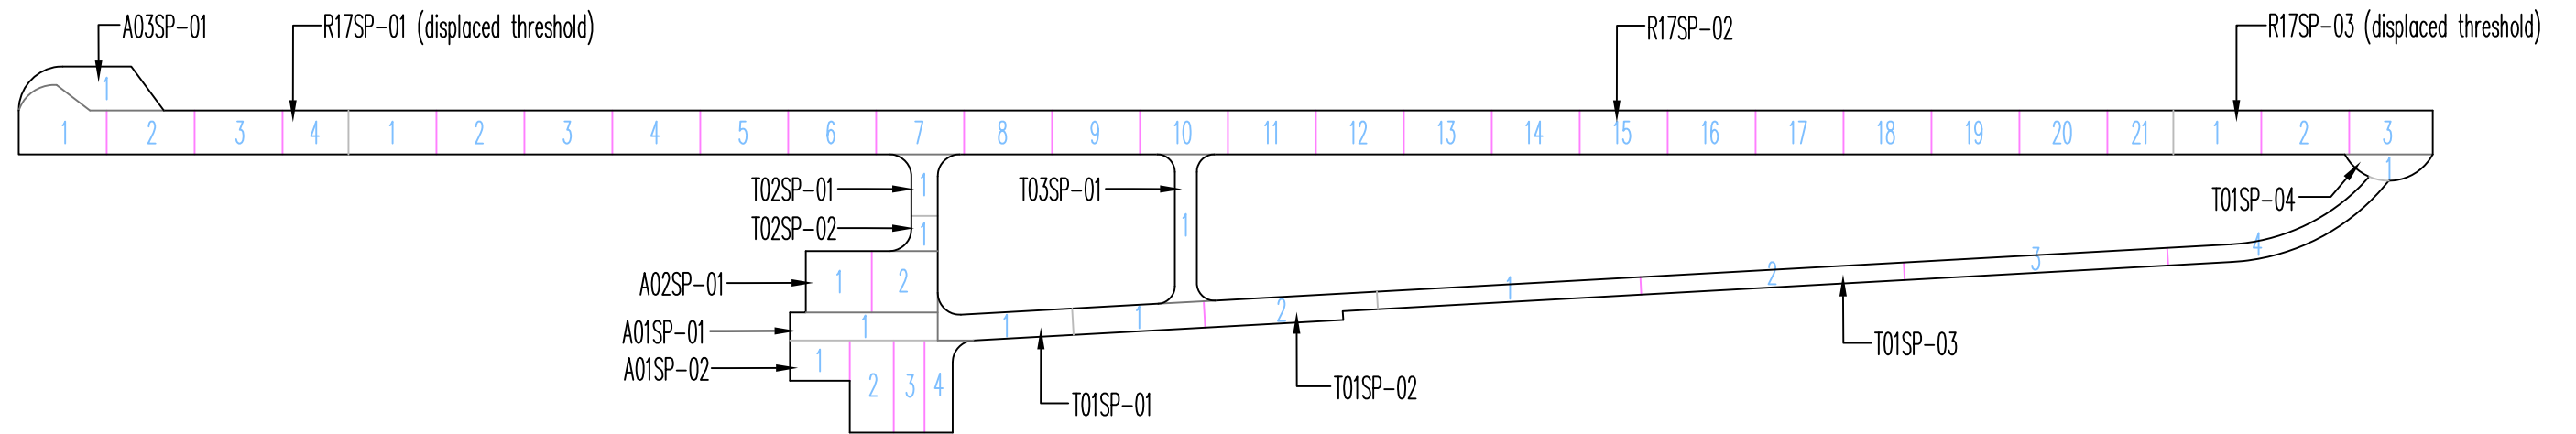
Figure SP-2. Pavement Branch, Section and Sample Unit Layout.
Sportsman Airpark

The pavements at your airport were divided into branches, sections and sample units in accordance with the methodology outlined in the current edition of ASTM D5430, *Standard Test Method for Airport Condition Index Surveys*. The branches, sections and sample units established at your airport are shown in Figure SP-2. A Branch Condition Report showing all branches, their associated areas, and their area-weighted average condition is provided in Appendix 1. Additionally, the Appendix 2 Section Condition Report provides information used to define each branch and section in the Micro PAVER database.
