Your Airport Report

TOLEDO STATE AIRPORT

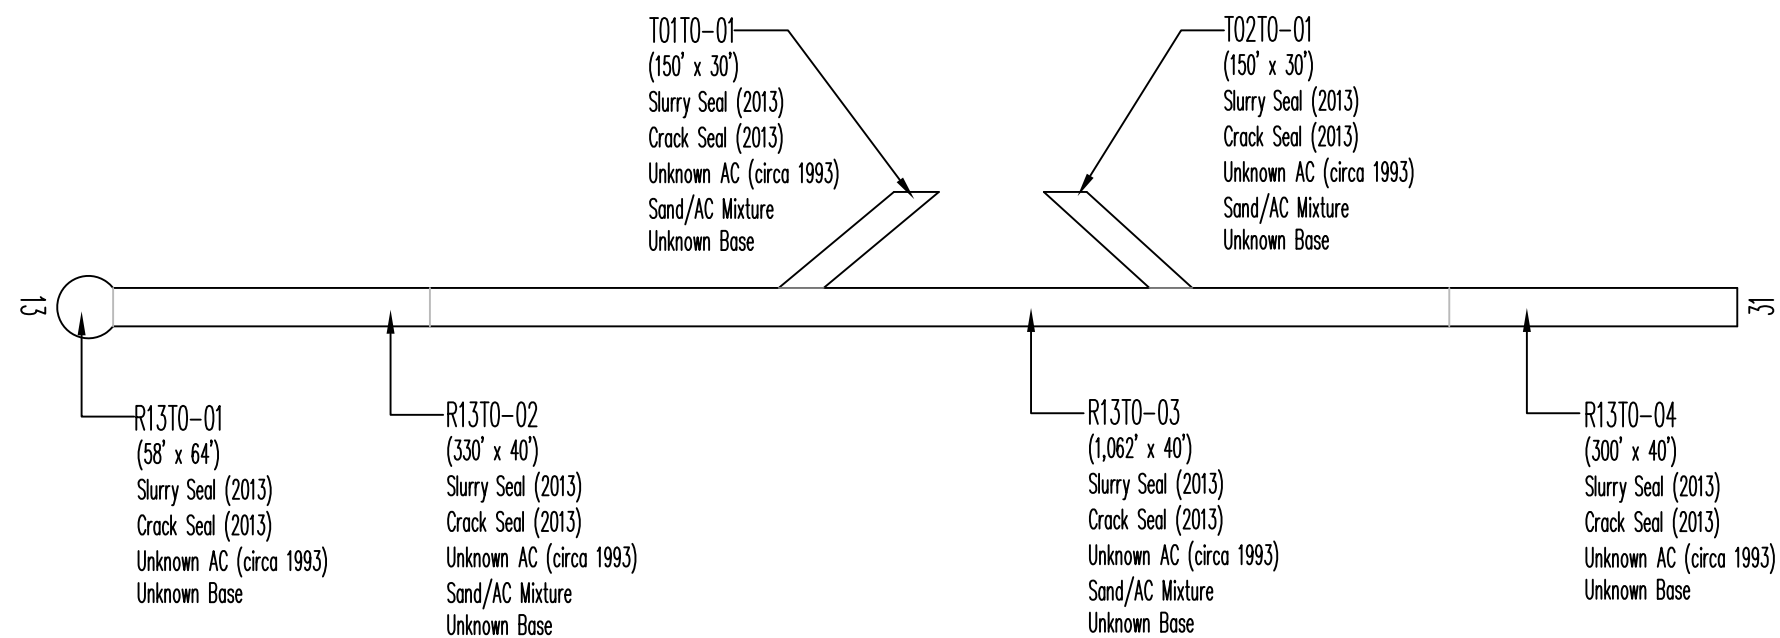
Figure T0-1. Airport Layout, Dimensions and Pavement Cross-Sections.
Toledo State Airport

To determine how your pavements were constructed and their age, a records review was conducted. Figure TO-1 shows the records review results. This figure identifies pavement boundaries, dimensions, pavement layer types, thicknesses and dates of construction. The most recent construction date for each pavement can also be found in the Section Condition Report in Appendix 2. Figure TO-1 and the information contained in Appendices 1, 2 and 4 ensure that your airport complies with the “pavement inventory” requirement of FAA’s PMMP guidelines.

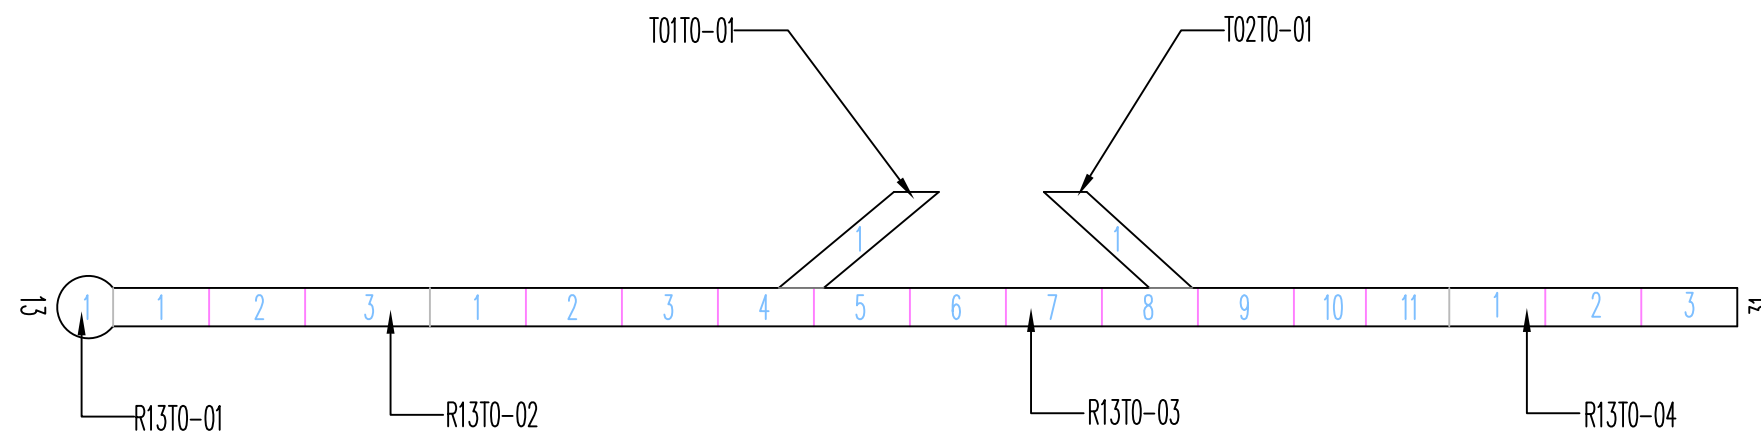
Figure T0-2. Pavement Branch, Section and Sample Unit Layout.
Toledo State Airport

The pavements at your airport were divided into branches, sections and sample units in accordance with the methodology outlined in the current edition of ASTM D5430, *Standard Test Method for Airport Condition Index Surveys*. The branches, sections and sample units established at your airport are shown in Figure TO-2. A Branch Condition Report showing all branches, their associated areas, and their area-weighted average condition is provided in Appendix 1. Additionally, the Appendix 2 Section Condition Report provides information used to define each branch and section in the Micro PAVER database.

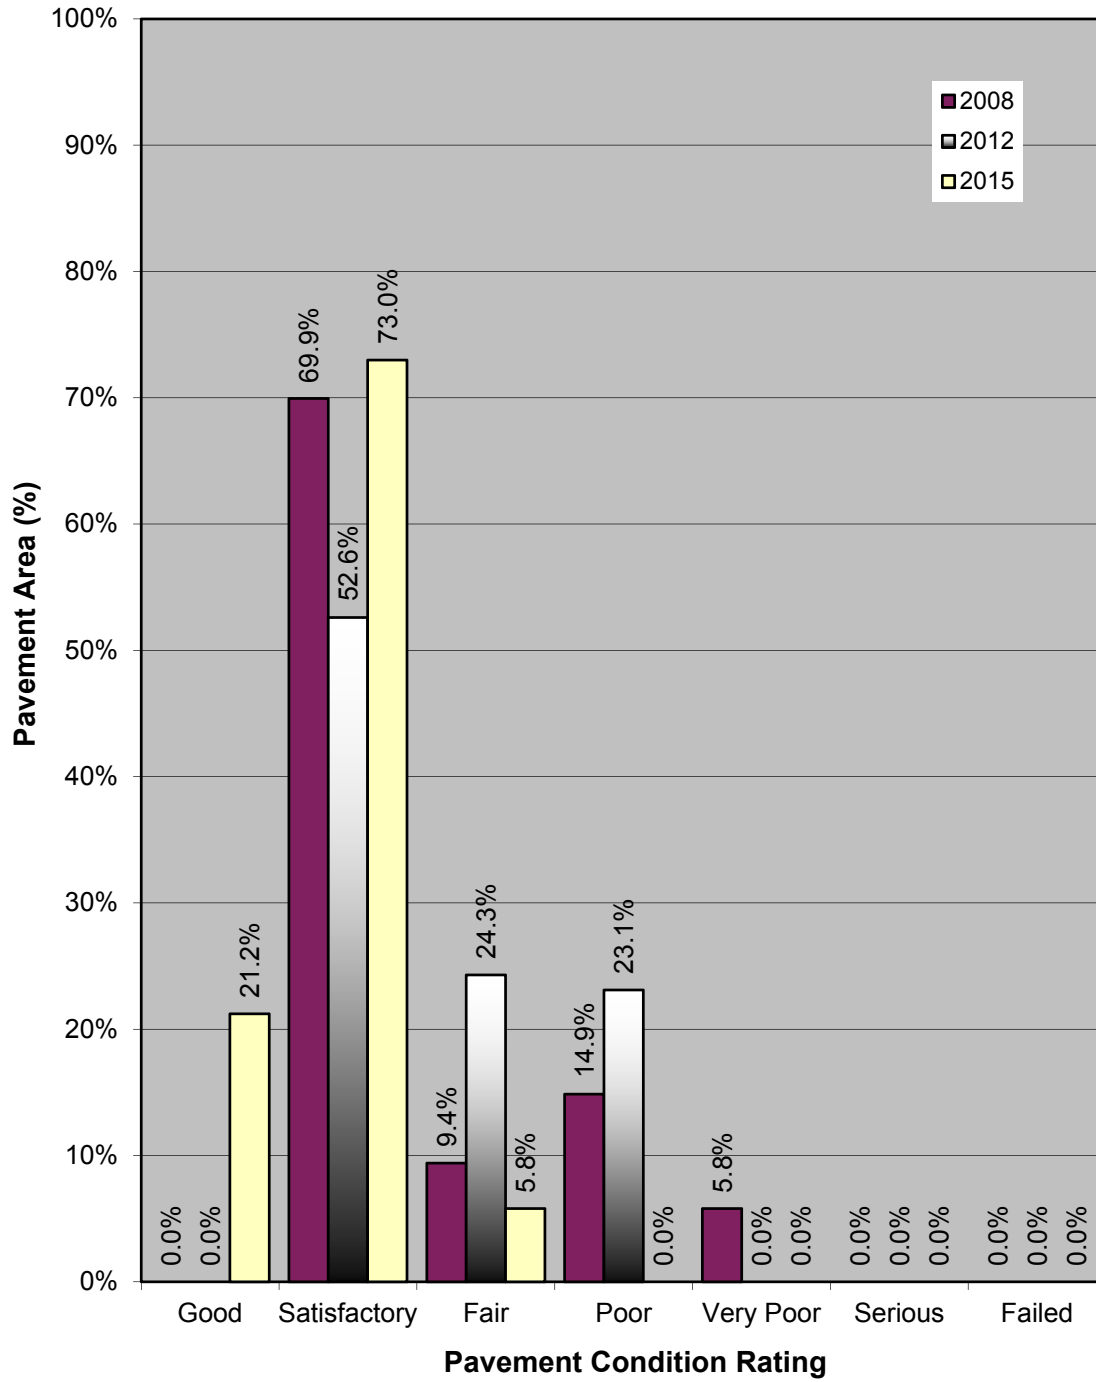
**Figure TO-4. Pavement Condition Distribution
Toledo State Airport**

Section PCIs at Toledo State Airport range from a low of 68 (a PCR of “Fair”) to a high of 91 (a PCR of “Good”). The area-weighted average PCI for all airport pavements is 84, corresponding to an overall PCR of “Satisfactory”. Figure TO-4 shows how much pavement area is associated with each Pavement Condition Rating category and also shows pavement condition distribution from the inspections conducted in 2008 and 2012.
