BROOKINGS AIRPORT

Figure BR-1. Airport Layout, Dimensions and Pavement Cross-Sections.
Brookings Airport

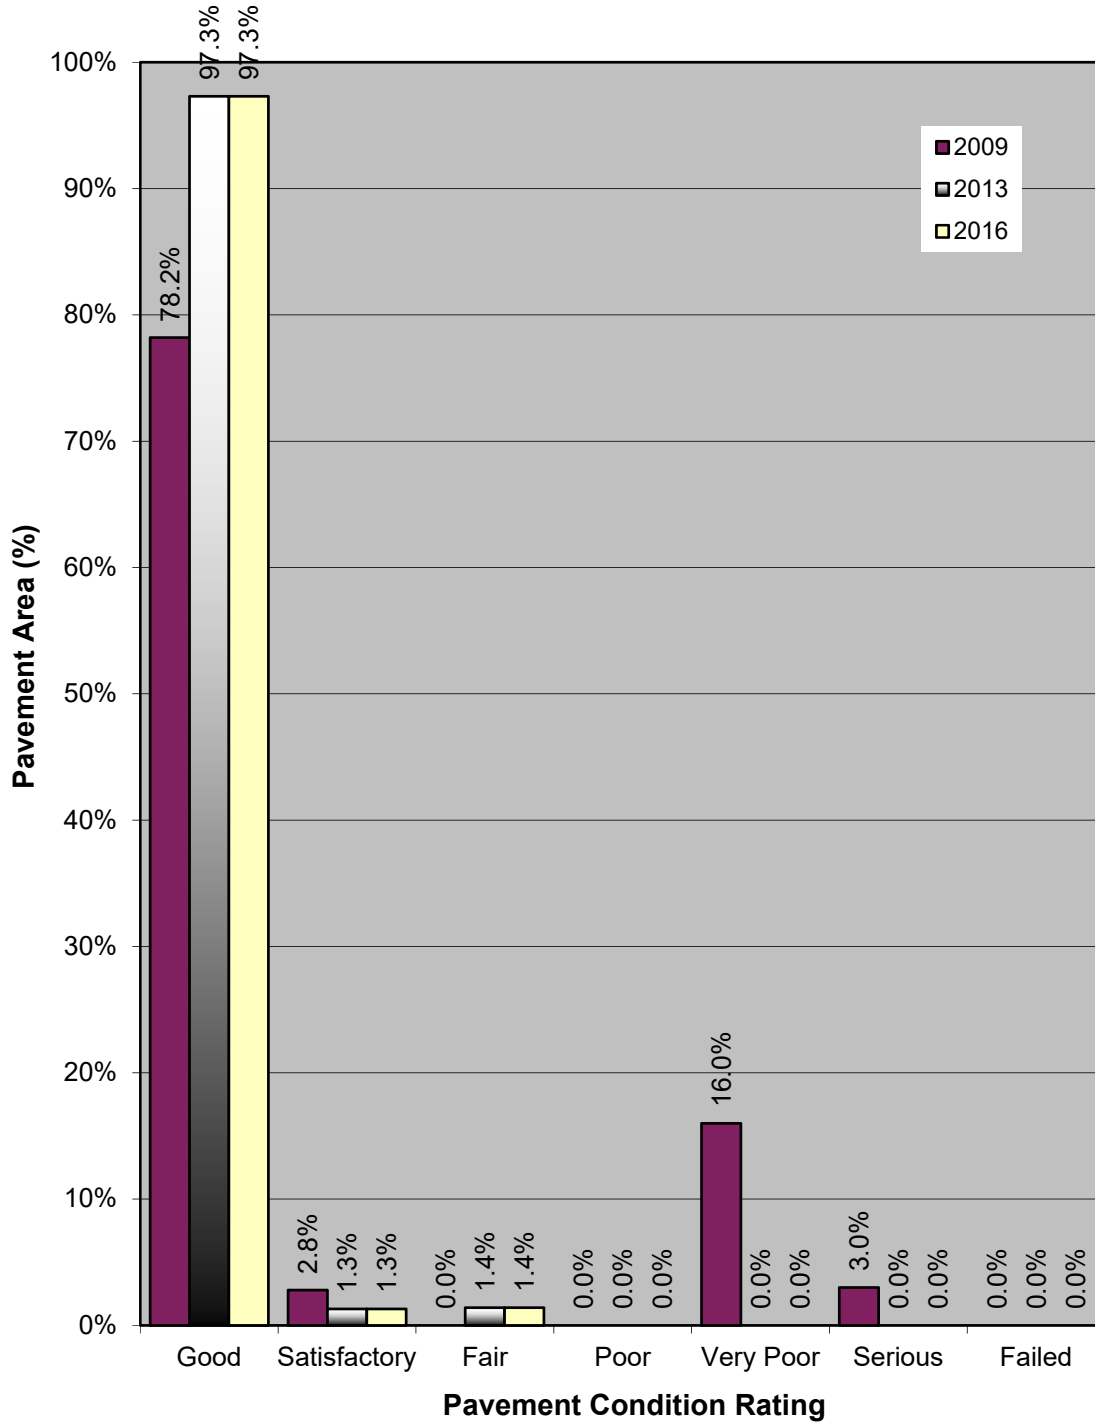
**Figure BR-4. Pavement Condition Distribution
Brookings Airport**

Section PCIs at Brookings Airport range from a low of 63 (a PCR of “Fair”) to a high of 100 (a PCR of “Good”). The area-weighted average PCI for all airport pavements is 94, corresponding to an overall PCR of “Good”. Figure BR-4 shows how much pavement area is associated with each Pavement Condition Rating category and also shows pavement condition distribution from the inspections conducted in 2009 and 2013.
