CHILOQUIN STATE AIRPORT

Figure CH-1. Airport Layout, Dimensions and Pavement Cross-Sections.
Chiloquin State Airport

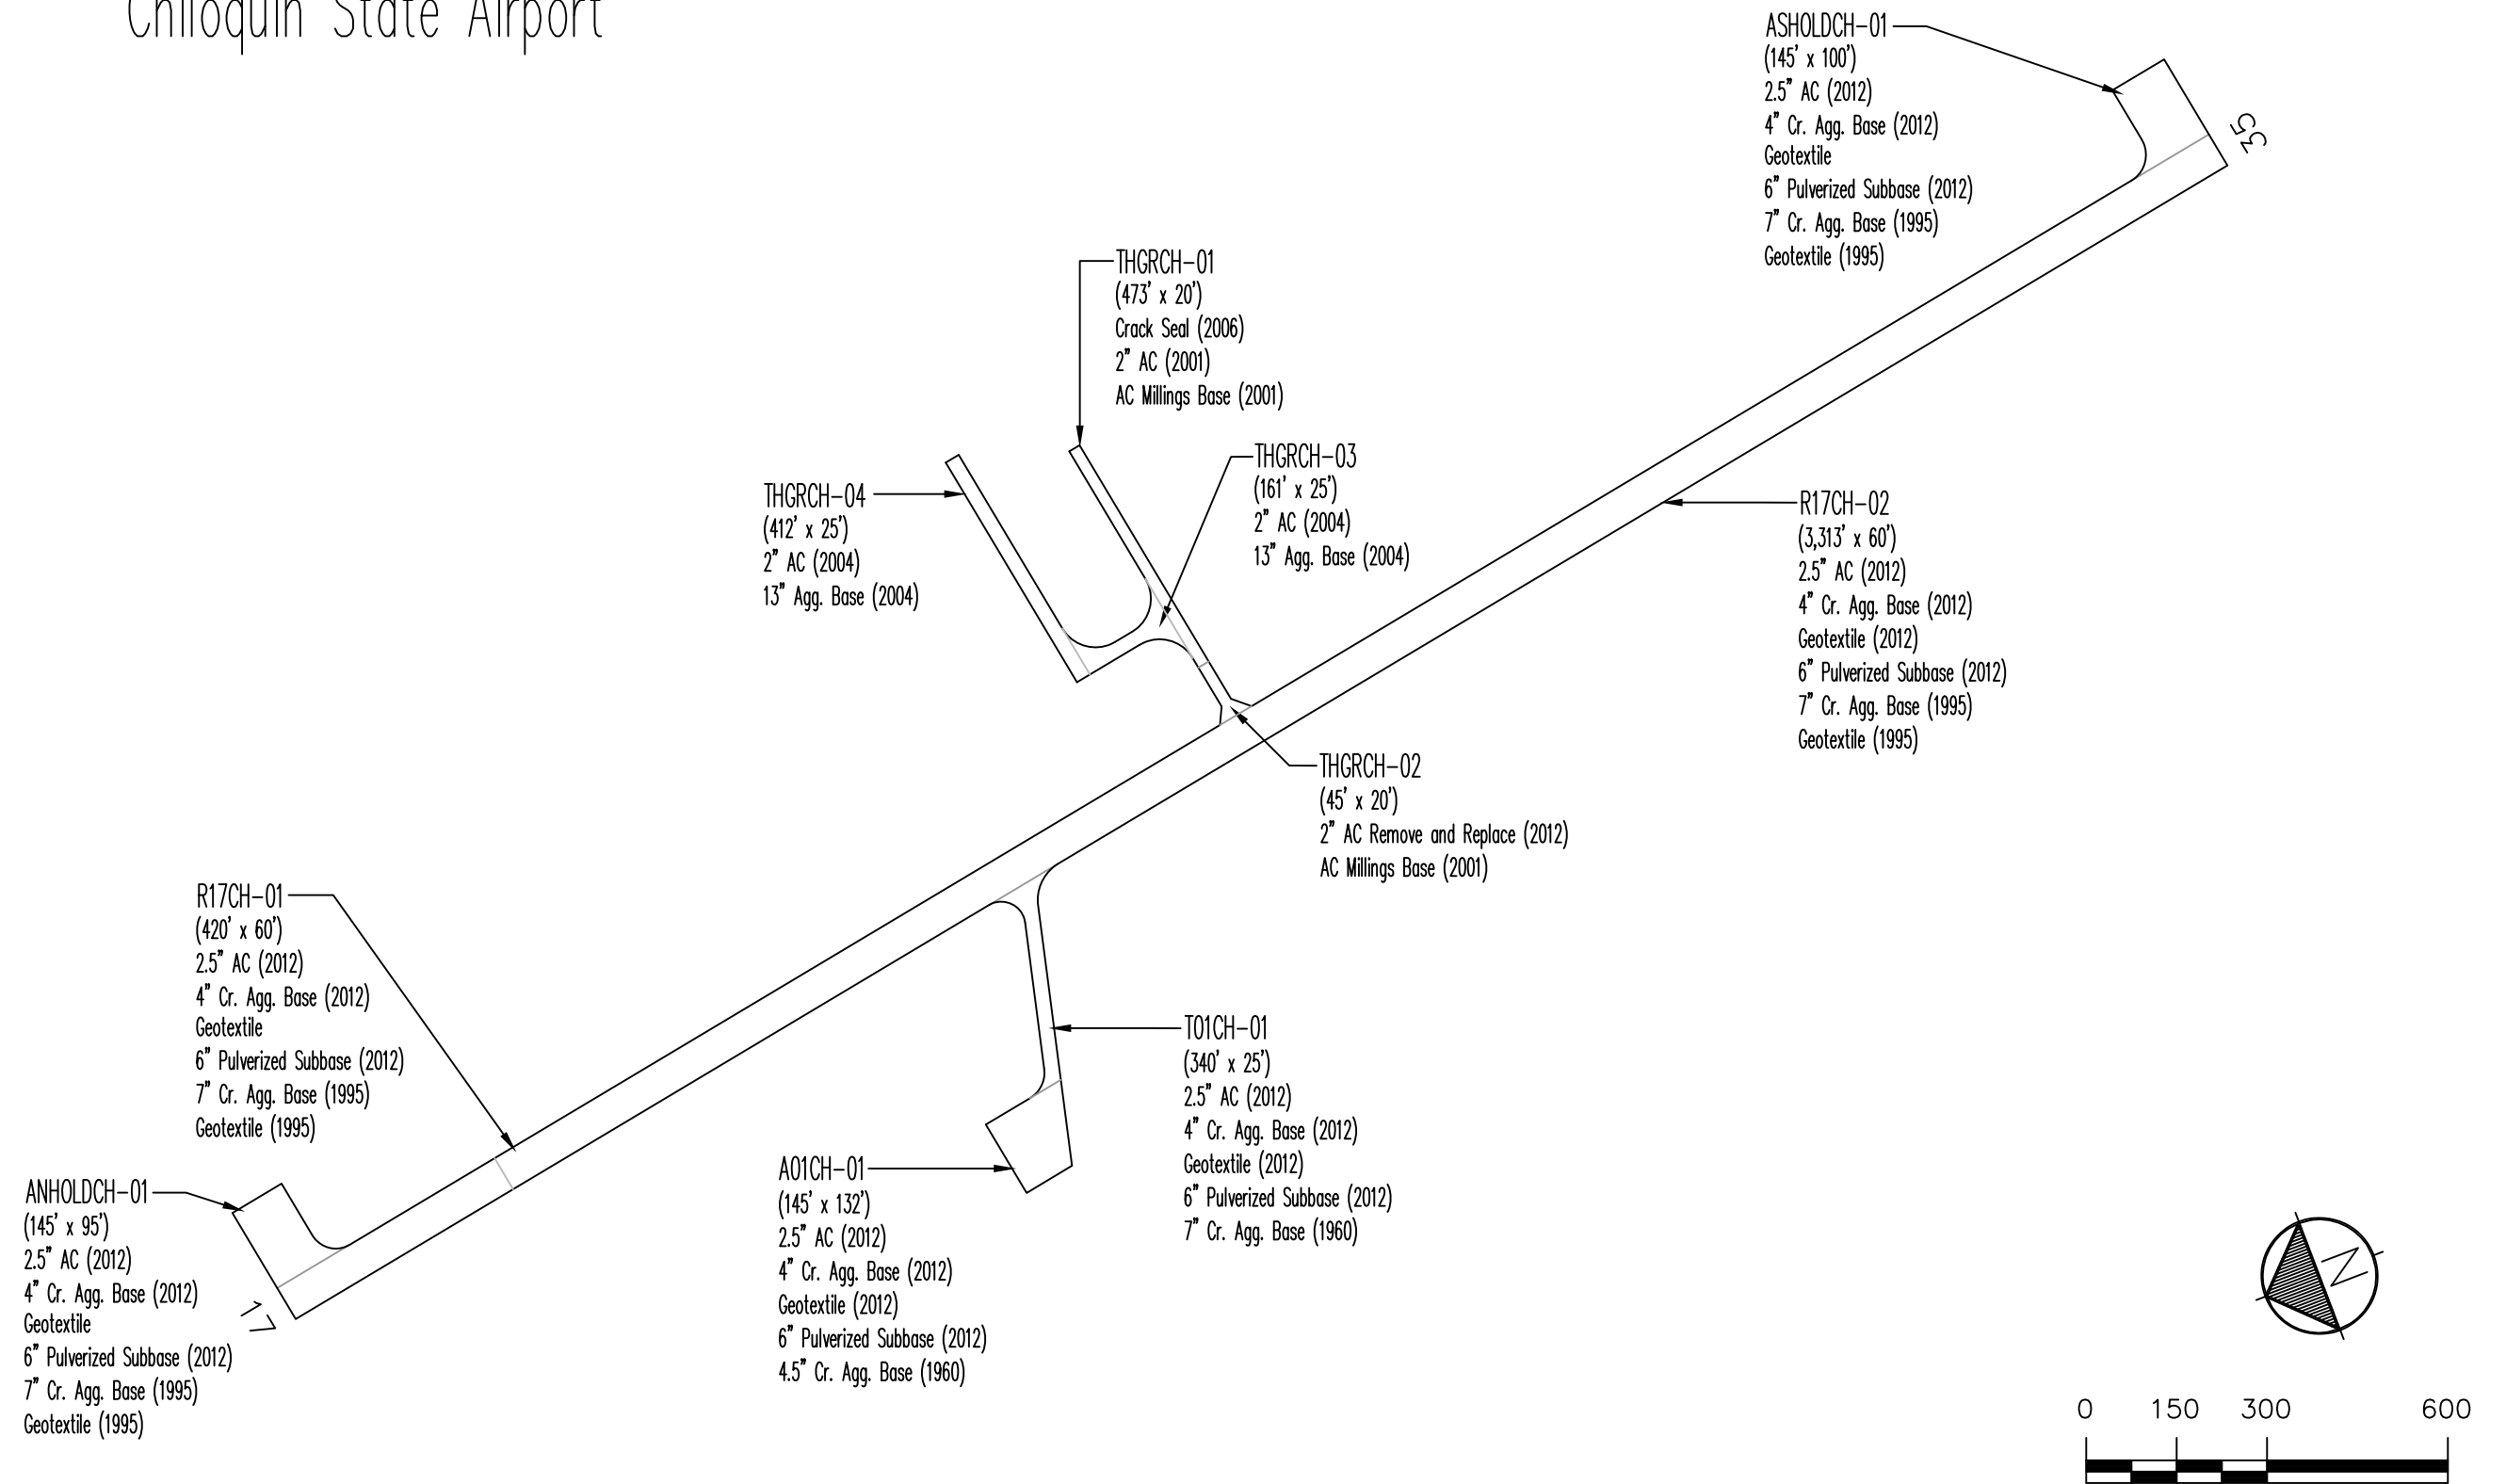
To determine how your pavements were constructed and their age, a records review was conducted. Figure CH-1 shows the records review results. This figure identifies pavement boundaries, dimensions, pavement layer types, thicknesses and dates of construction. The most recent construction date for each pavement can also be found in the Section Condition Report in Appendix 2. Figure CH-1 and the information contained in Appendices 1, 2 and 4 ensure that your airport complies with the “pavement inventory” requirement of FAA’s PMMP guidelines.

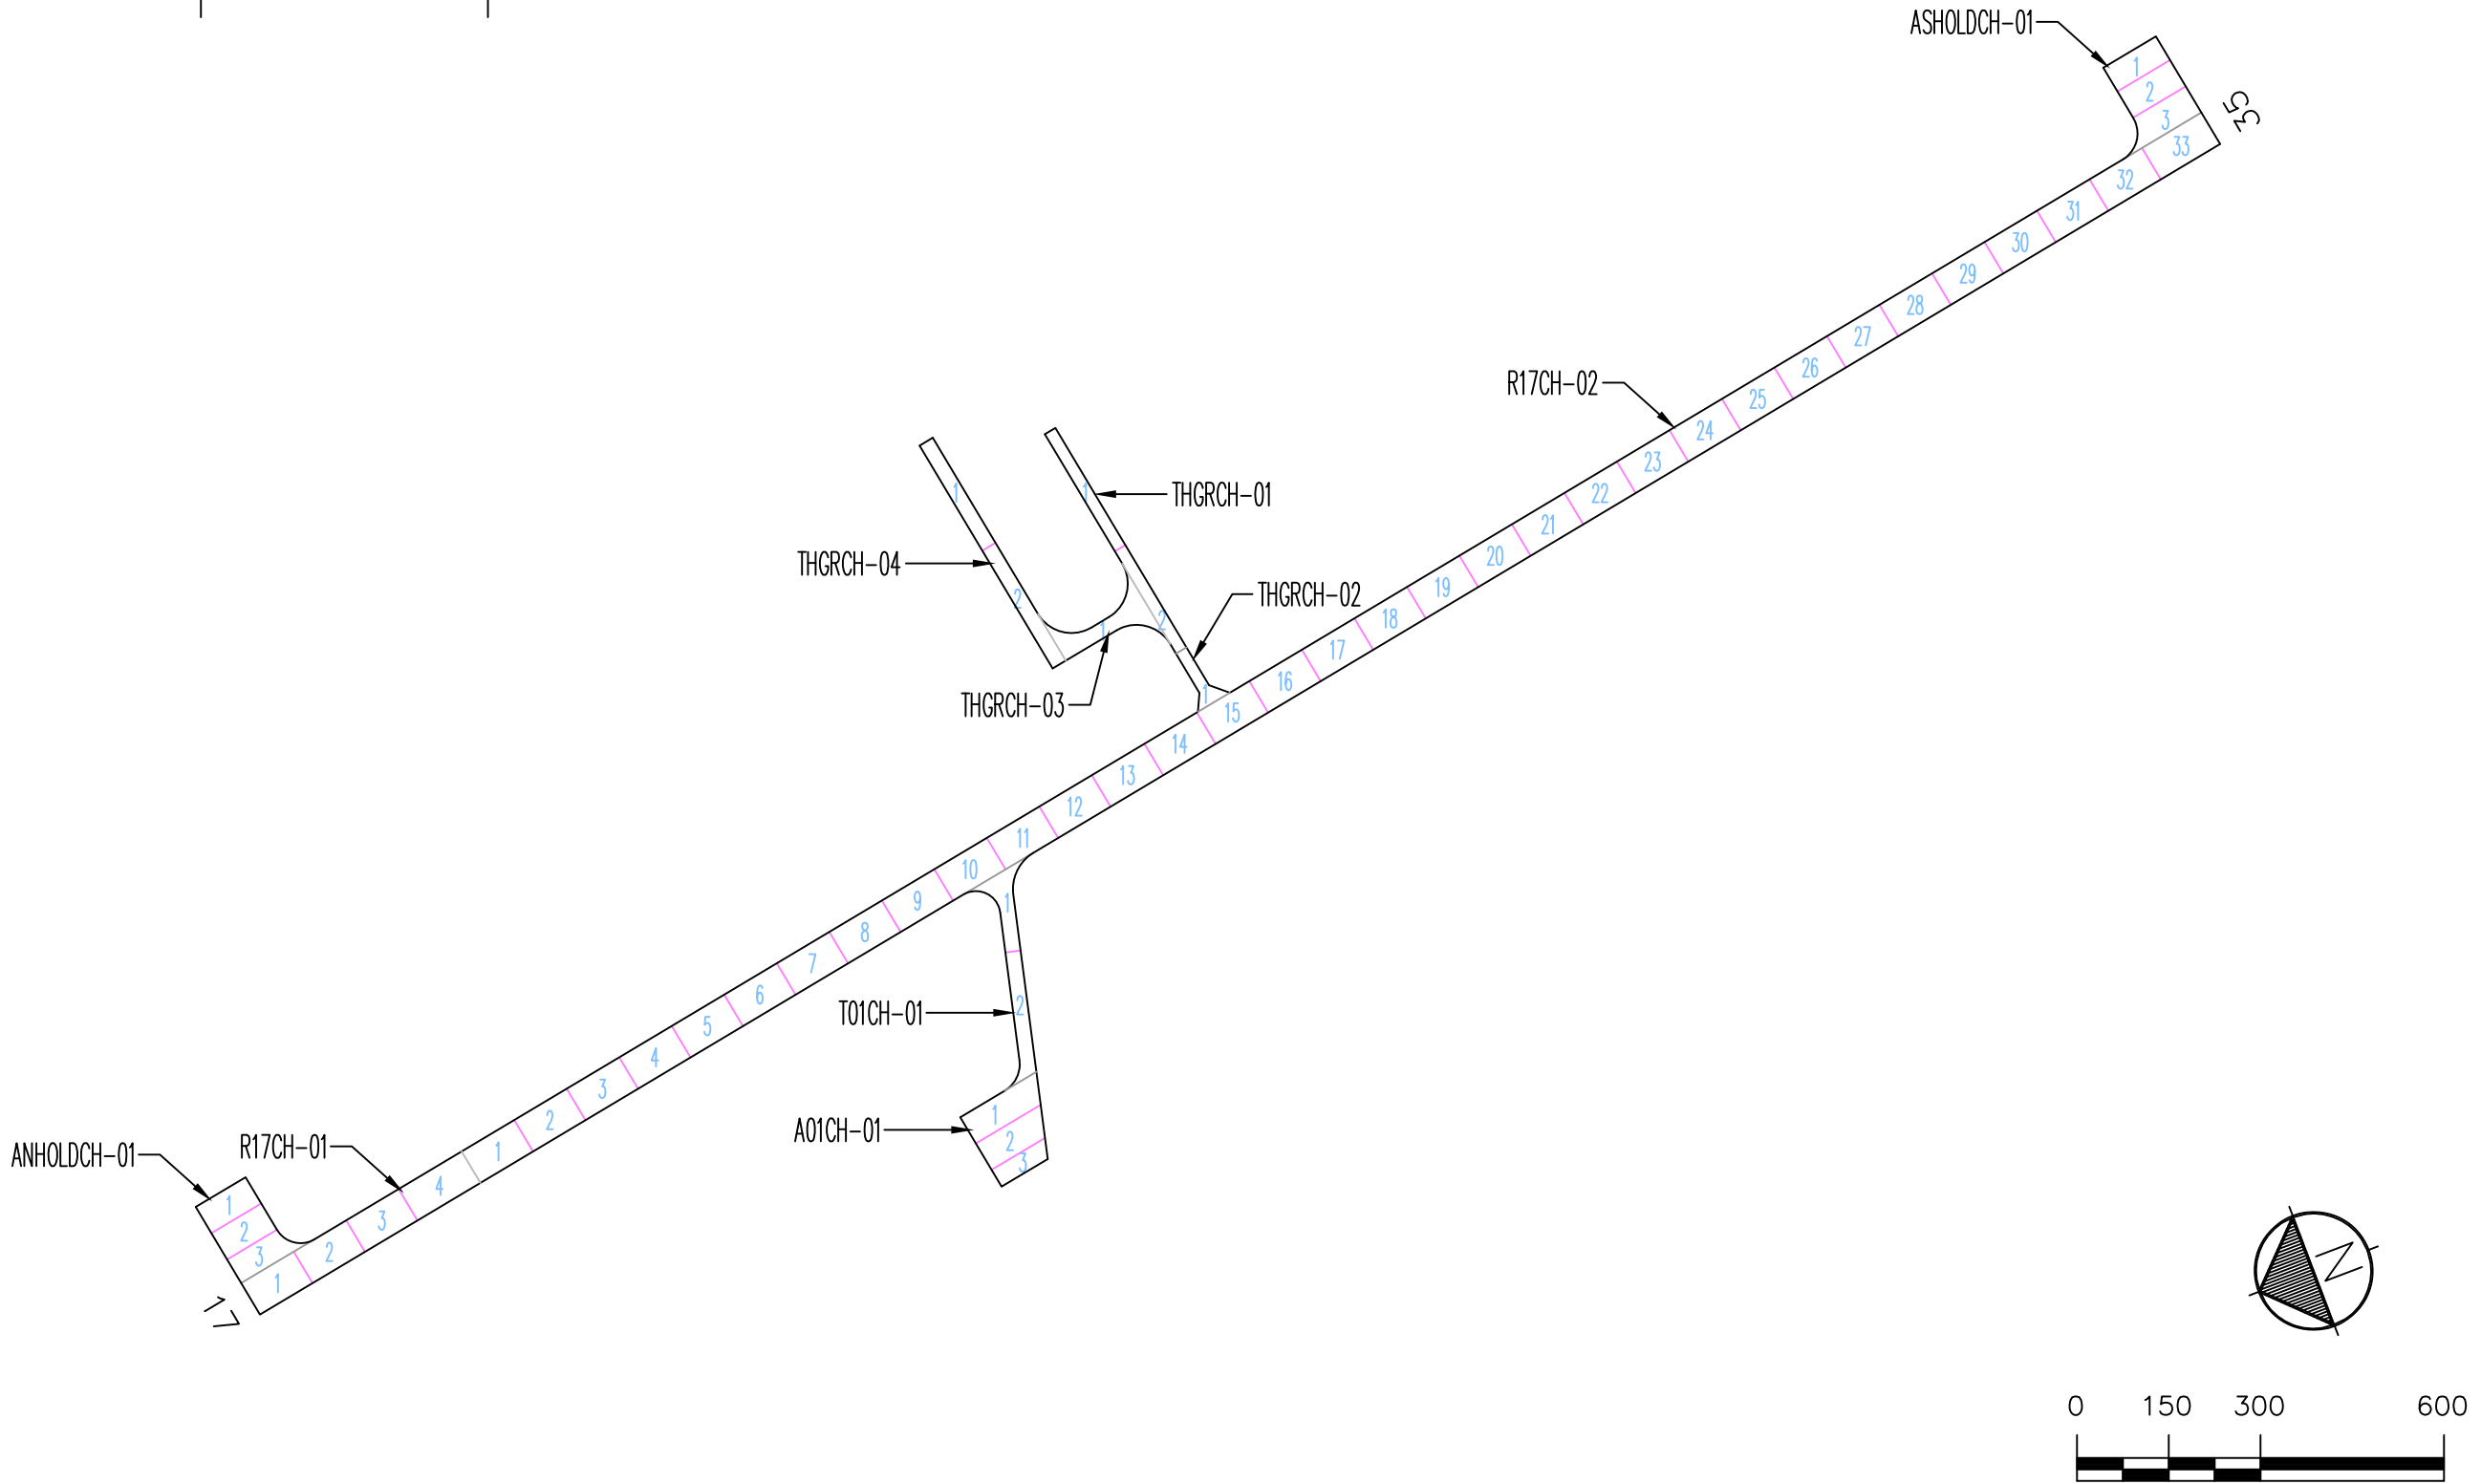
Figure CH-2. Pavement Branch, Section and Sample Unit Layout.
Chiloquin State Airport

The pavements at your airport were divided into branches, sections and sample units in accordance with the methodology outlined in the current edition of ASTM D5430, *Standard Test Method for Airport Condition Index Surveys*. The branches, sections and sample units established at your airport are shown in Figure CH-2. A Branch Condition Report showing all branches, their associated areas, and their area-weighted average condition is provided in Appendix 1. Additionally, the Appendix 2 Section Condition Report provides information used to define each branch and section in the Micro PAVER database.
