# COTTAGE GROVE STATE AIRPORT

This report describes how your Pavement Maintenance Management Program (PMMP) was developed. Your Program was developed as part of the Oregon Continuous Aviation System Plan sponsored in part by the Oregon Department of Aviation and the Federal Aviation Administration (FAA). The information and data contained in this report ensures you are in compliance with the requirements of FAA Grant Assurance Number 11 which states that any airport requesting federal funds for pavement improvement projects must have implemented a pavement maintenance management program.

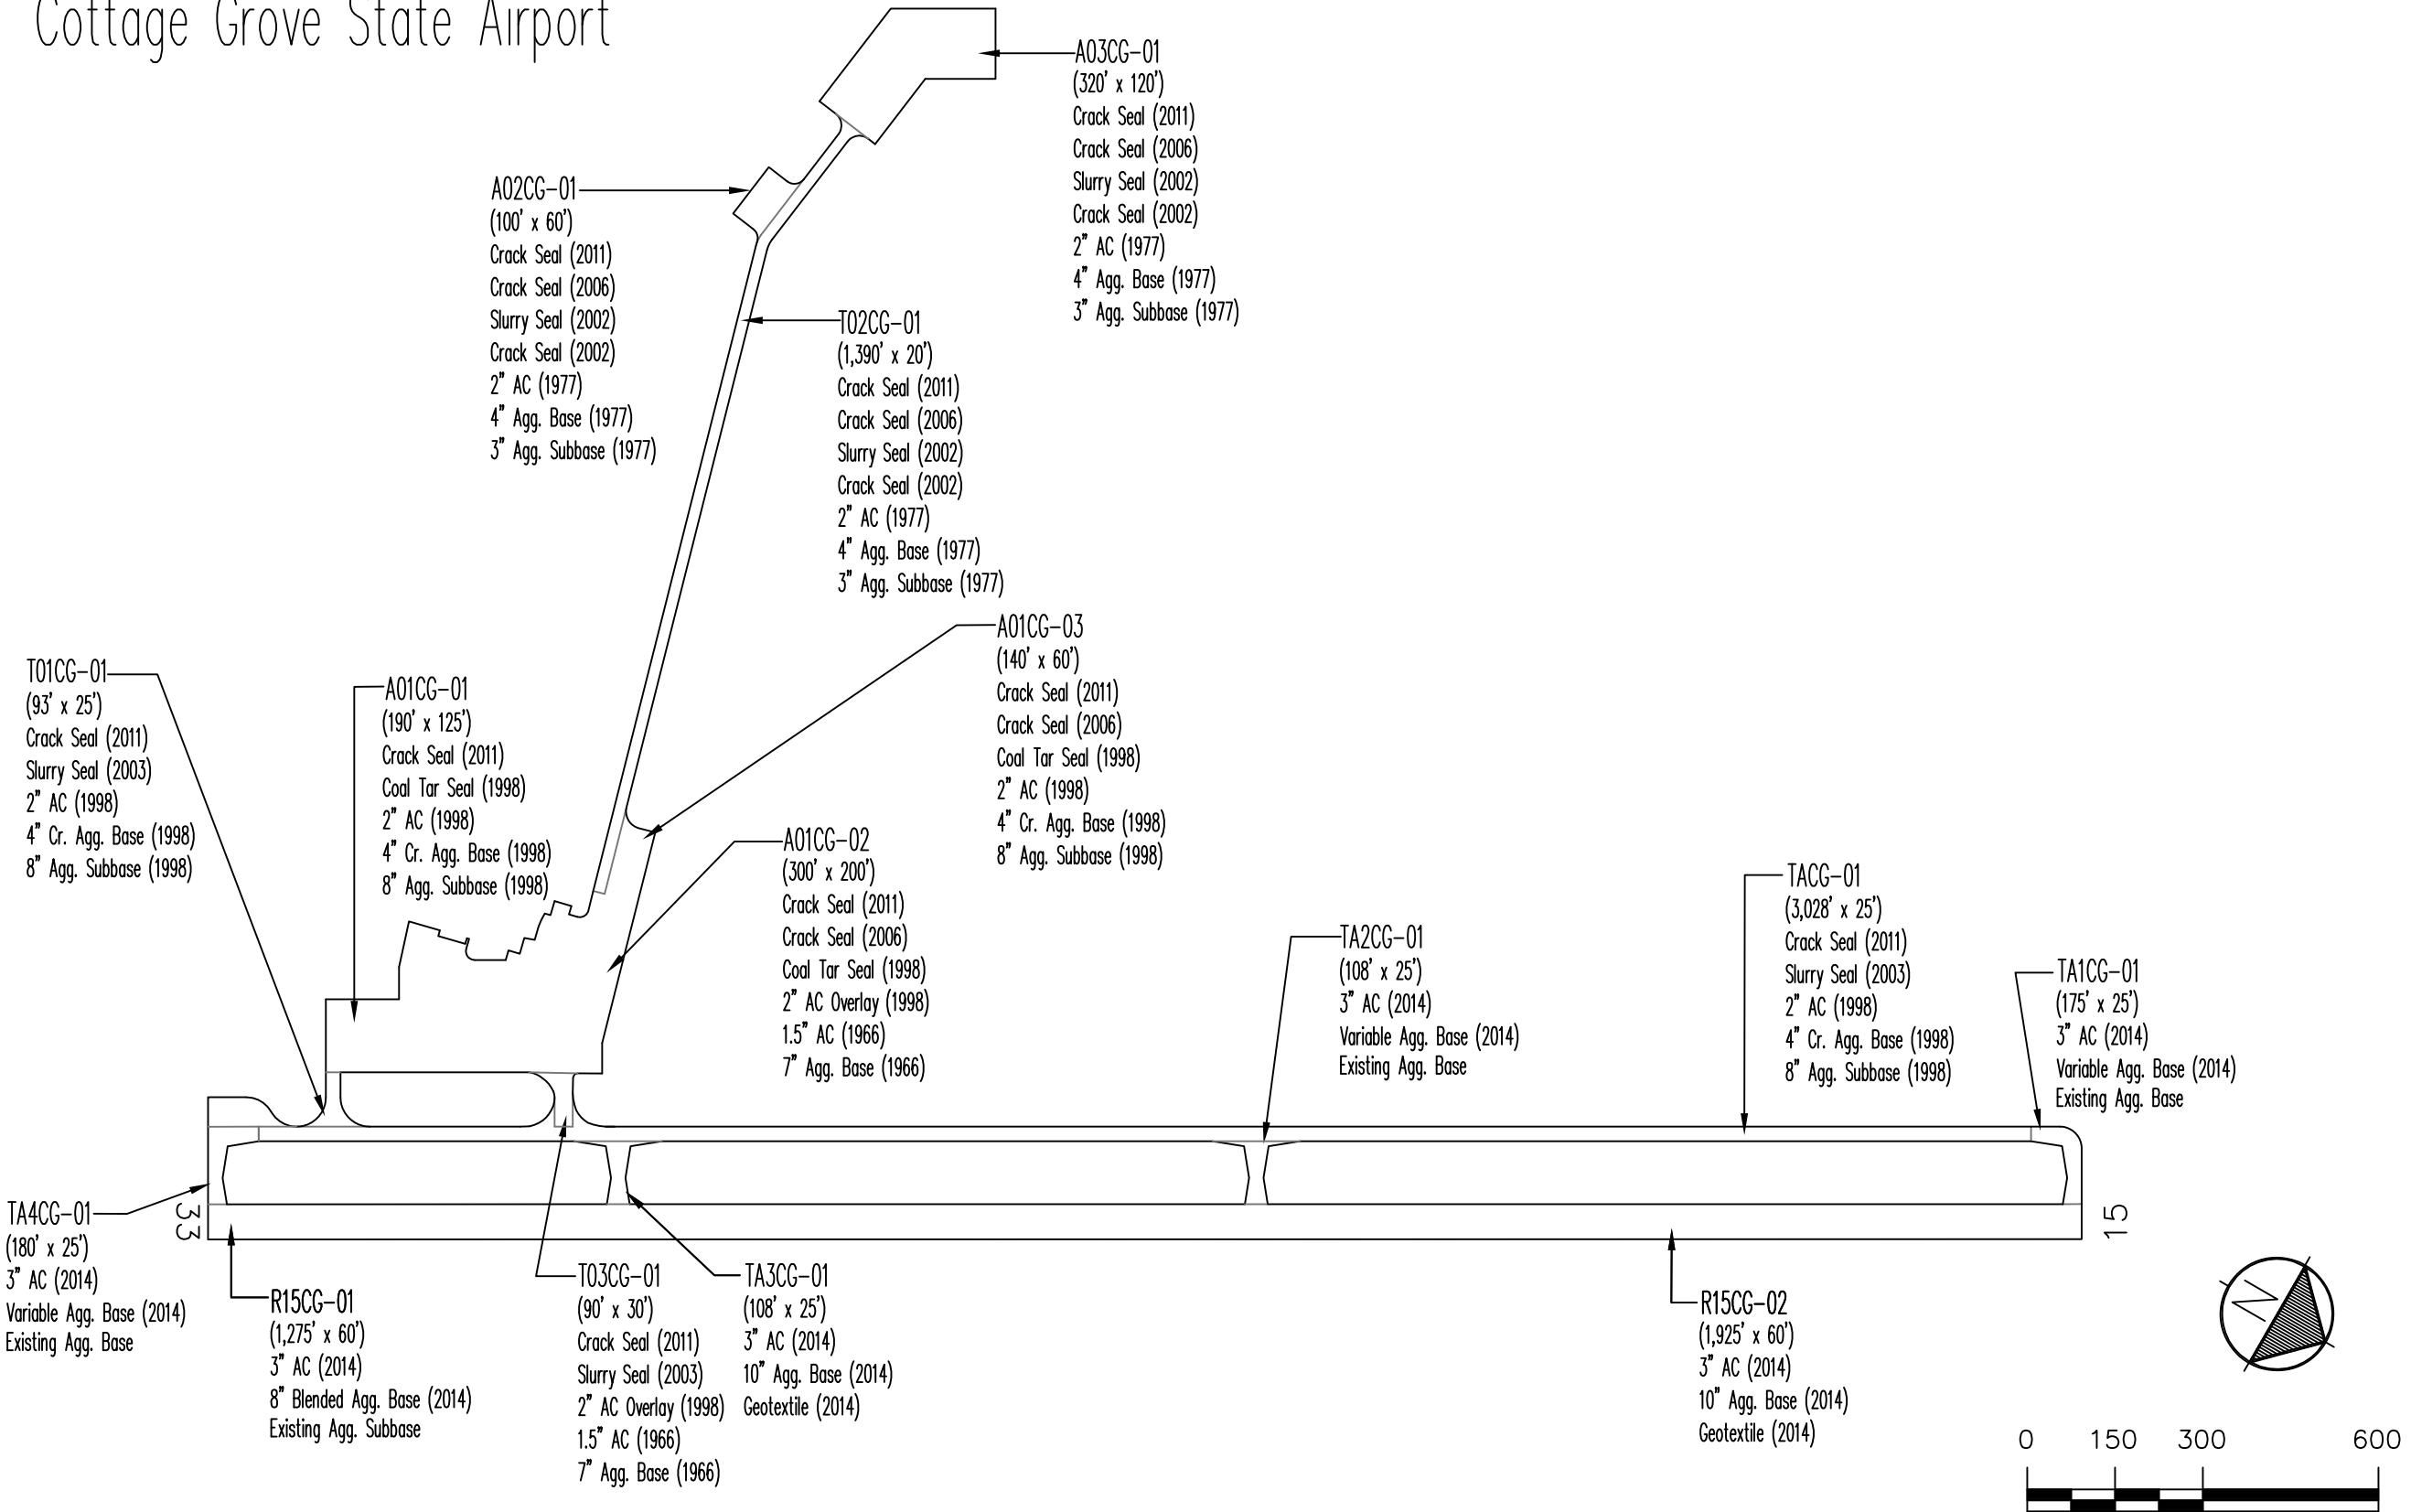
Figure CG-1. Airport Layout, Dimensions and Pavement Cross-Sections.

To determine how your pavements were constructed and their age, a records review was conducted. Figure CG-1 shows the records review results. This figure identifies pavement boundaries, dimensions, pavement layer types, thicknesses and dates of construction. The most recent construction date for each pavement can also be found in the Section Condition Report in Appendix 2. Figure CG-1 and the information contained in Appendices 1, 2 and 4 ensure that your airport complies with the “pavement inventory” requirement of FAA’s PMMP guidelines.
