# CRESWELL HOBBY FIELD

Figure CE-1. Airport Layout, Dimensions and Pavement Cross-Sections.  
Creswell Municipal Airport (Hobby Field)

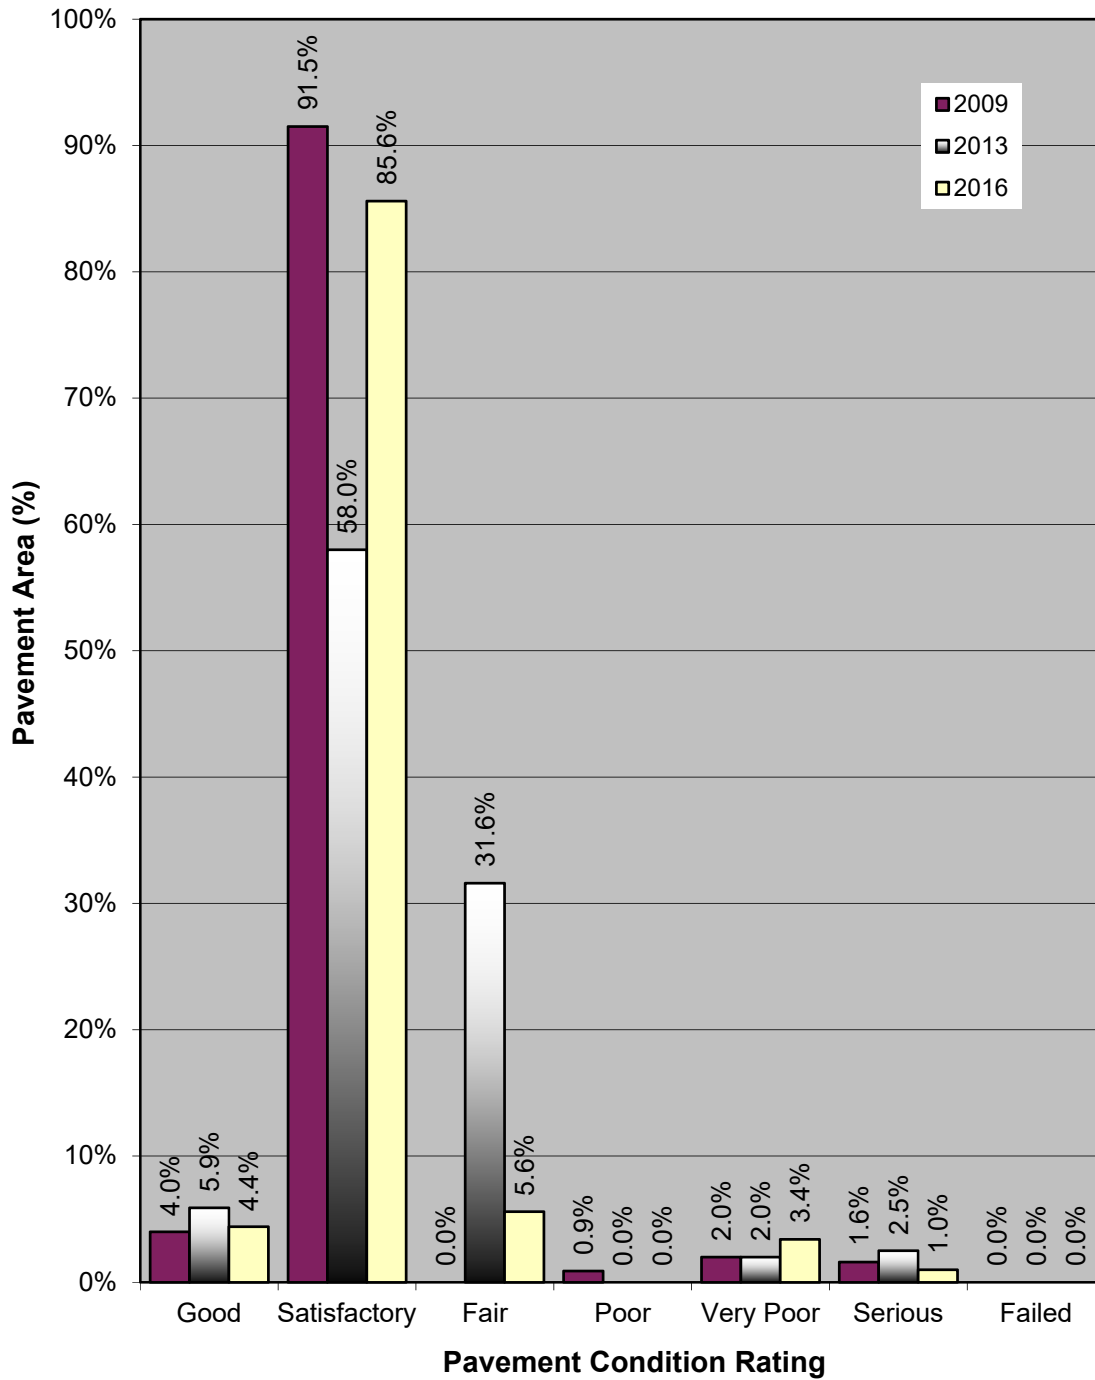
**Figure CE-4. Pavement Condition Distribution  
Creswell Hobby Field**

Section PCIs at Creswell Hobby Field range from a low of 23 (a PCR of “Serious”) to a high of 100 (a PCR of “Good”). The area-weighted average PCI for all airport pavements is 75, corresponding to an overall PCR of “Satisfactory”. Figure CE-4 shows how much pavement area is associated with each Pavement Condition Rating category and also shows pavement condition distribution from the inspections conducted in 2009 and 2013.

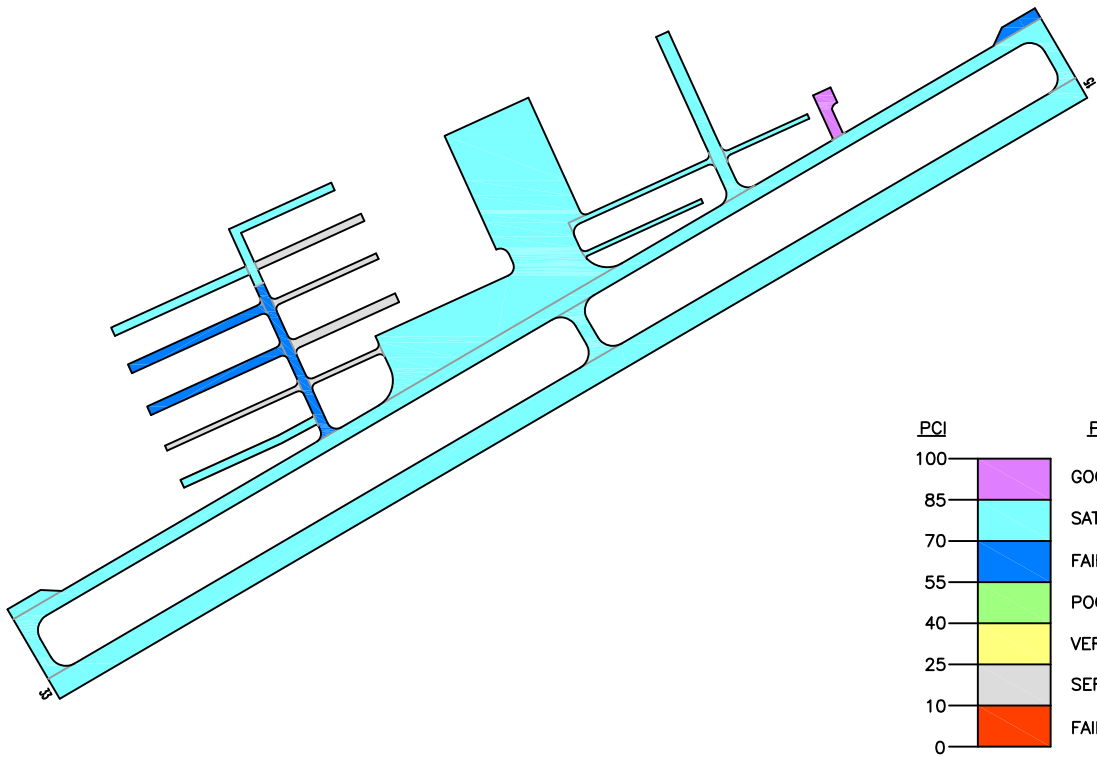
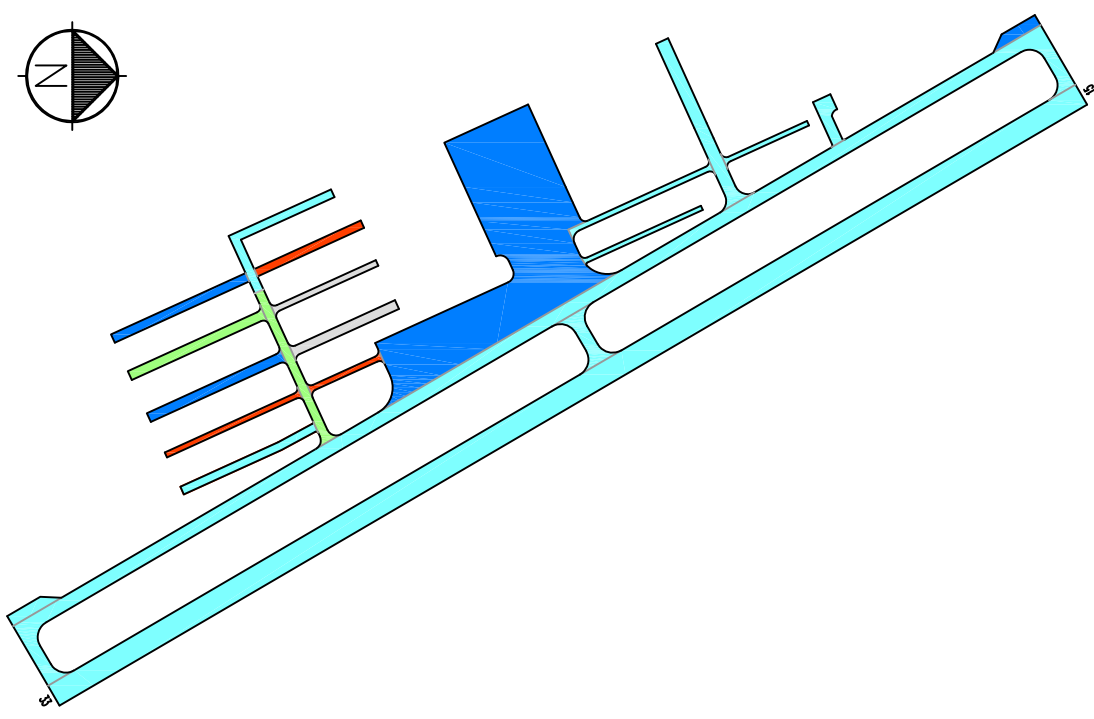
Figure CE-5. Future Pavement Condition.

### Predicted Condition in 2021.

### Predicted Condition in 2026.
