GOLD BEACH MUNICIPAL AIRPORT

Figure GB-1. Airport Layout, Dimensions and Pavement Cross-Sections.
Gold Beach Municipal Airport

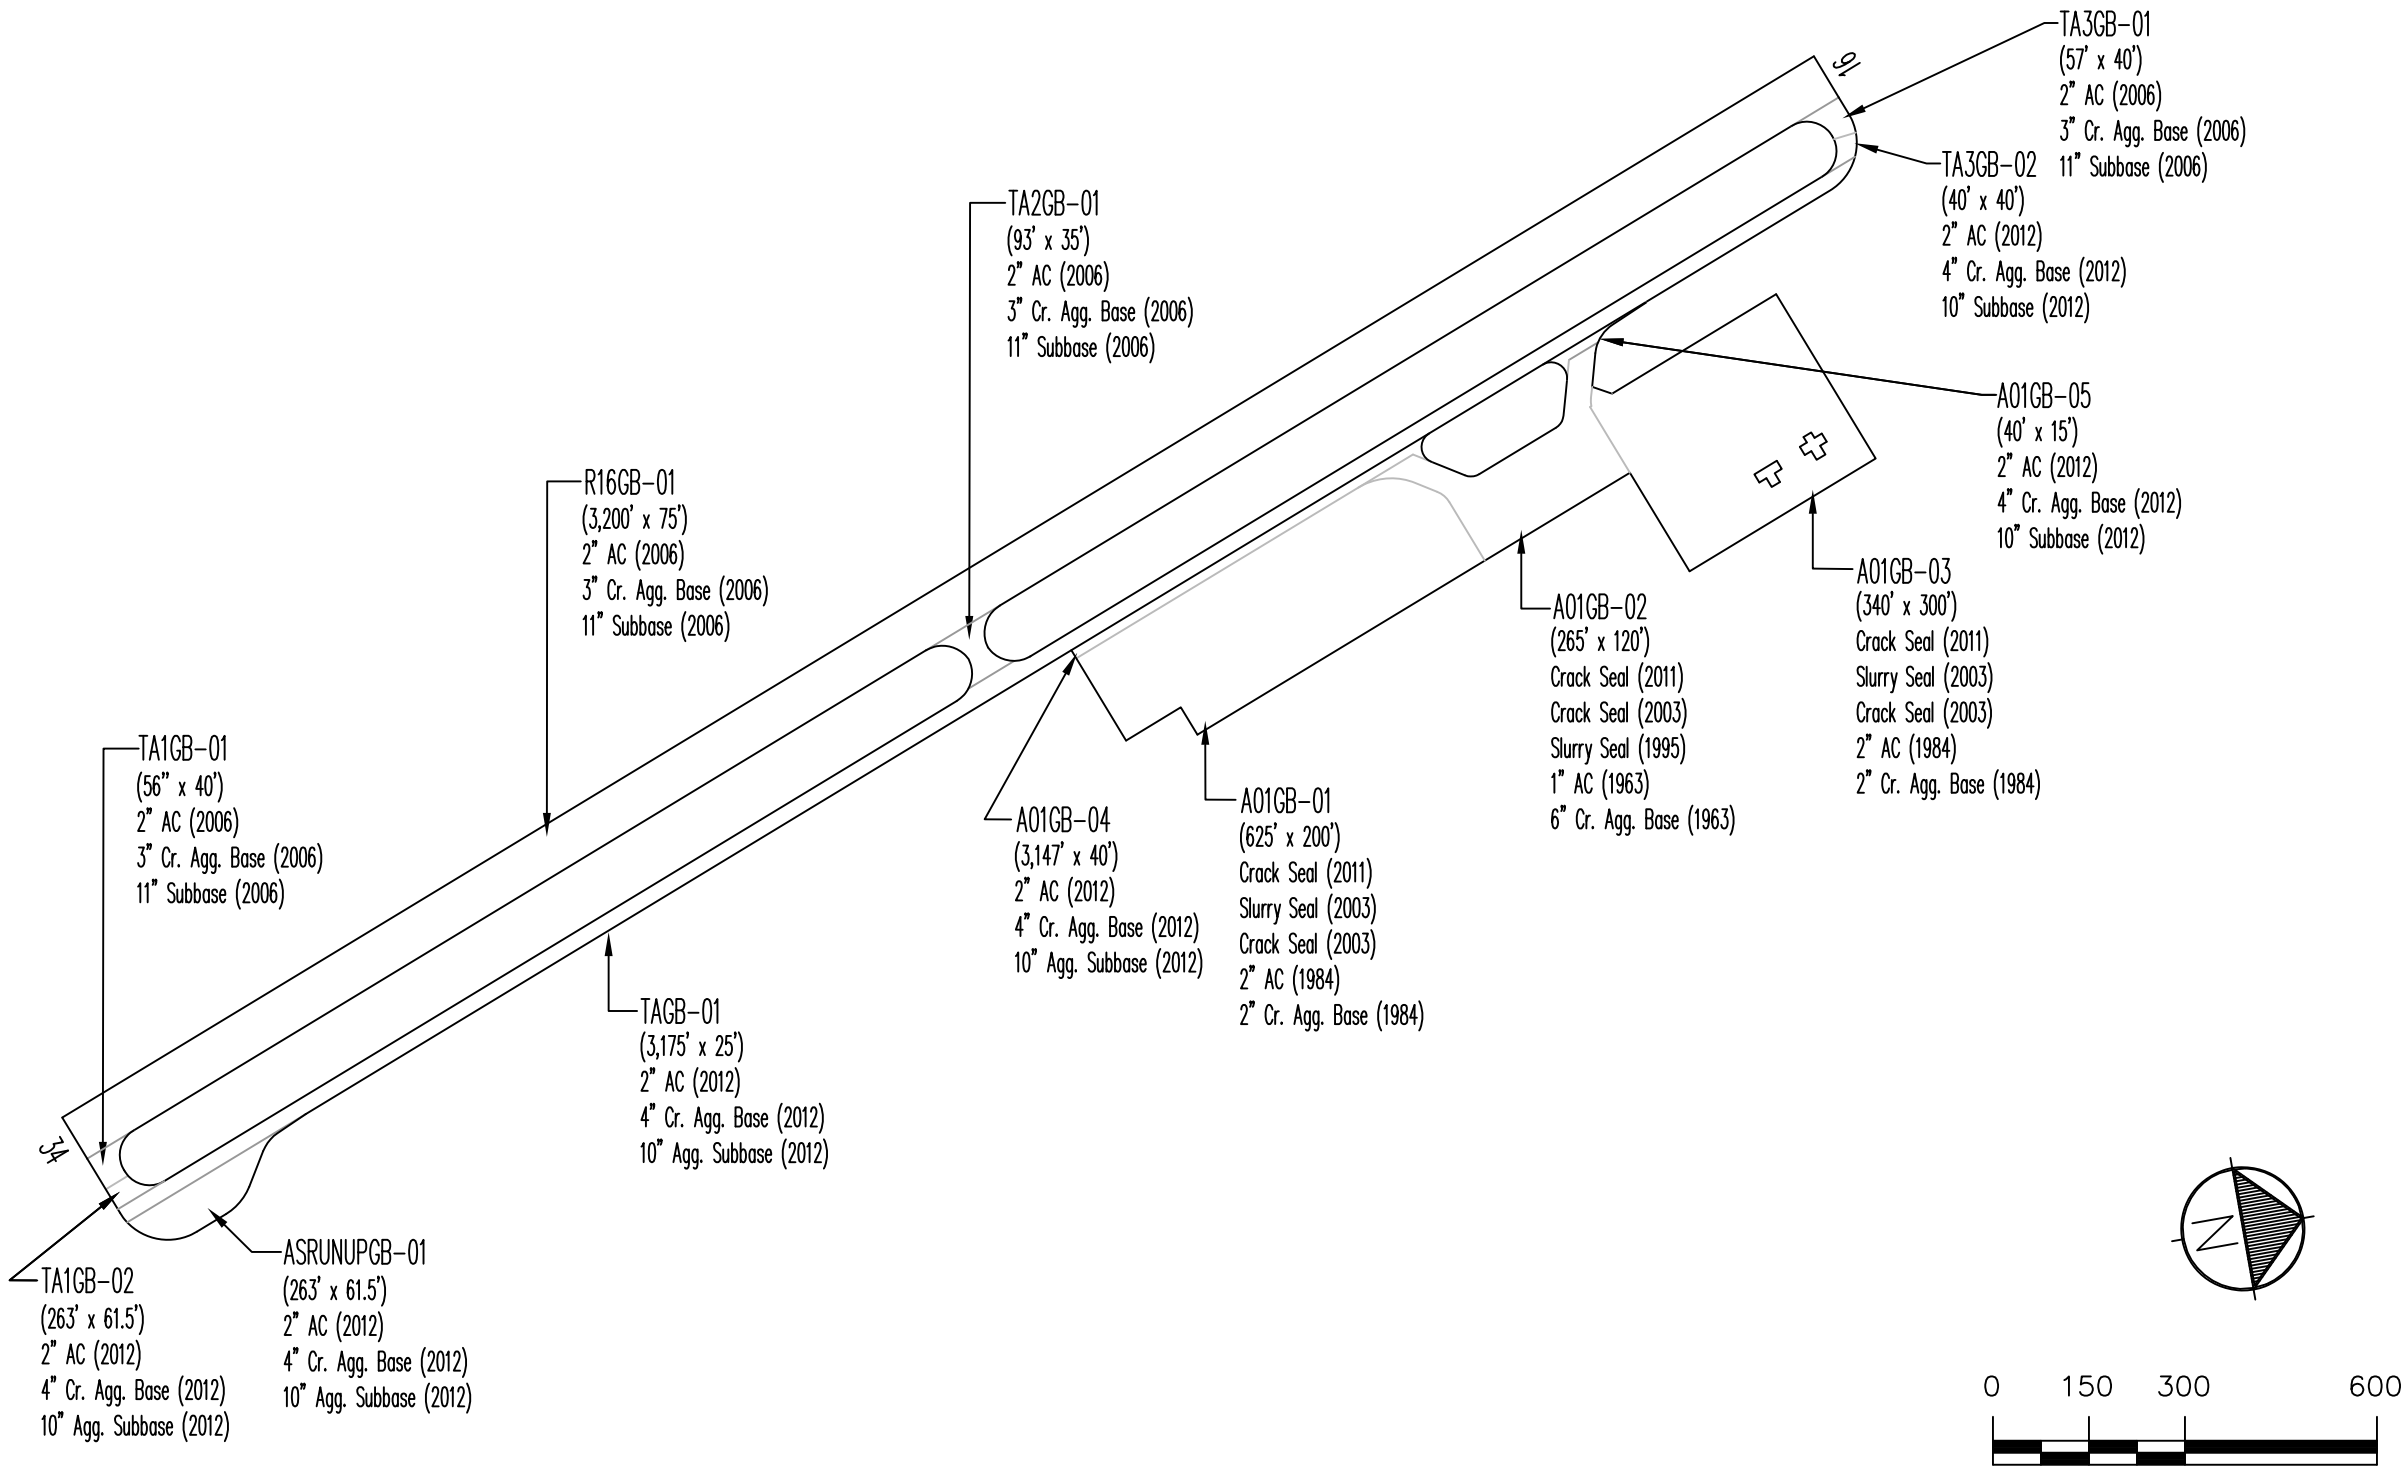
To determine how your pavements were constructed and their age, a records review was conducted. Figure GB-1 shows the records review results. This figure identifies pavement boundaries, dimensions, pavement layer types, thicknesses and dates of construction. The most recent construction date for each pavement can also be found in the Section Condition Report in Appendix 2. Figure GB-1 and the information contained in Appendices 1, 2 and 4 ensure that your airport complies with the “pavement inventory” requirement of FAA’s PMMP guidelines.

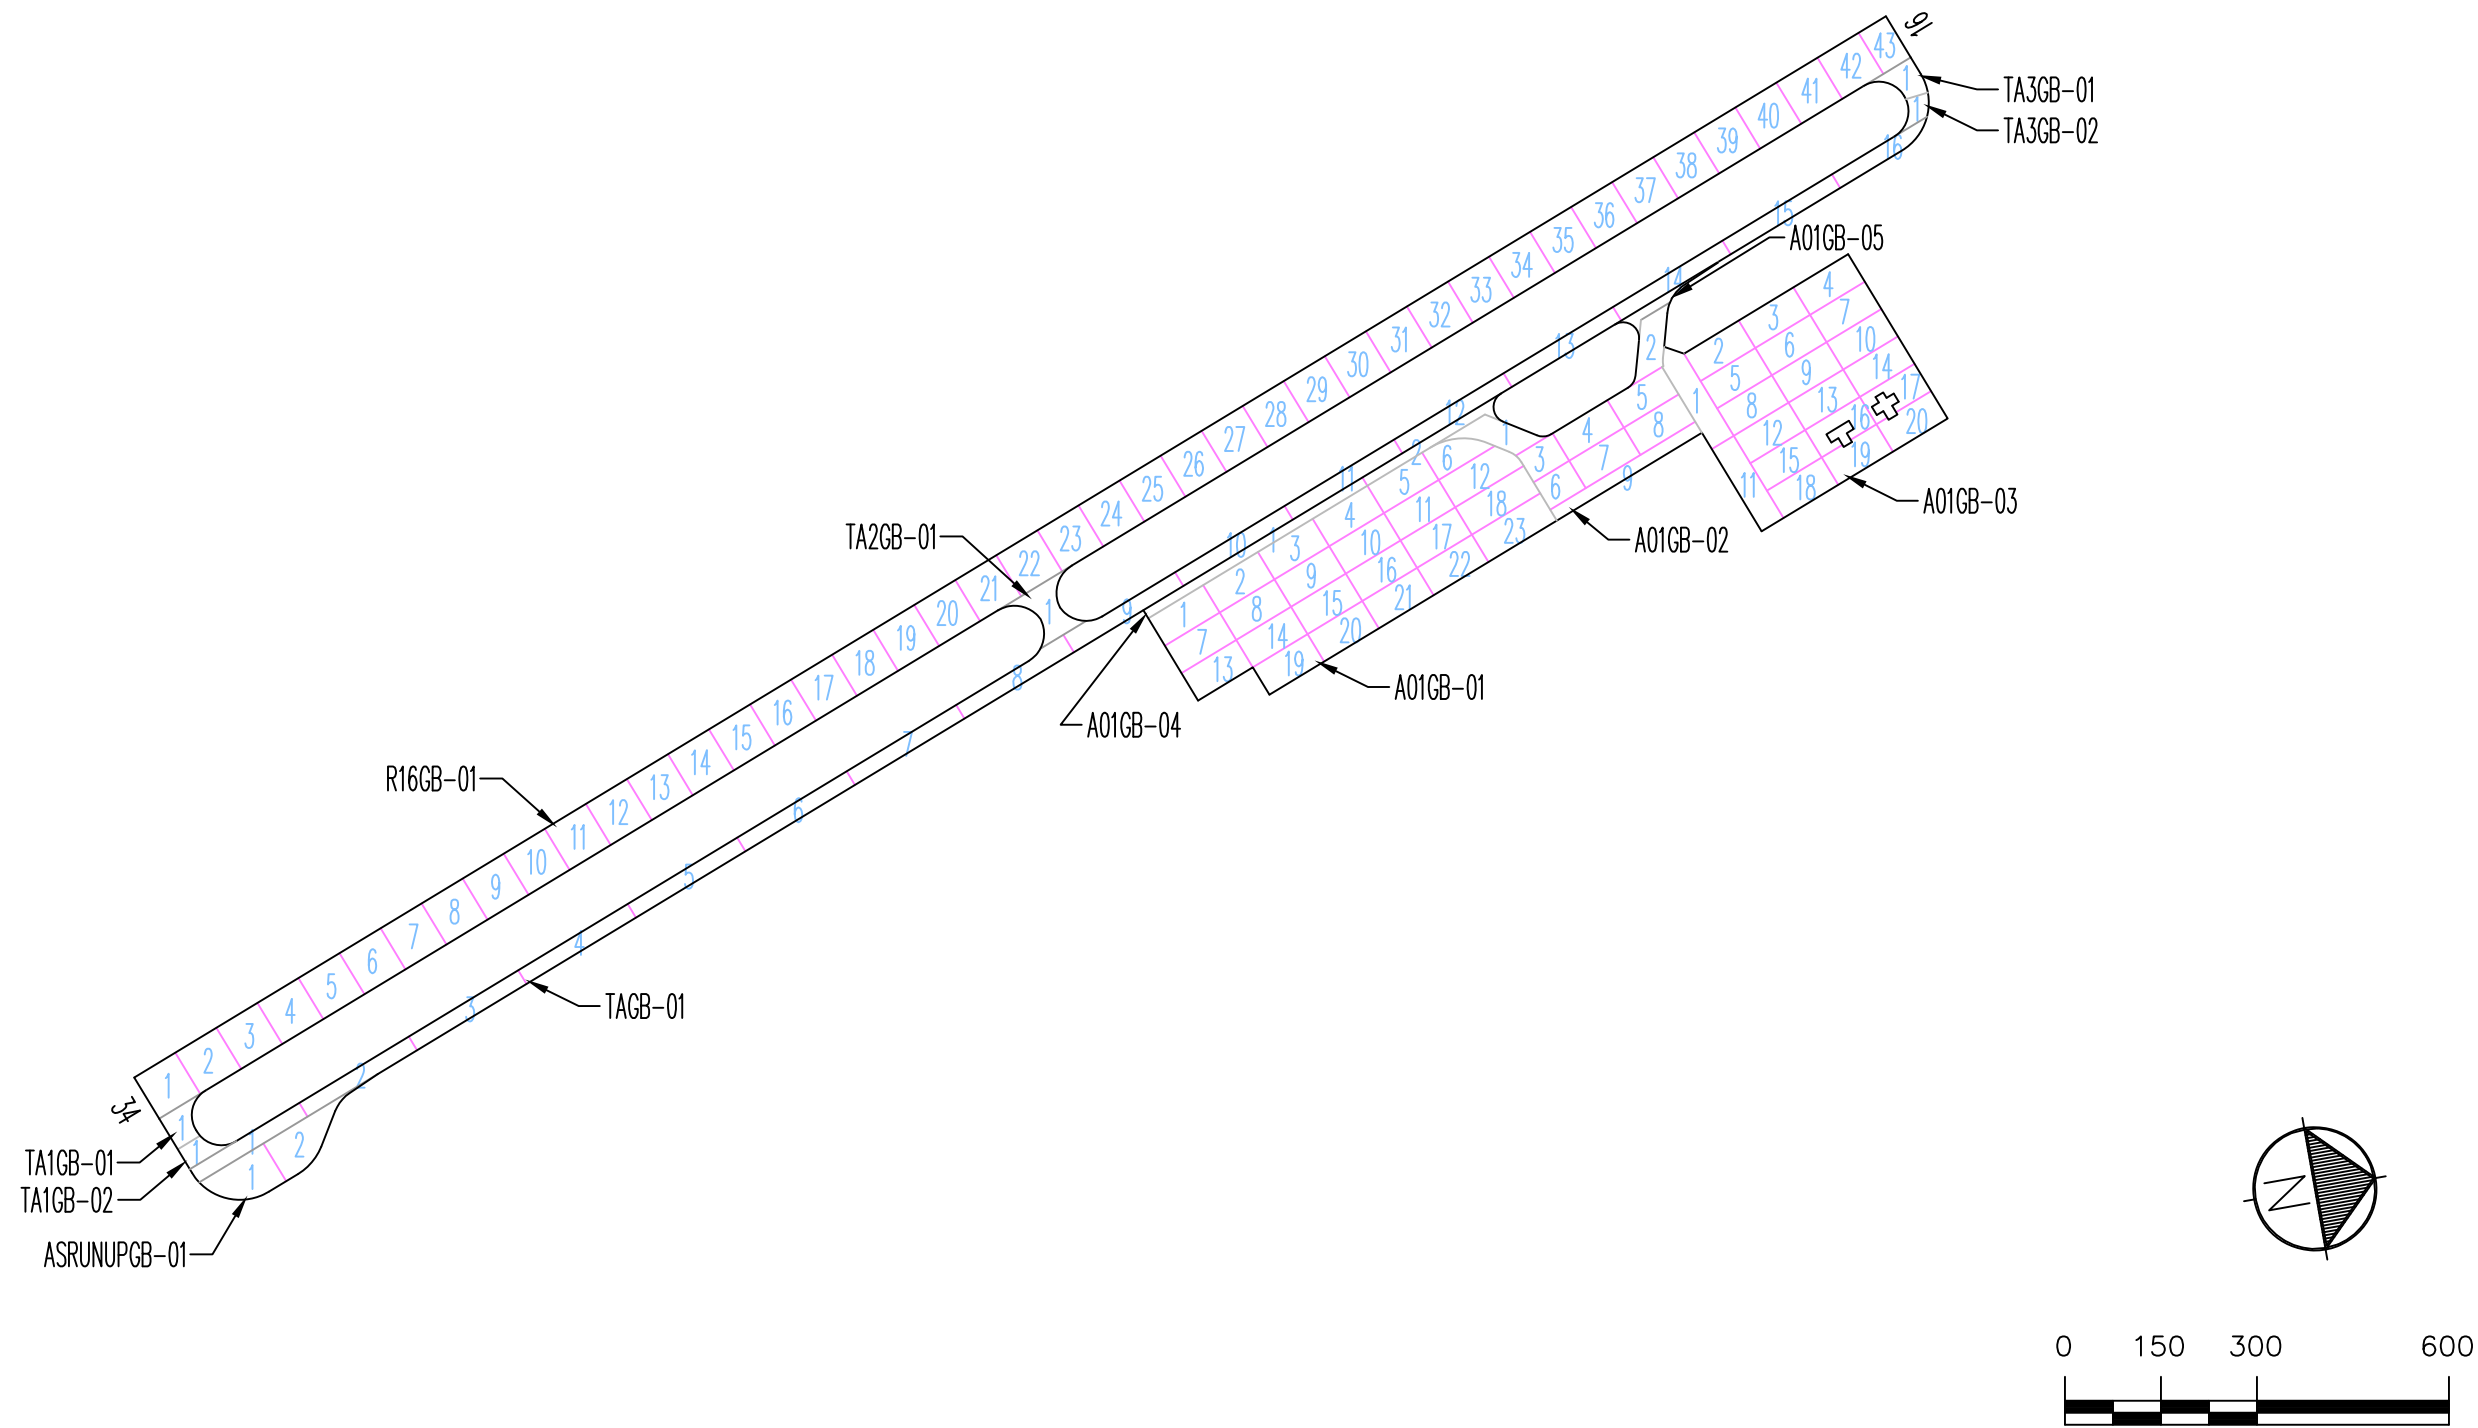
Figure GB-2. Pavement Branch, Section and Sample Unit Layout.
Gold Beach Municipal Airport

The pavements at your airport were divided into branches, sections and sample units in accordance with the methodology outlined in the current edition of ASTM D5430, *Standard Test Method for Airport Condition Index Surveys*. The branches, sections and sample units established at your airport are shown in Figure GB-2. A Branch Condition Report showing all branches, their associated areas, and their area-weighted average condition is provided in Appendix 1. Additionally, the Appendix 2 Section Condition Report provides information used to define each branch and section in the Micro PAVER database.
