GRANTS PASS AIRPORT

Figure GR-1A. Airport Layout, Dimensions and Pavement Cross-Sections.
Grants Pass Airport

Figure GR-2. Pavement Branch, Section and Sample Unit Layout.
Grants Pass Airport

Figure GR-3. Pavement Condition in July 2016.
Grants Pass Airport

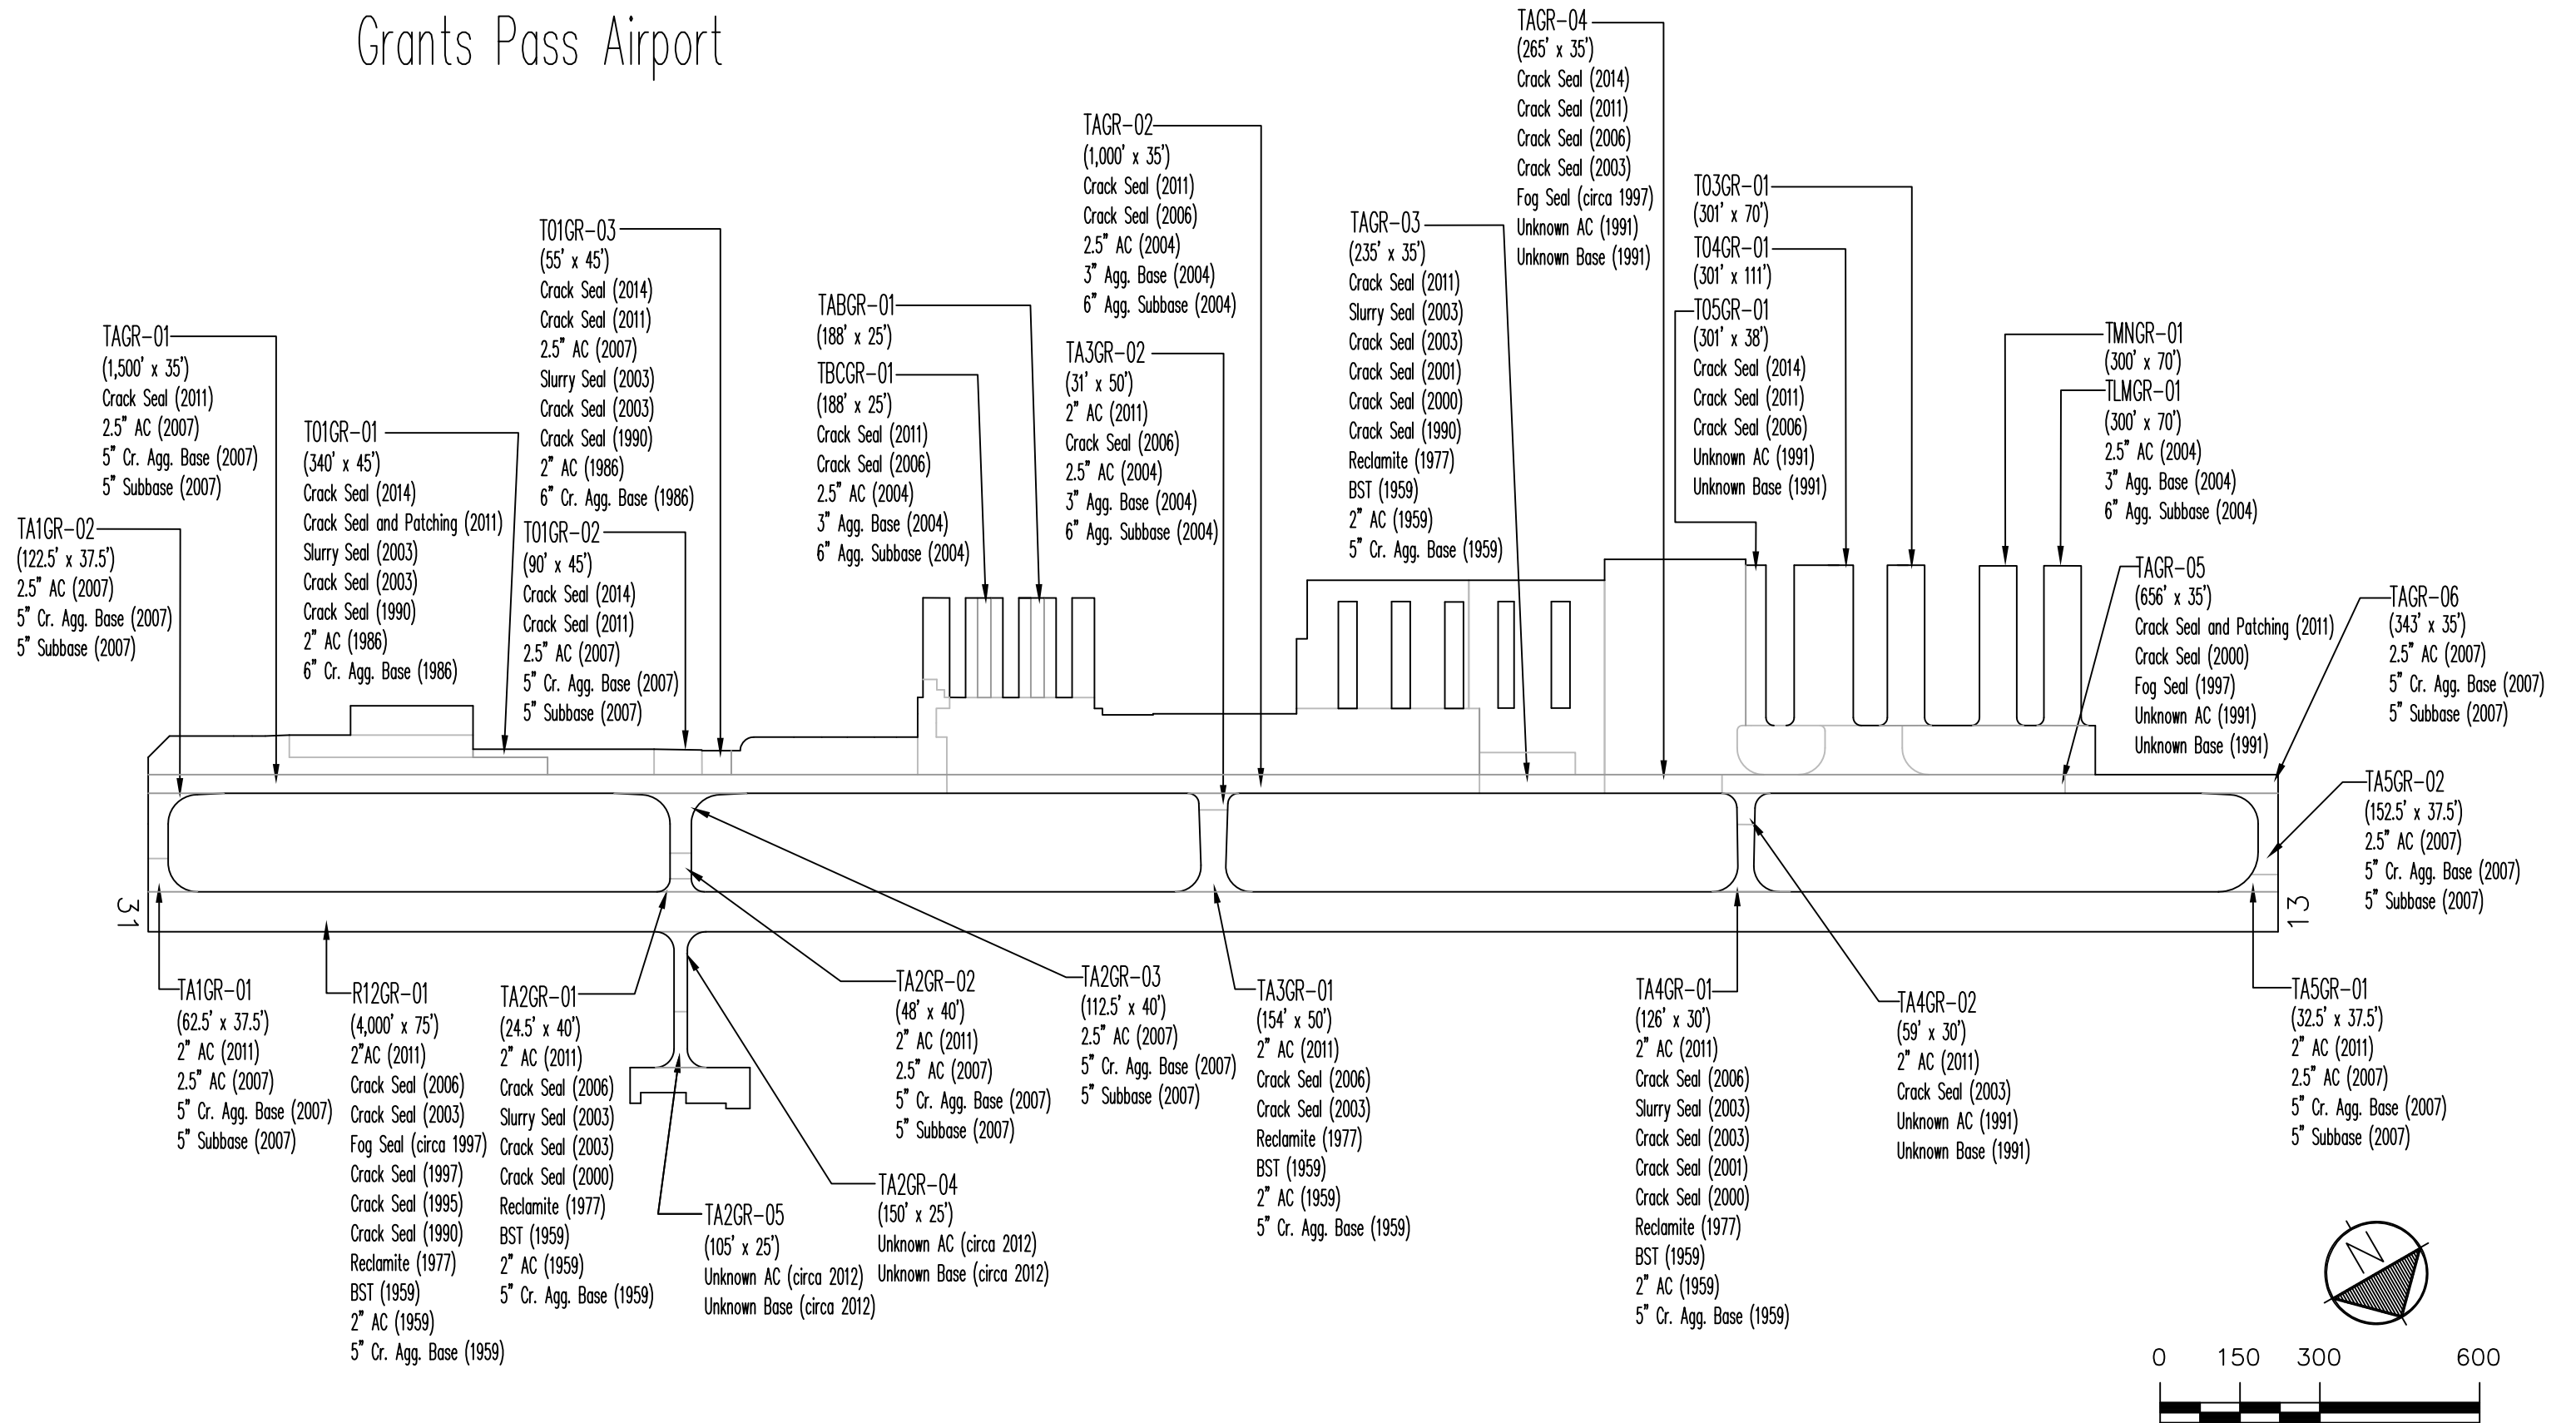
To determine how your pavements were constructed and their age, a records review was conducted. Figure GR-1 shows the records review results. This figure identifies pavement boundaries, dimensions, pavement layer types, thicknesses and dates of construction. The most recent construction date for each pavement can also be found in the Section Condition Report in Appendix 2. Figure GR-1 and the information contained in Appendices 1, 2 and 4 ensure that your airport complies with the “pavement inventory” requirement of FAA’s PMMP guidelines.

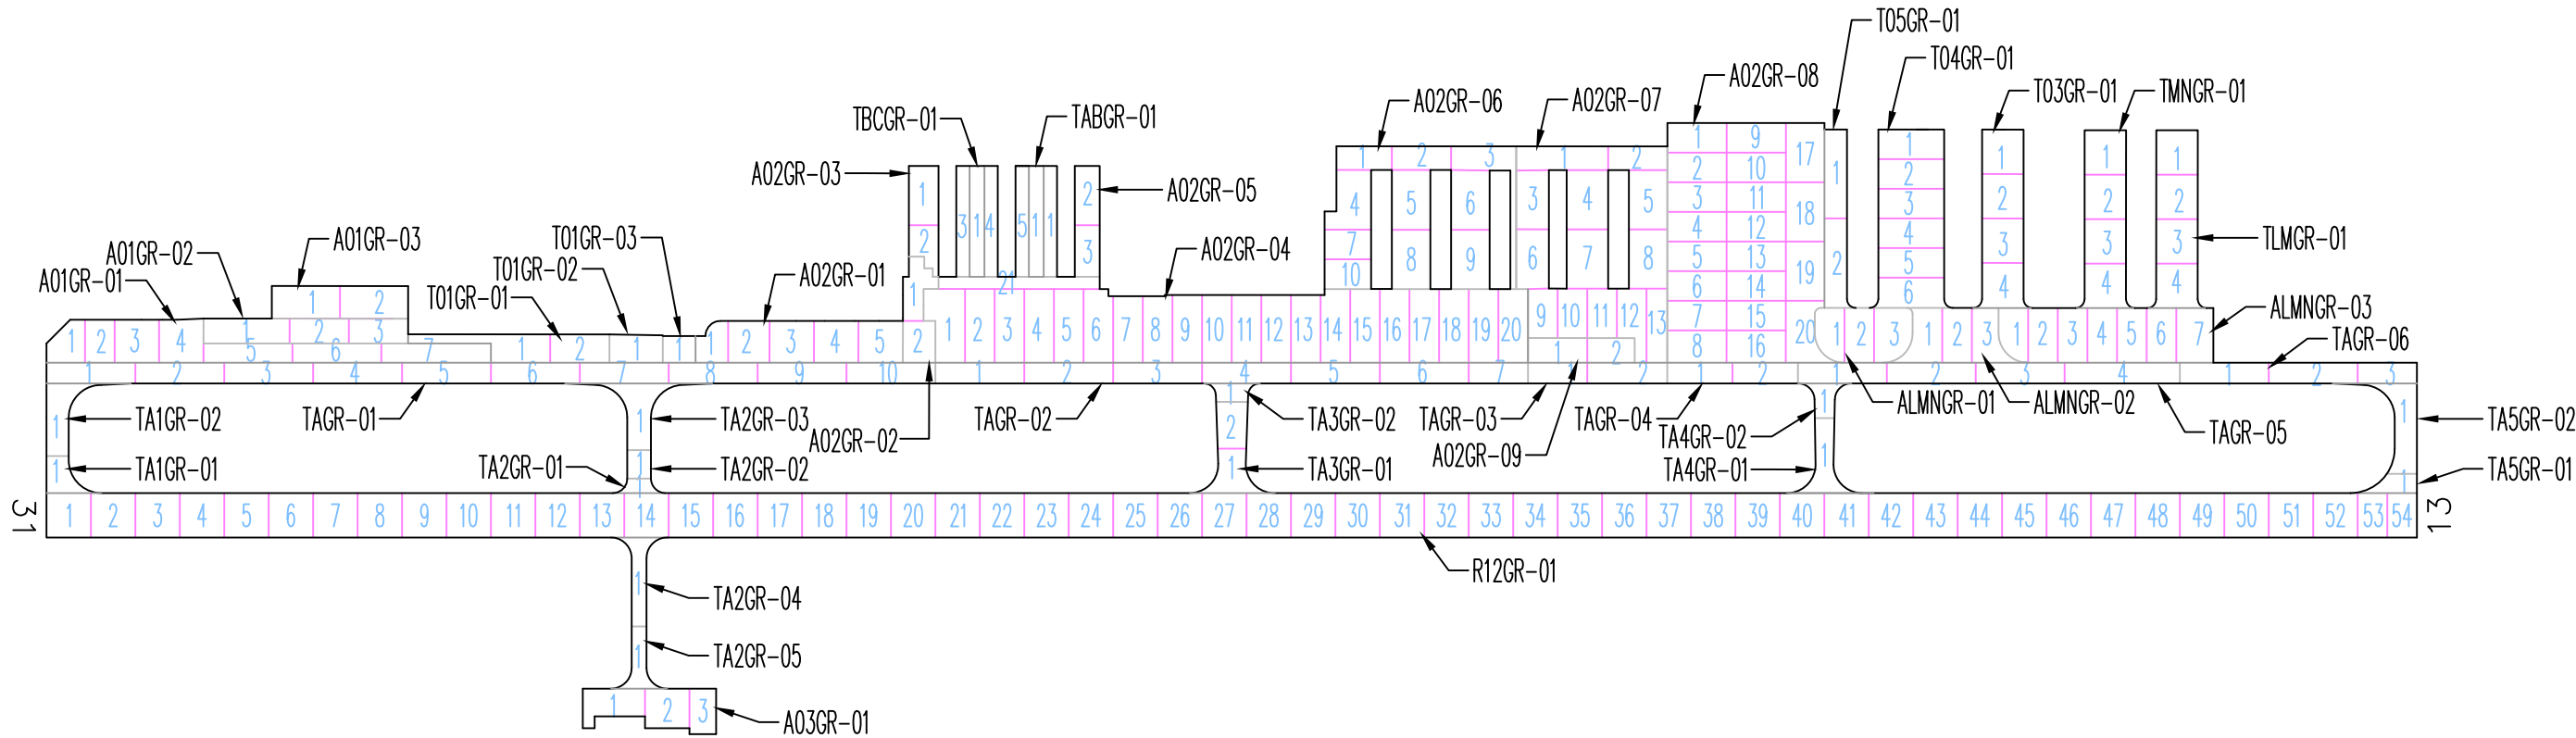
The pavements at your airport were divided into branches, sections and sample units in accordance with the methodology outlined in the current edition of ASTM D5430, *Standard Test Method for Airport Condition Index Surveys*. The branches, sections and sample units established at your airport are shown in Figure GR-2. A Branch Condition Report showing all branches, their associated areas, and their area-weighted average condition is provided in Appendix 1. Additionally, the Appendix 2 Section Condition Report provides information used to define each branch and section in the Micro PAVER database.

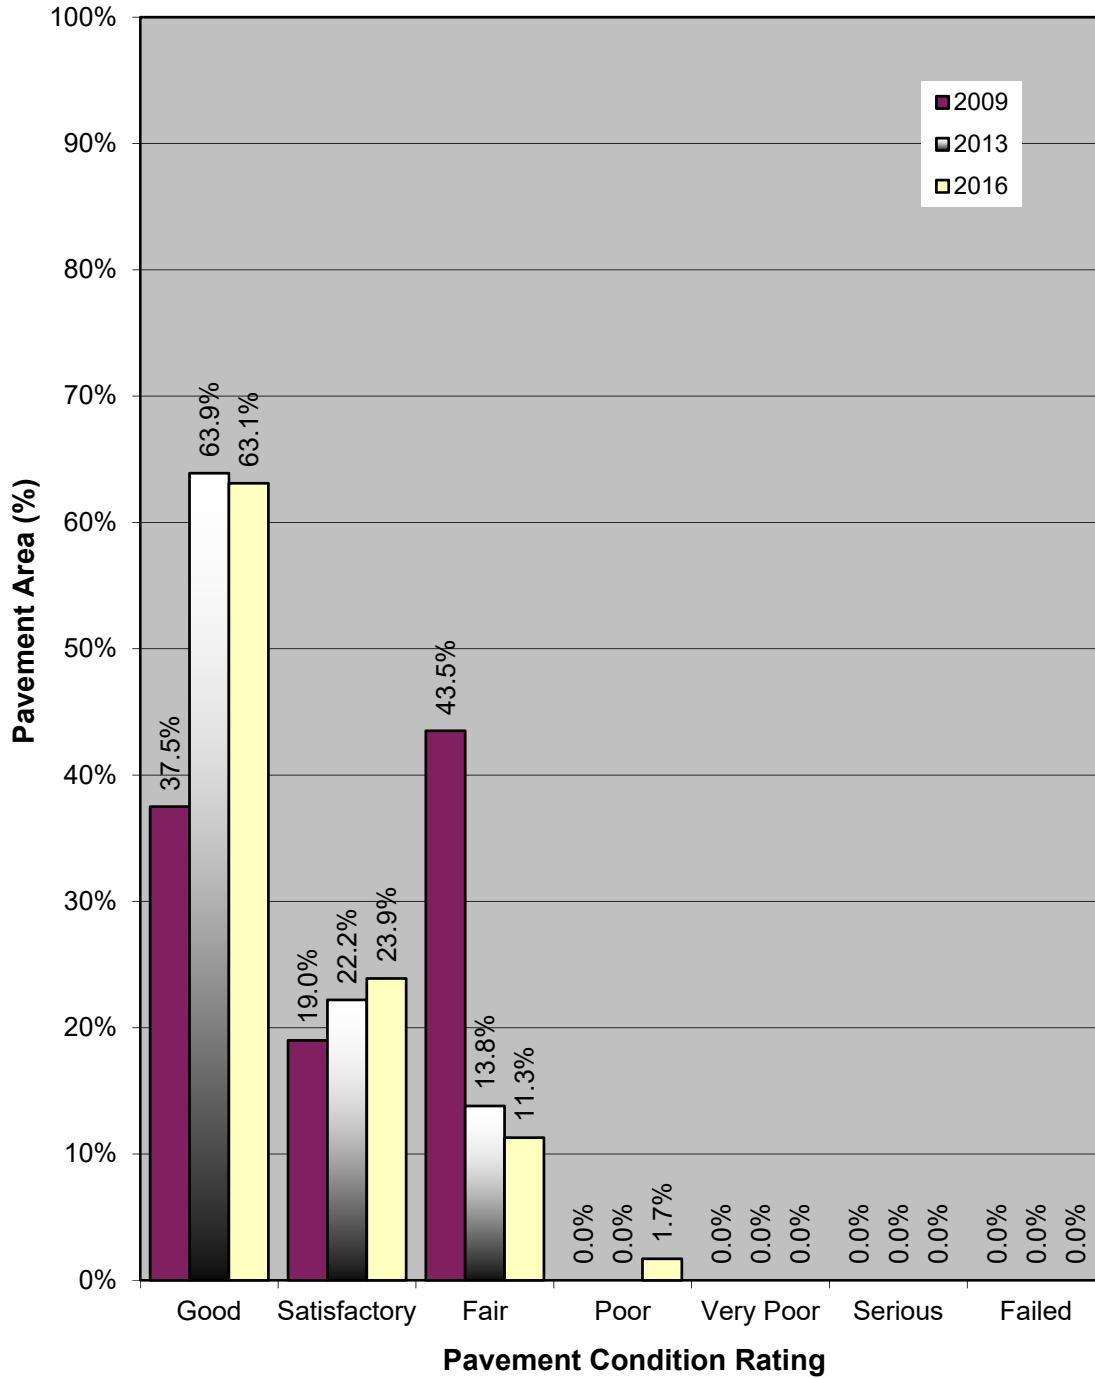
**Figure GR-4. Pavement Condition Distribution
Grants Pass Airport**

Section PCIs at Grants Pass Airport range from a low of 52 (a PCR of “Poor”) to a high of 100 (a PCR of “Good”). The area-weighted average PCI for all airport pavements is 86, corresponding to an overall PCR of “Good”. Figure GR-4 shows how much pavement area is associated with each Pavement Condition Rating category and also shows pavement condition distribution from the inspections conducted in 2009 and 2013.
