LAKE COUNTY AIRPORT

This report describes how your Pavement Maintenance Management Program (PMMP) was developed. Your Program was developed as part of the Oregon Continuous Aviation System Plan sponsored in part by the Oregon Department of Aviation and the Federal Aviation Administration (FAA). The information and data contained in this report ensures you are in compliance with the requirements of FAA Grant Assurance Number 11 which states that any airport requesting federal funds for pavement improvement projects must have implemented a pavement maintenance management program.

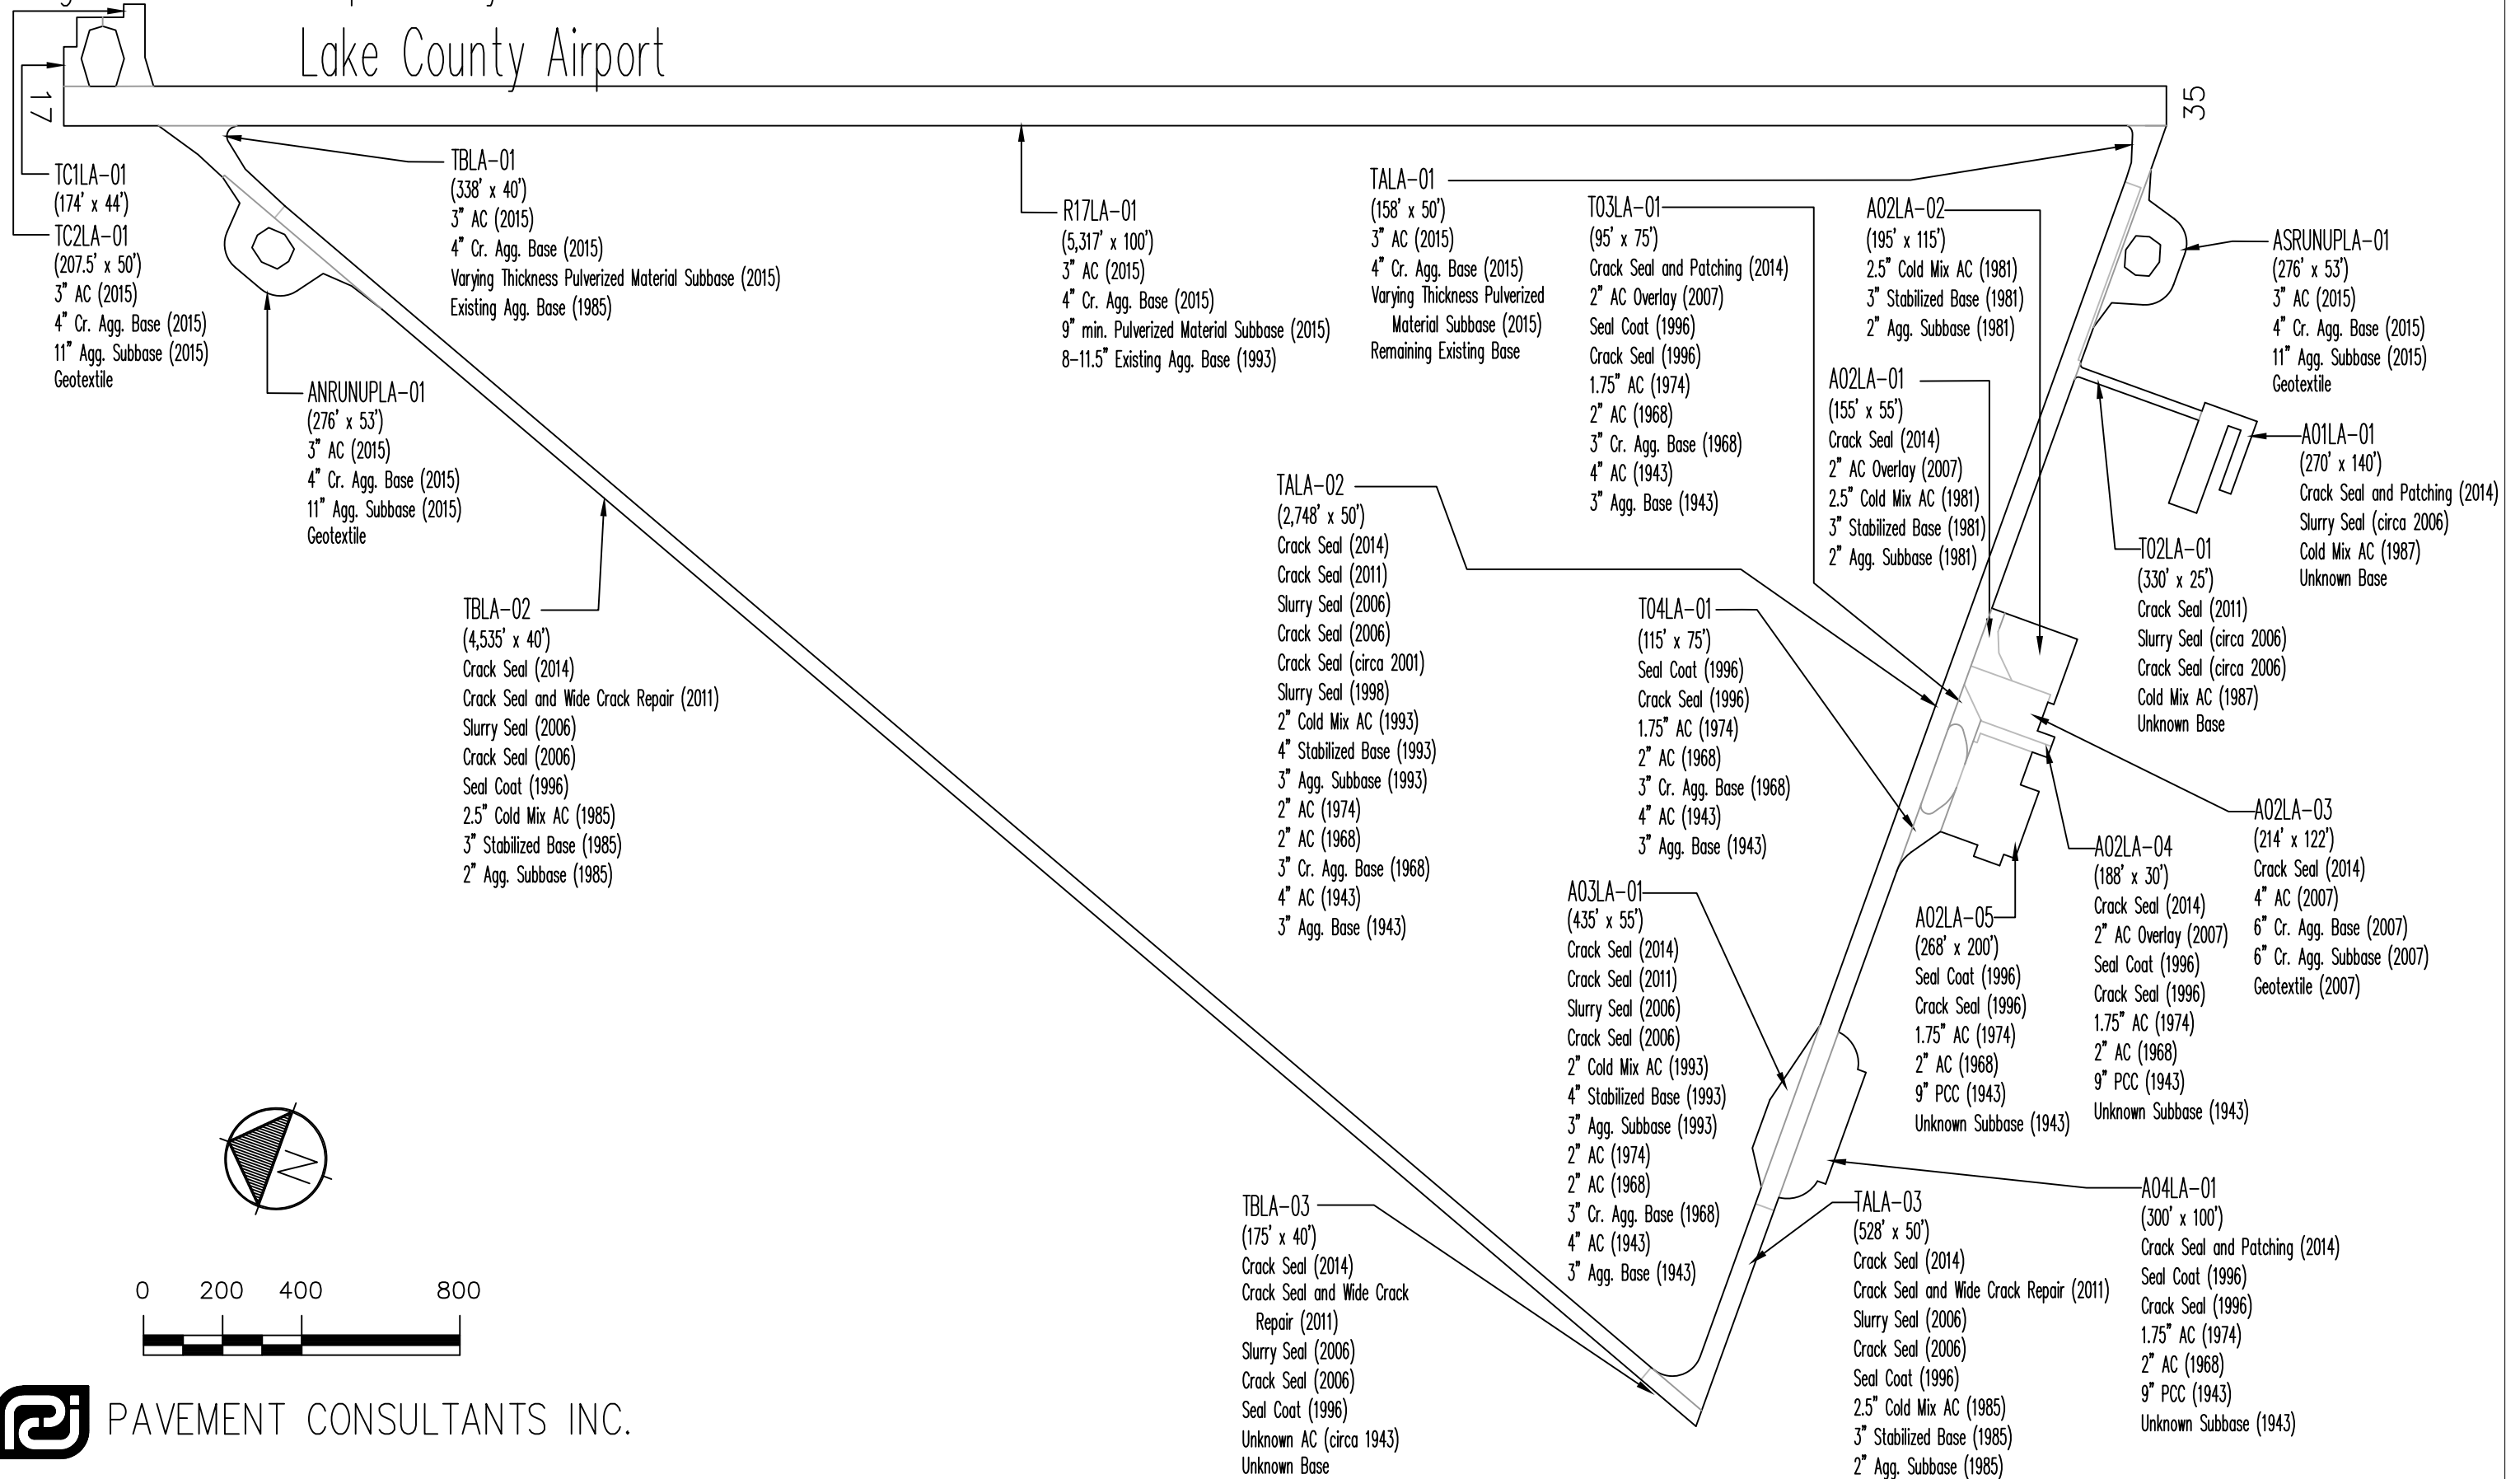
Figure LA-1. Airport Layout, Dimensions and Pavement Cross-Sections.

To determine how your pavements were constructed and their age, a records review was conducted. Figure LA-1 shows the records review results. This figure identifies pavement boundaries, dimensions, pavement layer types, thicknesses and dates of construction. The most recent construction date for each pavement can also be found in the Section Condition Report in Appendix 2. Figure LA-1 and the information contained in Appendices 1, 2 and 4 ensure that your airport complies with the “pavement inventory” requirement of FAA’s PMMP guidelines.

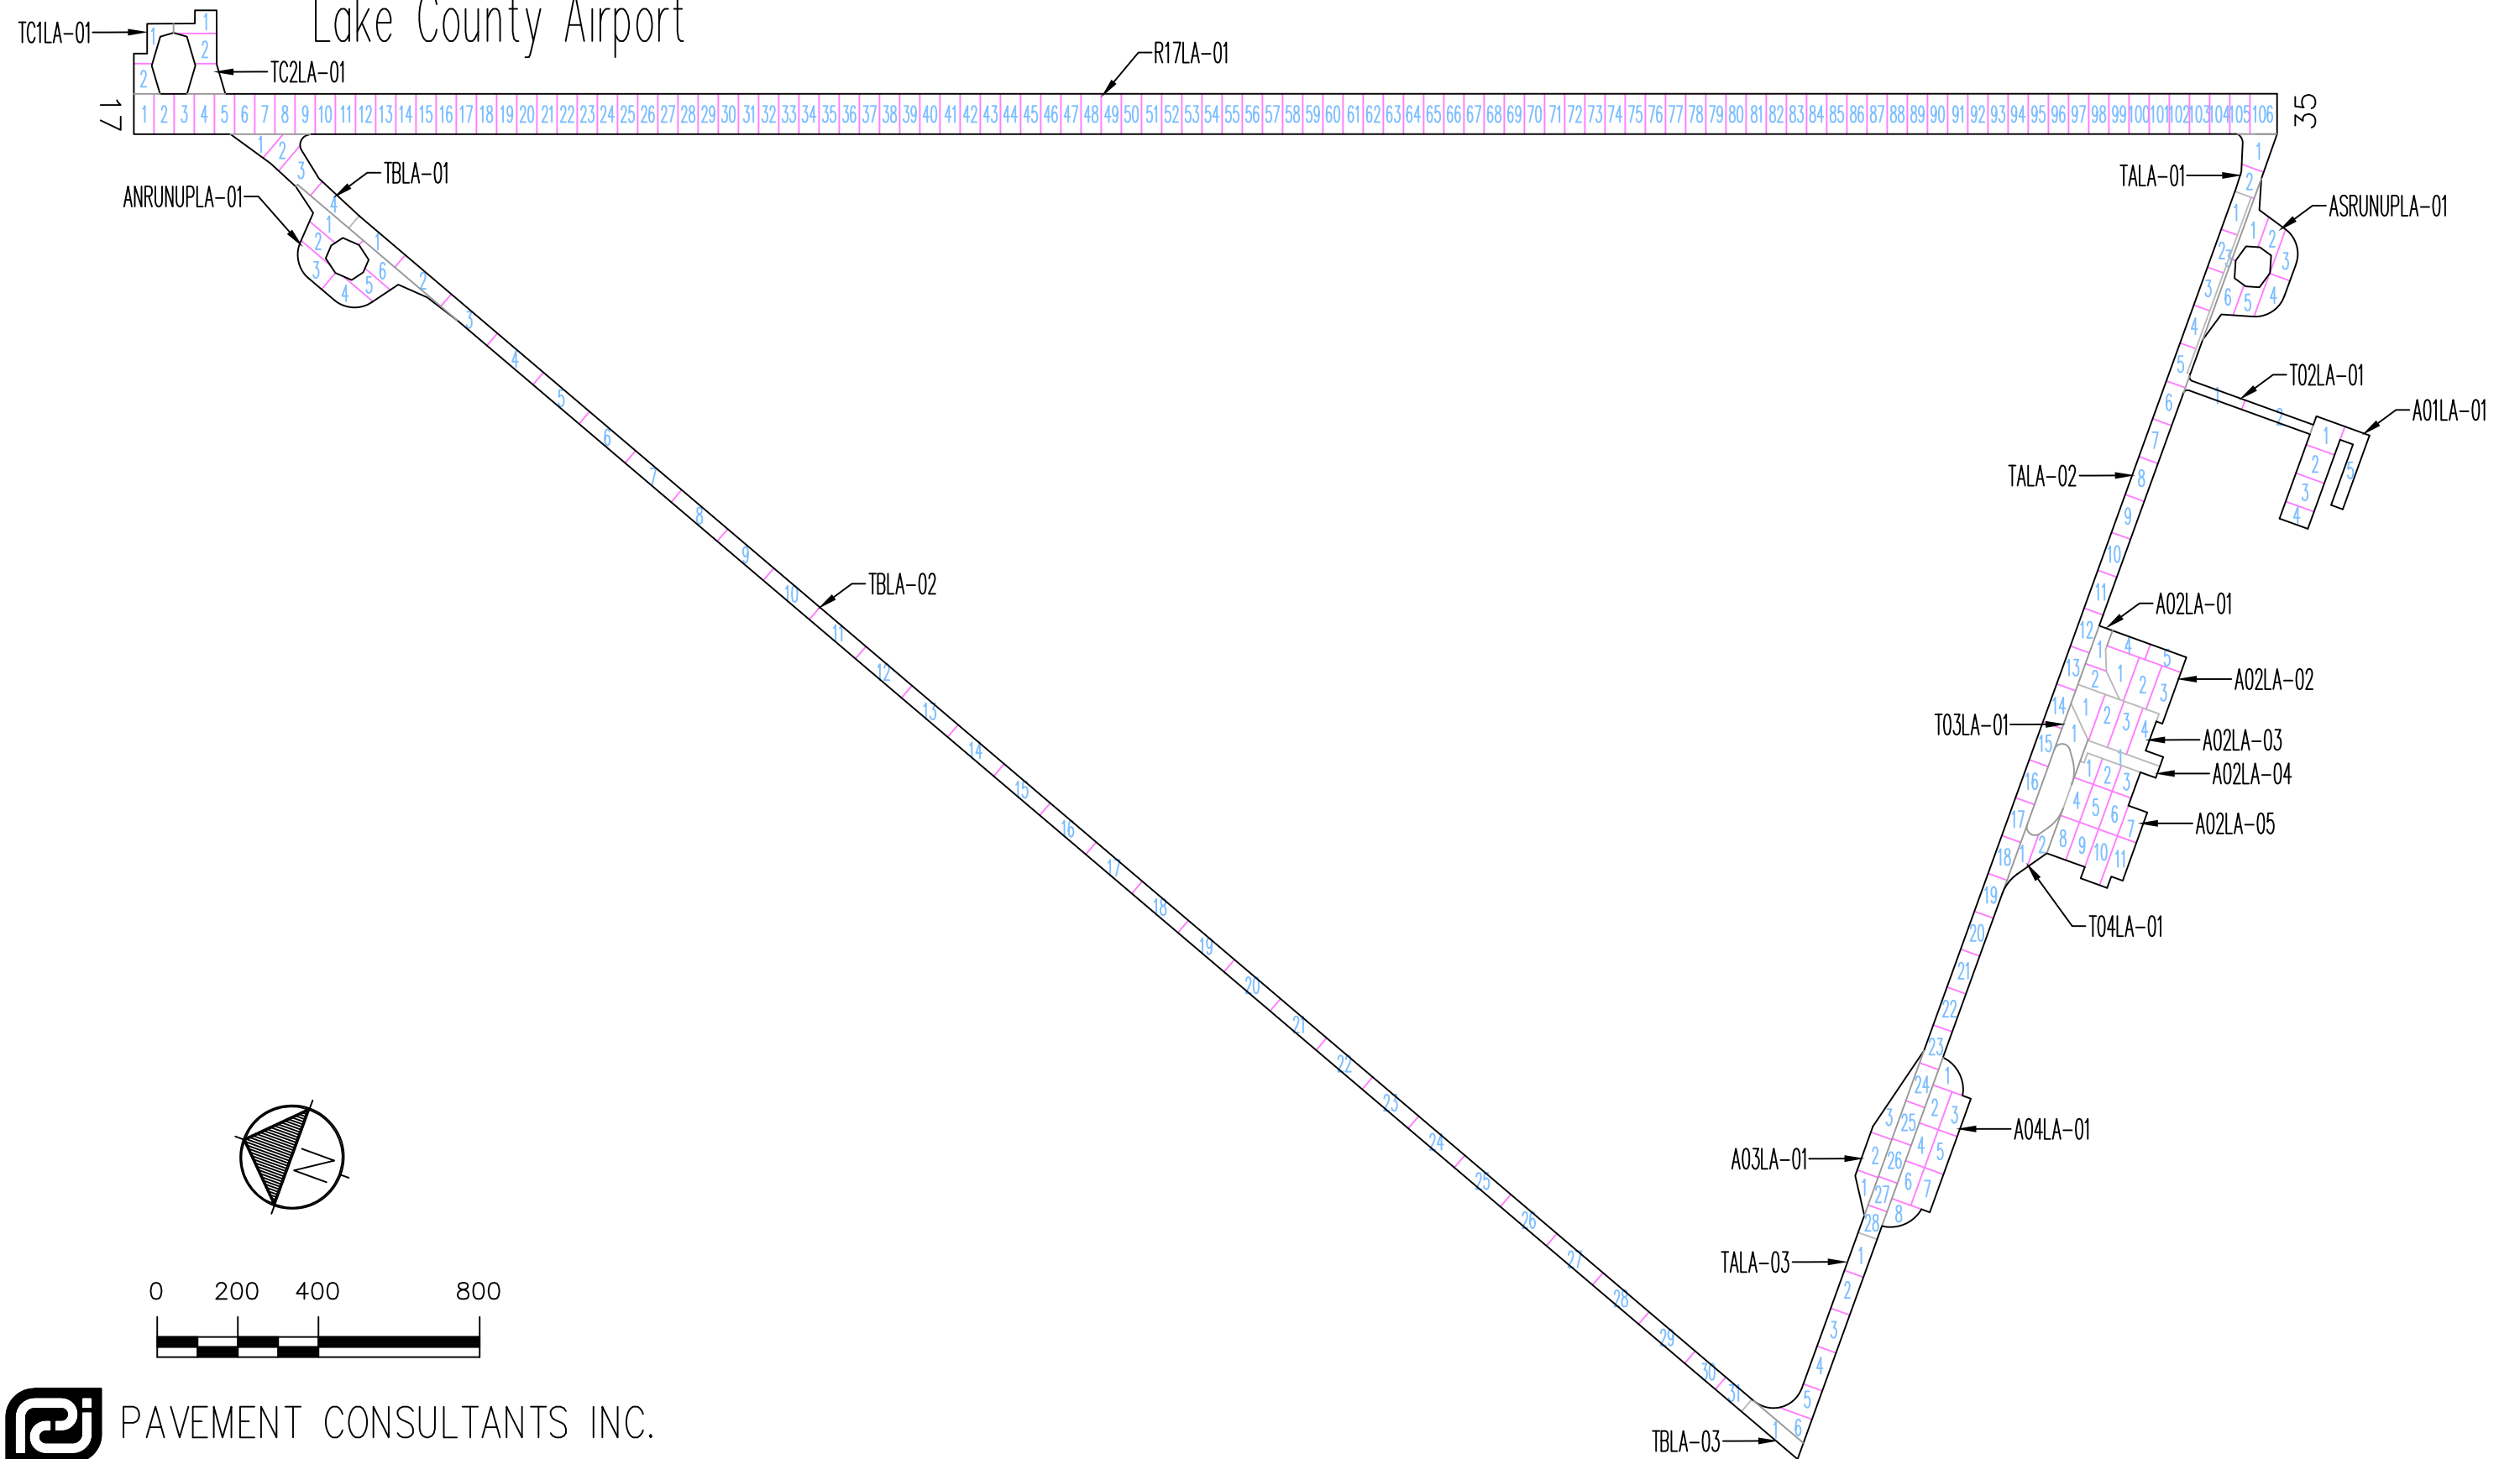
Figure LA-2. Pavement Branch, Section and Sample Unit Layout.

The pavements at your airport were divided into branches, sections and sample units in accordance with the methodology outlined in the current edition of ASTM D5430, *Standard Test Method for Airport Condition Index Surveys*. The branches, sections and sample units established at your airport are shown in Figure LA-2. A Branch Condition Report showing all branches, their associated areas, and their area-weighted average condition is provided in Appendix 1. Additionally, the Appendix 2 Section Condition Report provides information used to define each branch and section in the Micro PAVER database.
