MYRTLE CREEK MUNICIPAL AIRPORT

Figure MC-1. Airport Layout, Dimensions and Pavement Cross-Sections.
Myrtle Creek Municipal Airport

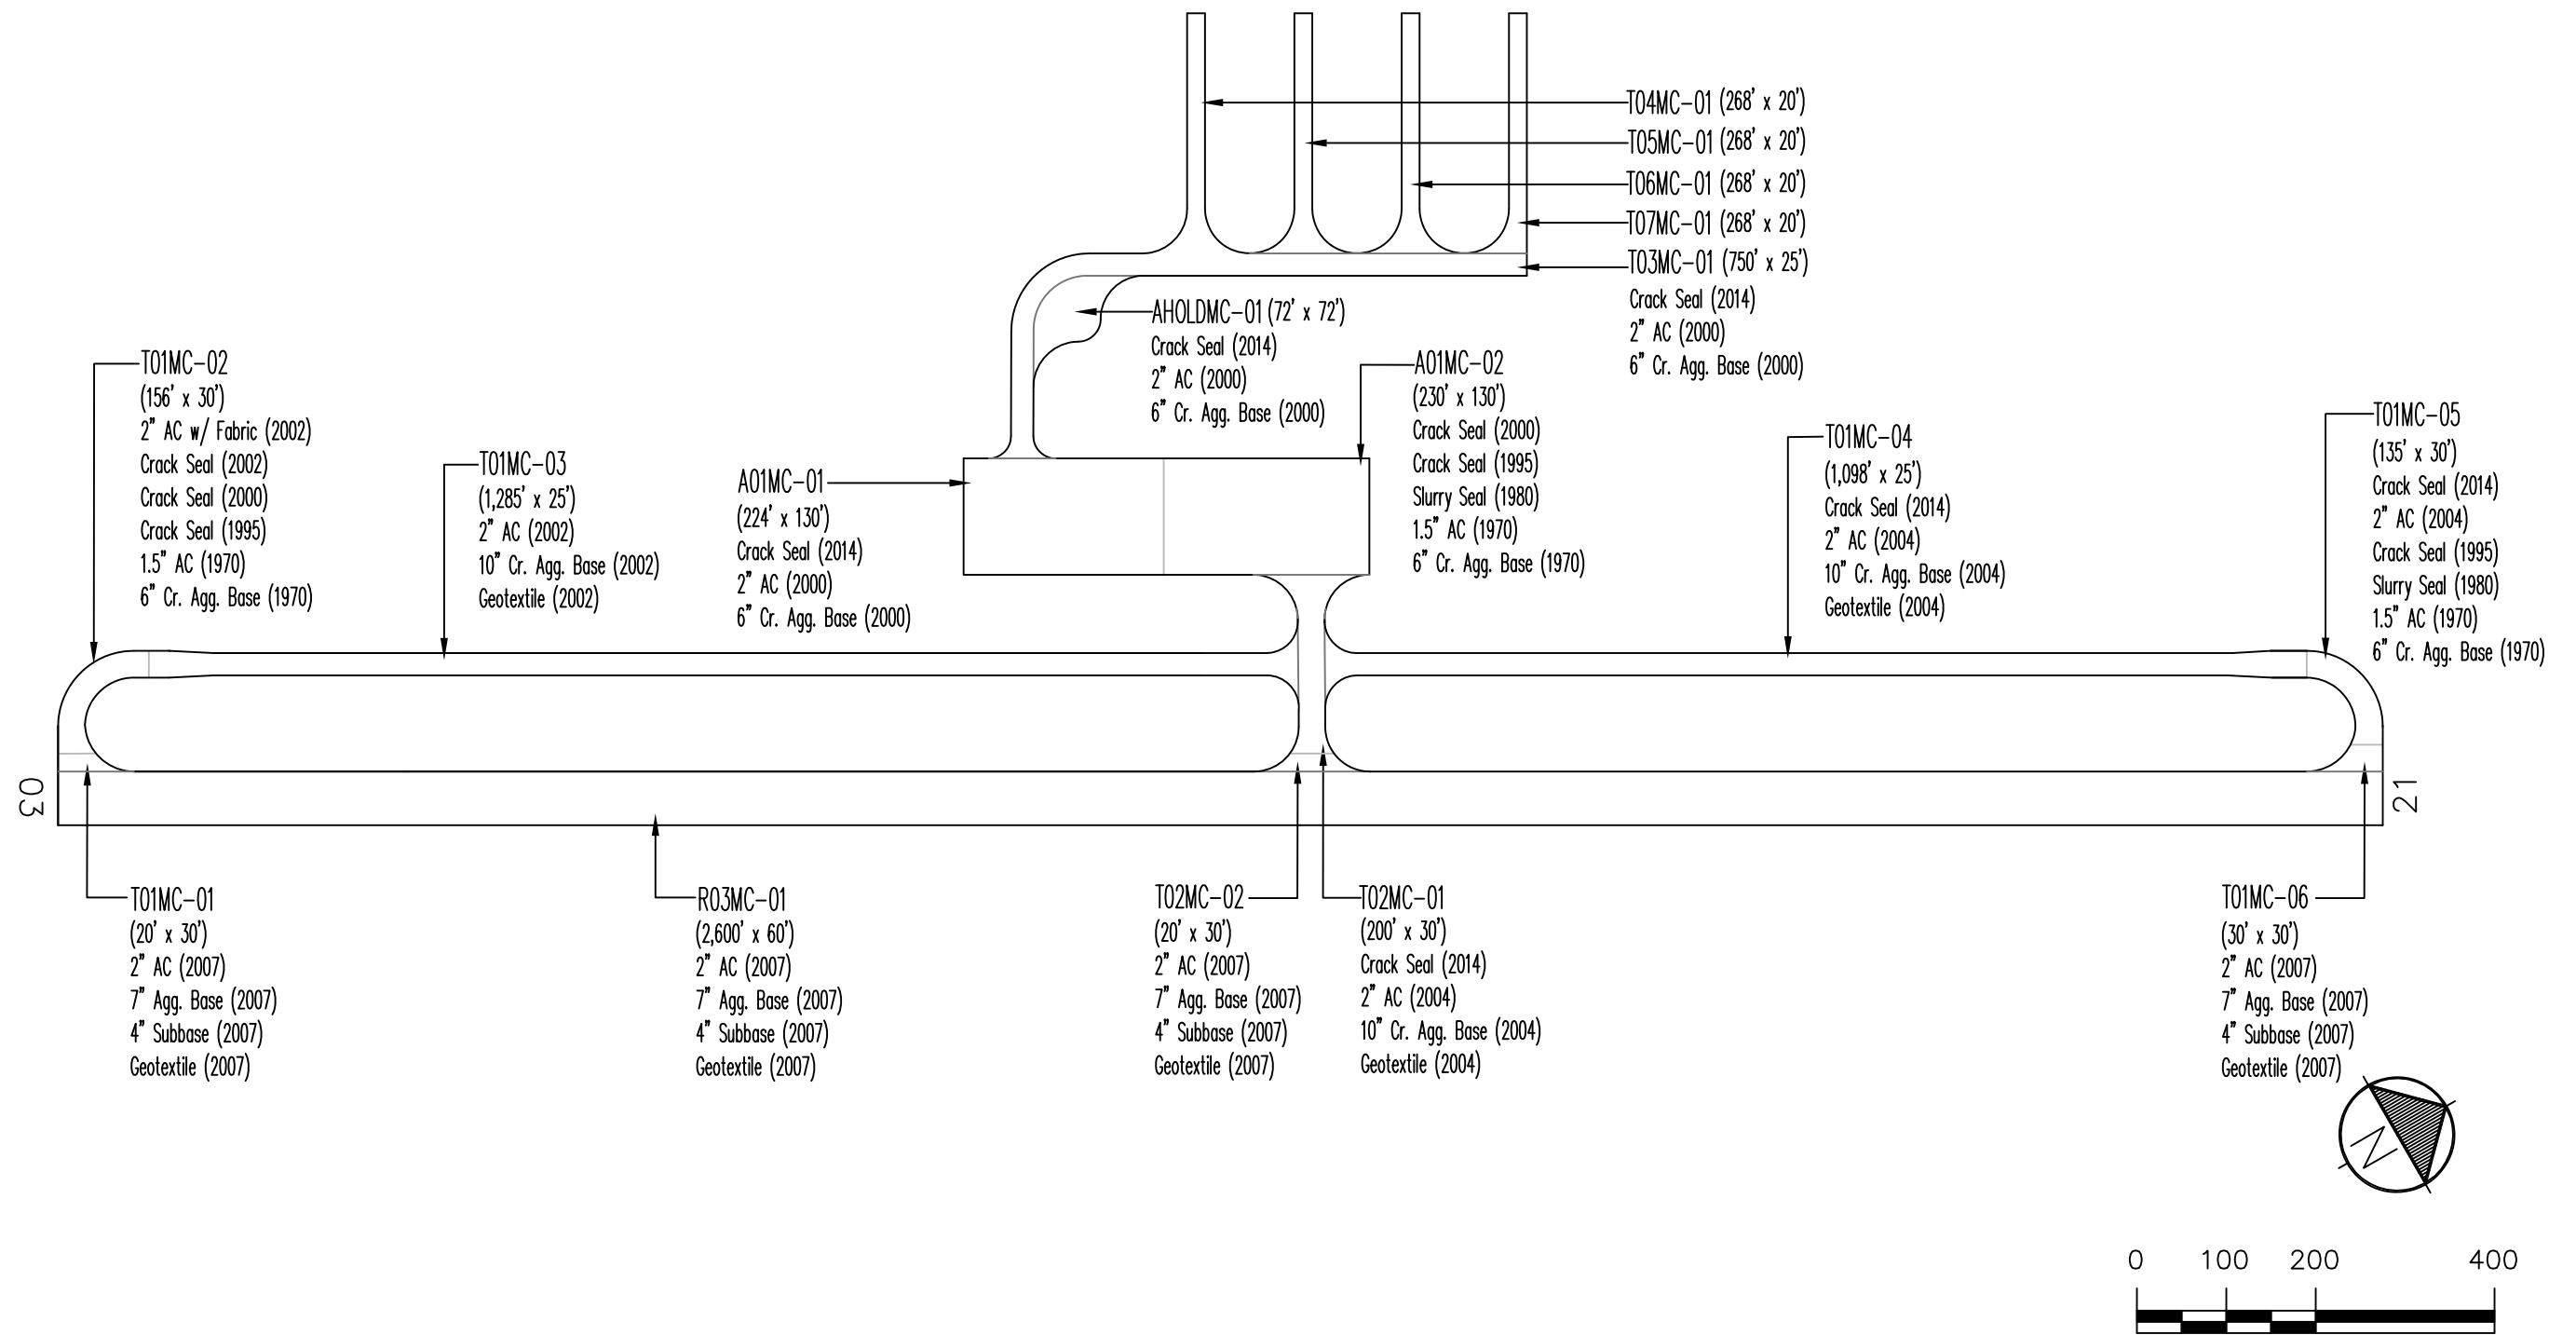
To determine how your pavements were constructed and their age, a records review was conducted. Figure MC-1 shows the records review results. This figure identifies pavement boundaries, dimensions, pavement layer types, thicknesses and dates of construction. The most recent construction date for each pavement can also be found in the Section Condition Report in Appendix 2. Figure MC-1 and the information contained in Appendices 1, 2 and 4 ensure that your airport complies with the “pavement inventory” requirement of FAA’s PMMP guidelines.

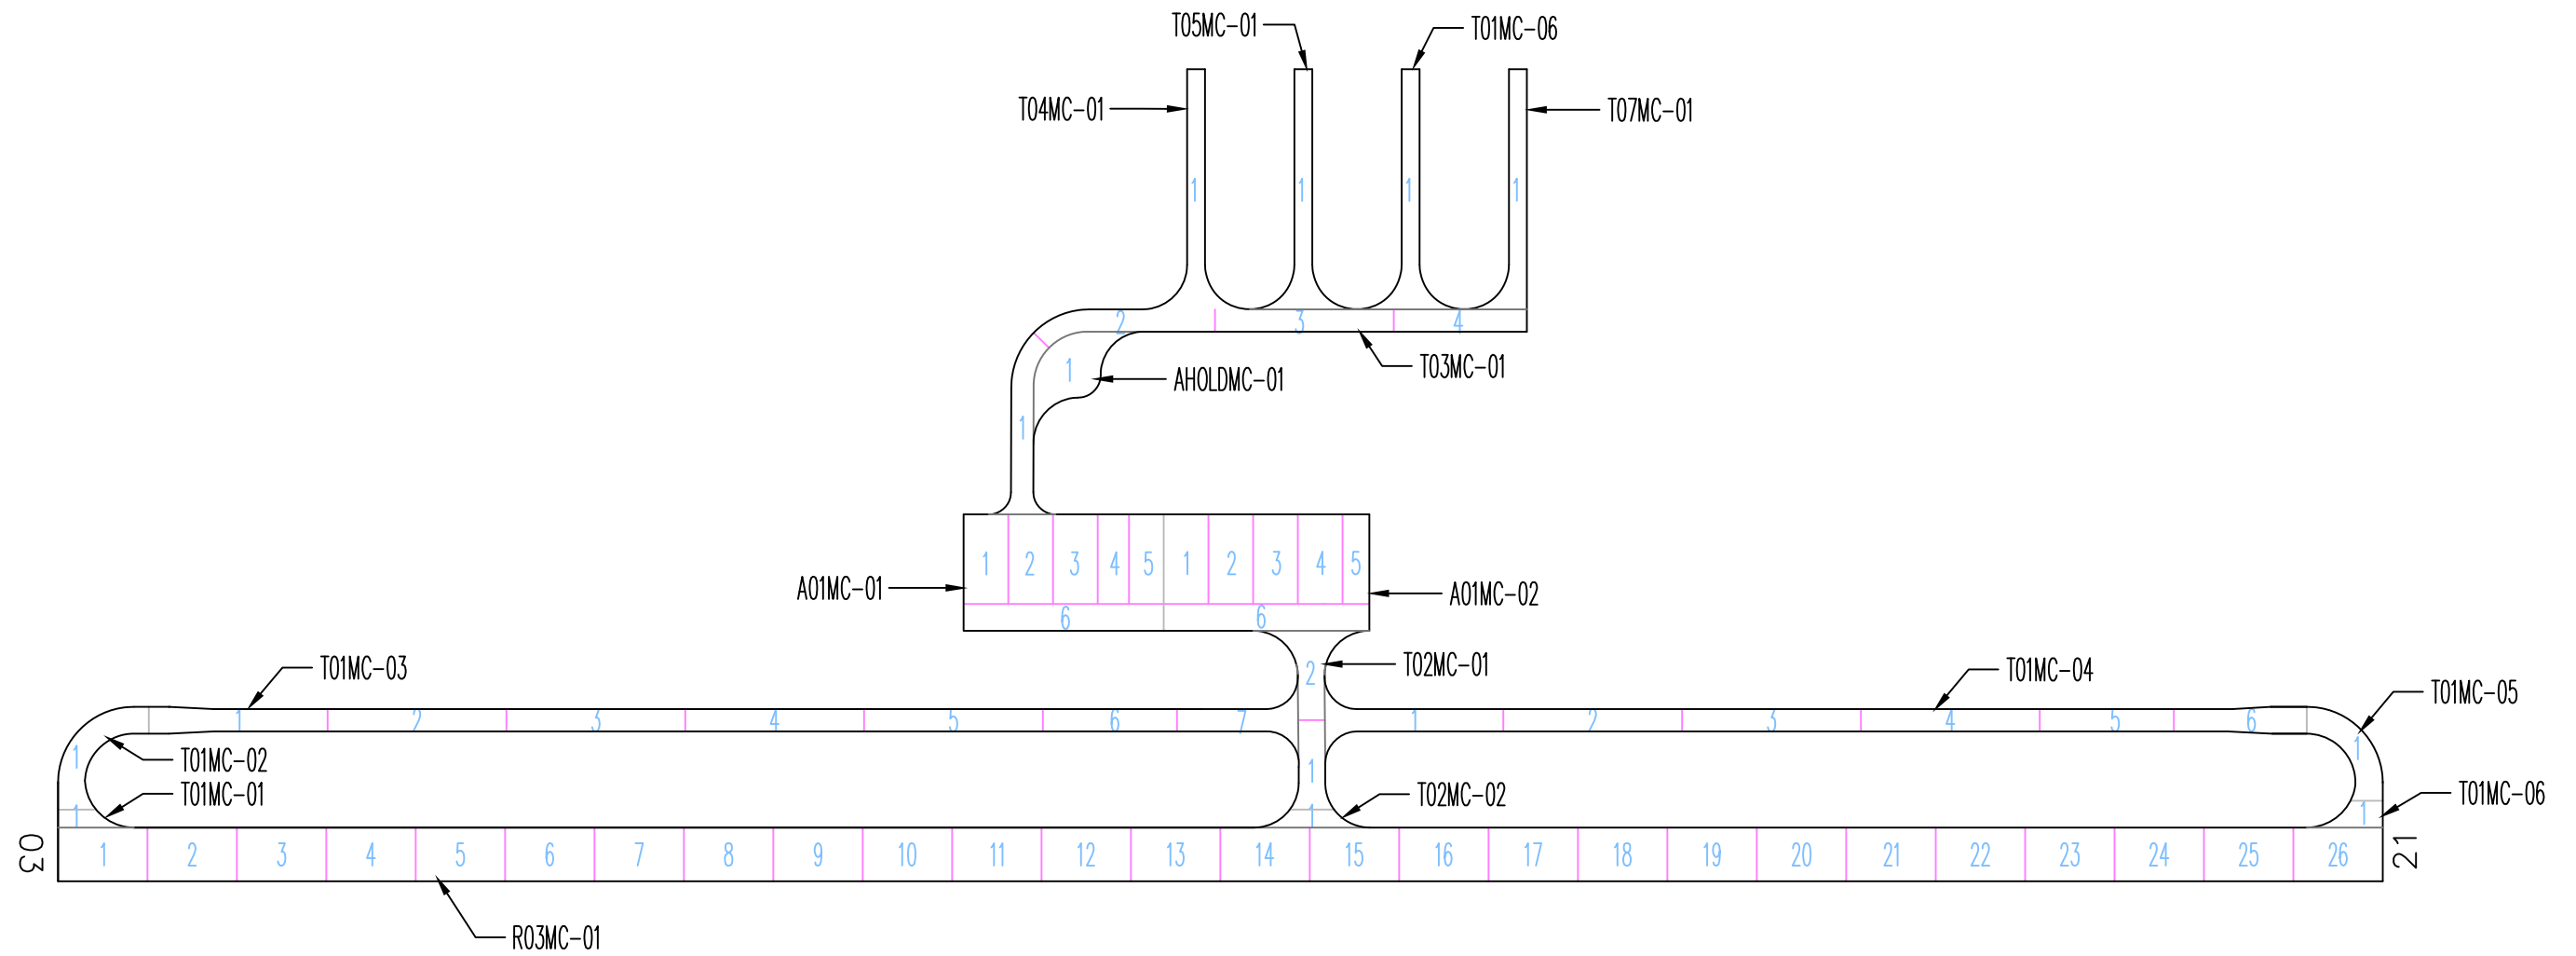
Figure MC-2. Pavement Branch, Section and Sample Unit Layout.
Myrtle Creek Municipal Airport

The pavements at your airport were divided into branches, sections and sample units in accordance with the methodology outlined in the current edition of ASTM D5430, *Standard Test Method for Airport Condition Index Surveys*. The branches, sections and sample units established at your airport are shown in Figure MC-2. A Branch Condition Report showing all branches, their associated areas, and their area-weighted average condition is provided in Appendix 1. Additionally, the Appendix 2 Section Condition Report provides information used to define each branch and section in the Micro PAVER database.
