PINEHURST STATE AIRPORT

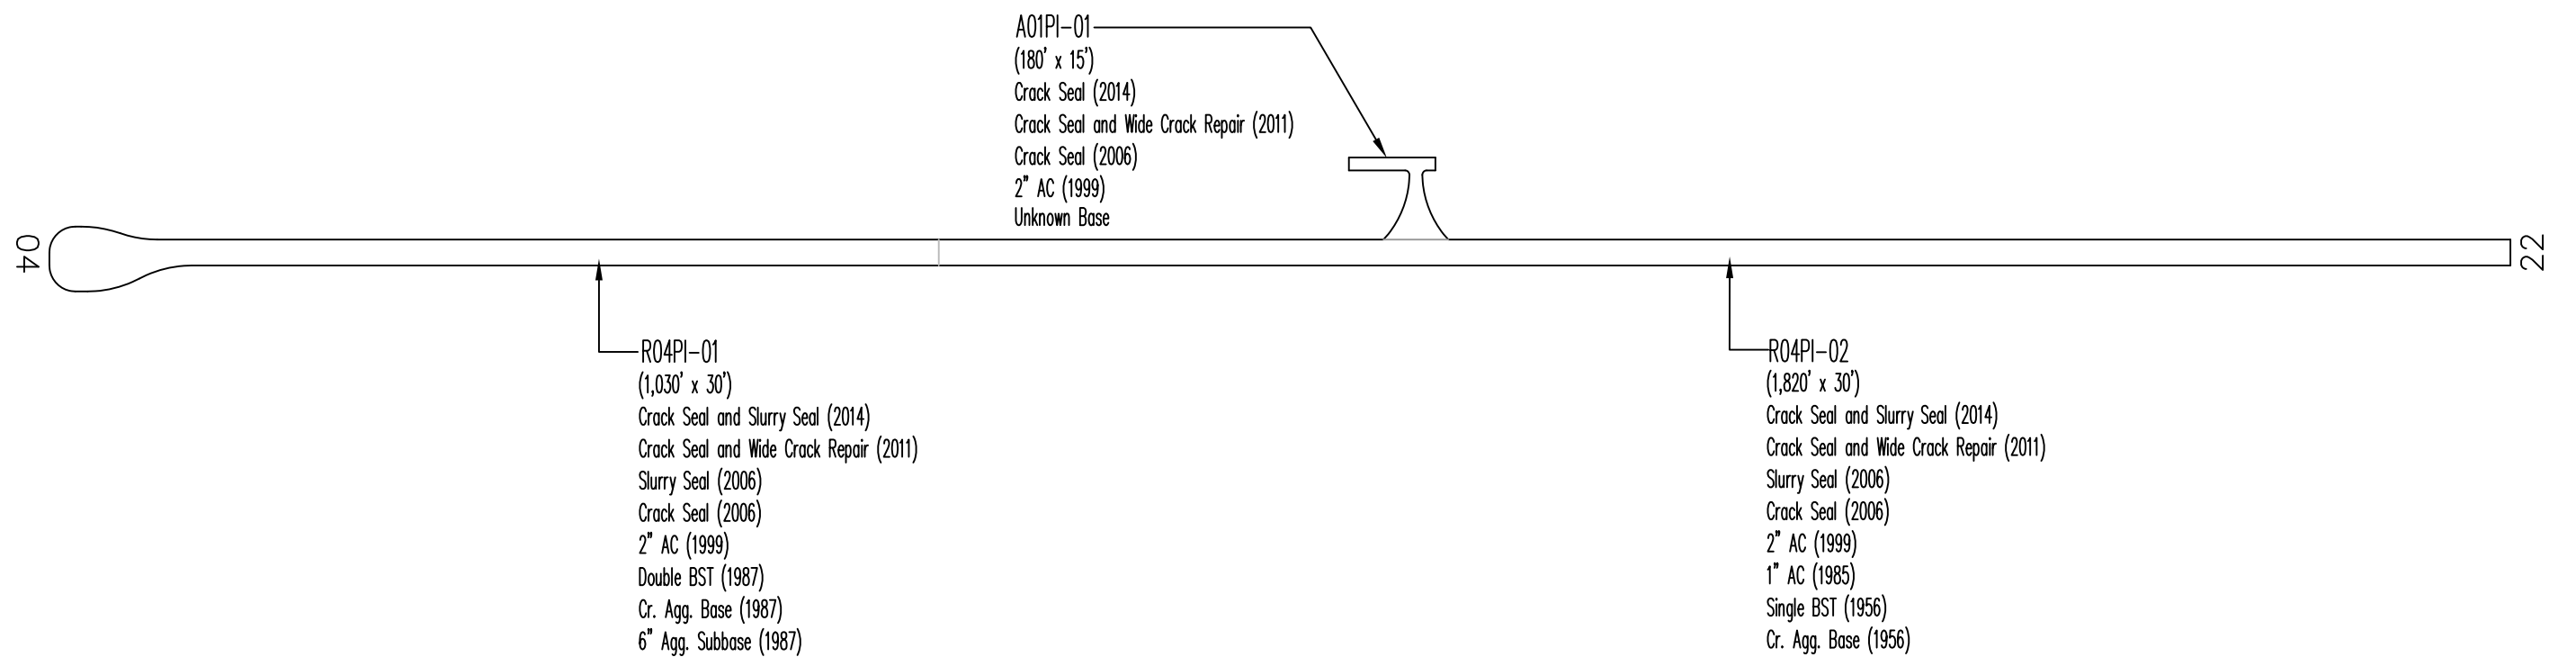
Figure PI-1. Airport Layout, Dimensions and Pavement Cross-Sections.
Pinehurst State Airport

To determine how your pavements were constructed and their age, a records review was conducted. Figure PI-1 shows the records review results. This figure identifies pavement boundaries, dimensions, pavement layer types, thicknesses and dates of construction. The most recent construction date for each pavement can also be found in the Section Condition Report in Appendix 2. Figure PI-1 and the information contained in Appendices 1, 2 and 4 ensure that your airport complies with the “pavement inventory” requirement of FAA’s PMMP guidelines.

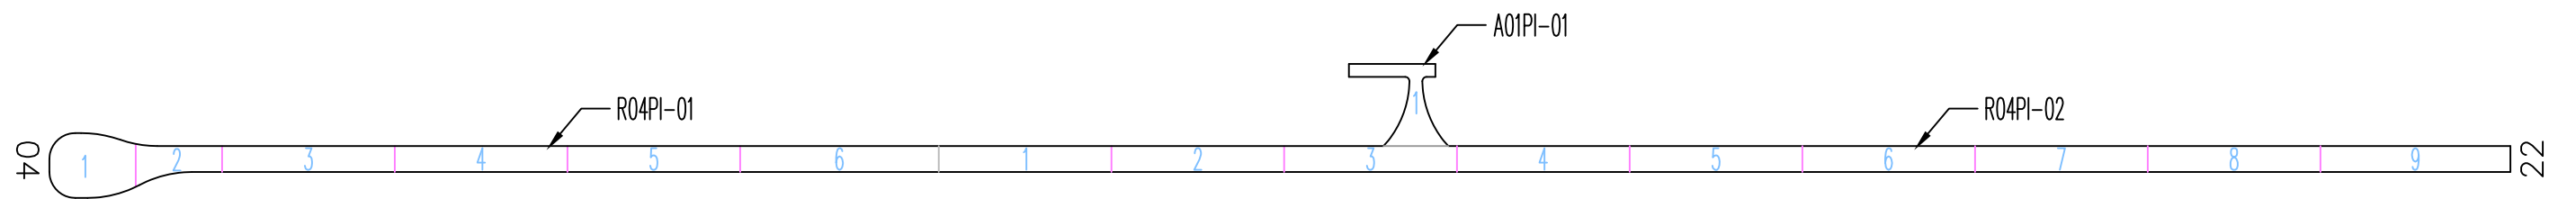
Figure PI-2. Pavement Branch, Section and Sample Unit Layout.
Pinehurst State Airport

The pavements at your airport were divided into branches, sections and sample units in accordance with the methodology outlined in the current edition of ASTM D5430, *Standard Test Method for Airport Condition Index Surveys*. The branches, sections and sample units established at your airport are shown in Figure PI-2. A Branch Condition Report showing all branches, their associated areas, and their area-weighted average condition is provided in Appendix 1. Additionally, the Appendix 2 Section Condition Report provides information used to define each branch and section in the Micro PAVER database.
