PROSPECT STATE AIRPORT

This report describes how your Pavement Maintenance Management Program (PMMP) was developed. Your Program was developed as part of the Oregon Continuous Aviation System Plan sponsored in part by the Oregon Department of Aviation and the Federal Aviation Administration (FAA). The information and data contained in this report ensures you are in compliance with the requirements of FAA Grant Assurance Number 11 which states that any airport requesting federal funds for pavement improvement projects must have implemented a pavement maintenance management program.

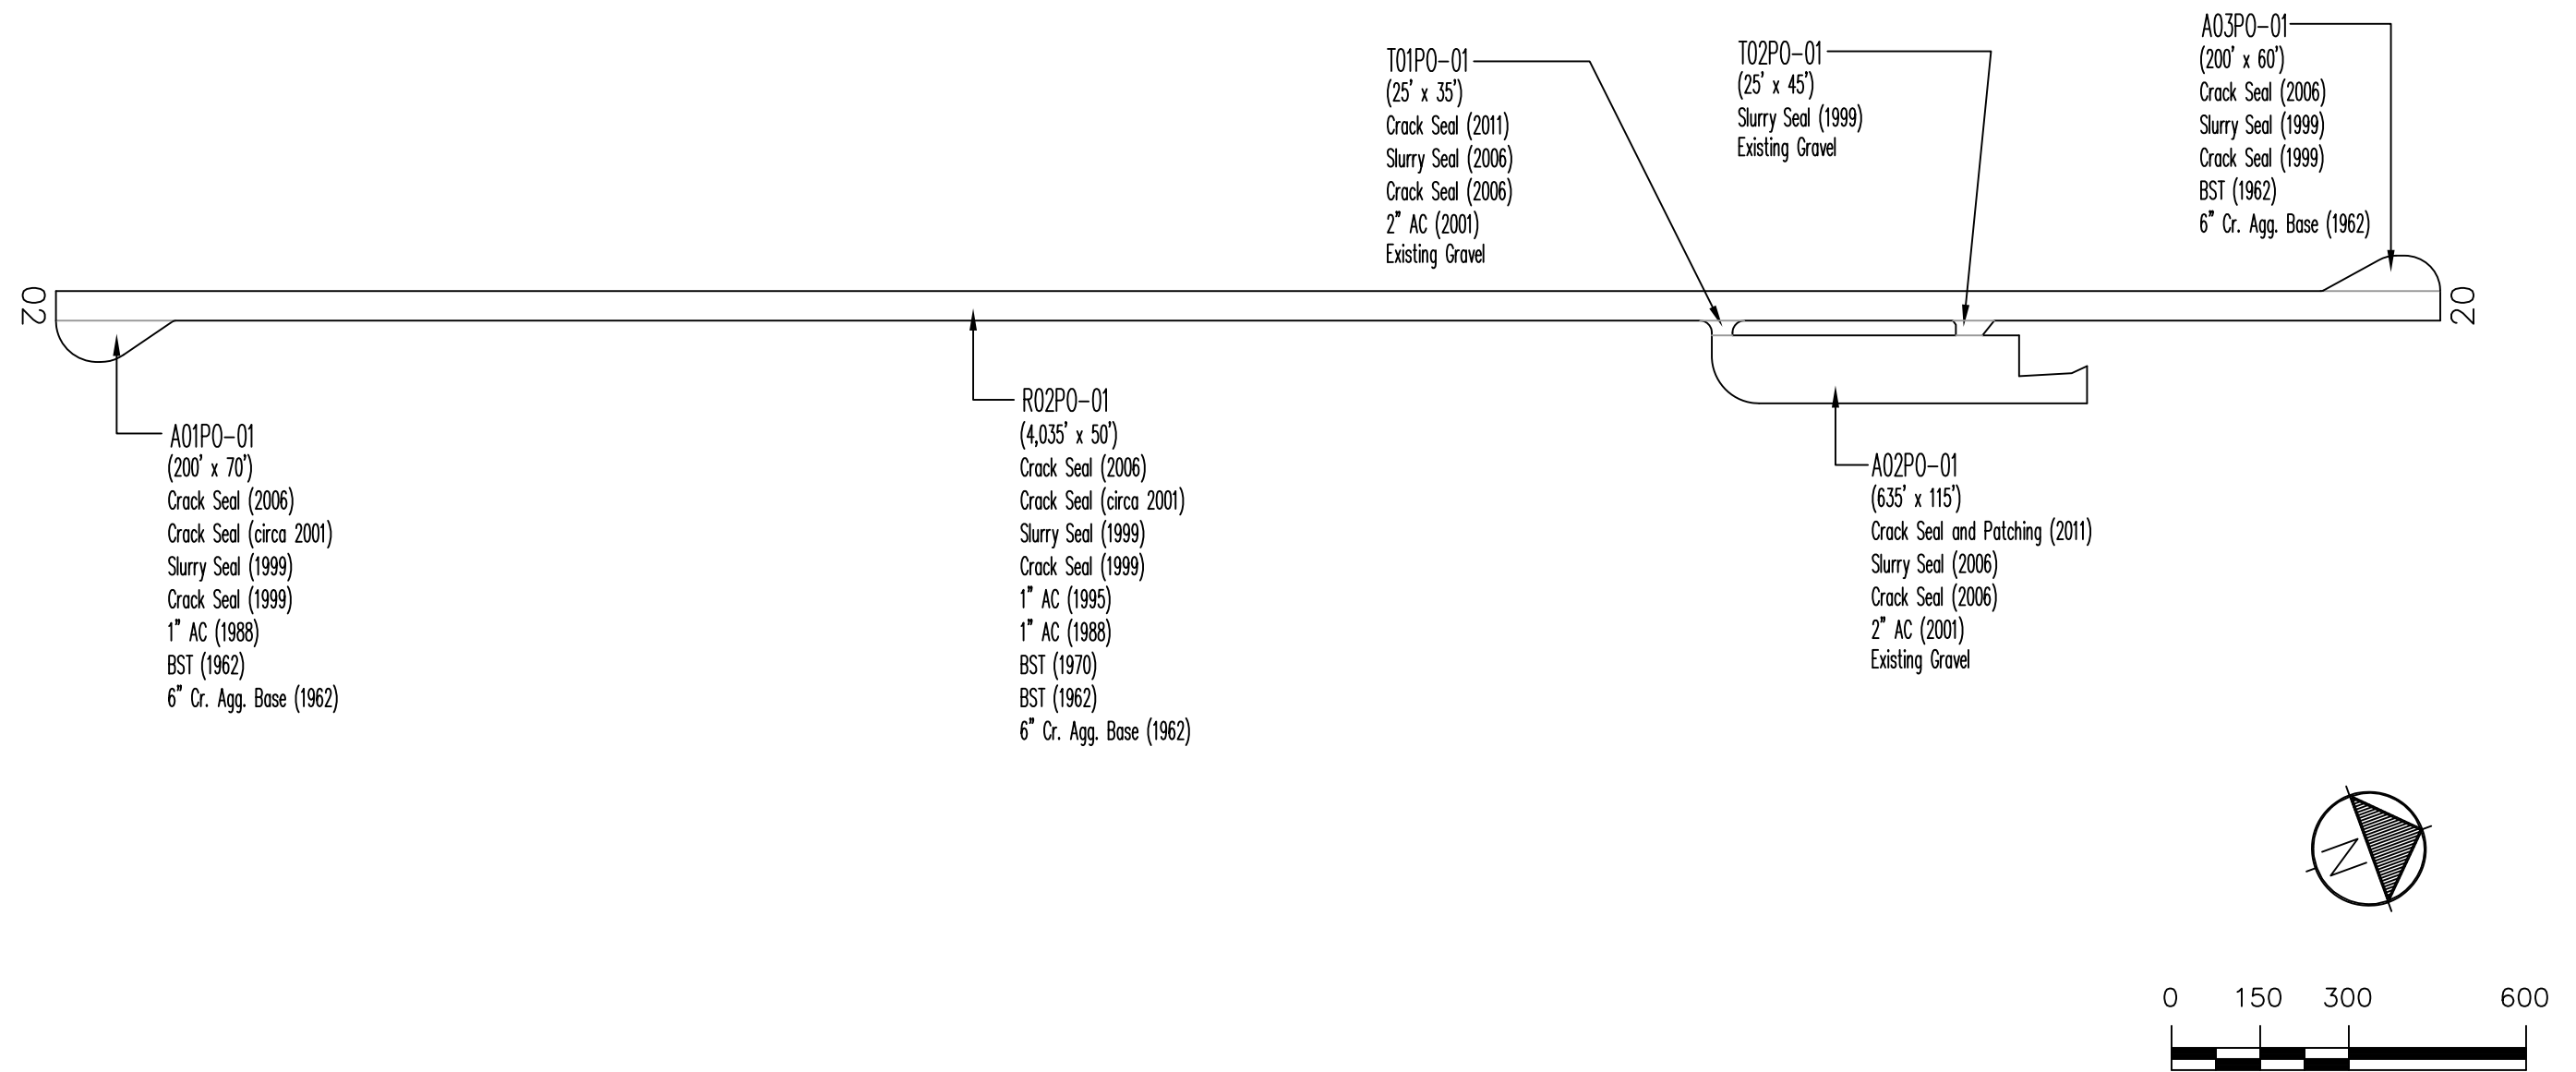
Figure PO-1. Airport Layout, Dimensions and Pavement Cross-Sections.
Prospect State Airport

To determine how your pavements were constructed and their age, a records review was conducted. Figure PO-1 shows the records review results. This figure identifies pavement boundaries, dimensions, pavement layer types, thicknesses and dates of construction. The most recent construction date for each pavement can also be found in the Section Condition Report in Appendix 2. Figure PO-1 and the information contained in Appendices 1, 2 and 4 ensure that your airport complies with the “pavement inventory” requirement of FAA’s PMMP guidelines.
