ROSEBURG REGIONAL AIRPORT

This report describes how your Pavement Maintenance Management Program (PMMP) was developed. Your Program was developed as part of the Oregon Continuous Aviation System Plan sponsored in part by the Oregon Department of Aviation and the Federal Aviation Administration (FAA). The information and data contained in this report ensures you are in compliance with the requirements of FAA Grant Assurance Number 11 which states that any airport requesting federal funds for pavement improvement projects must have implemented a pavement maintenance management program.

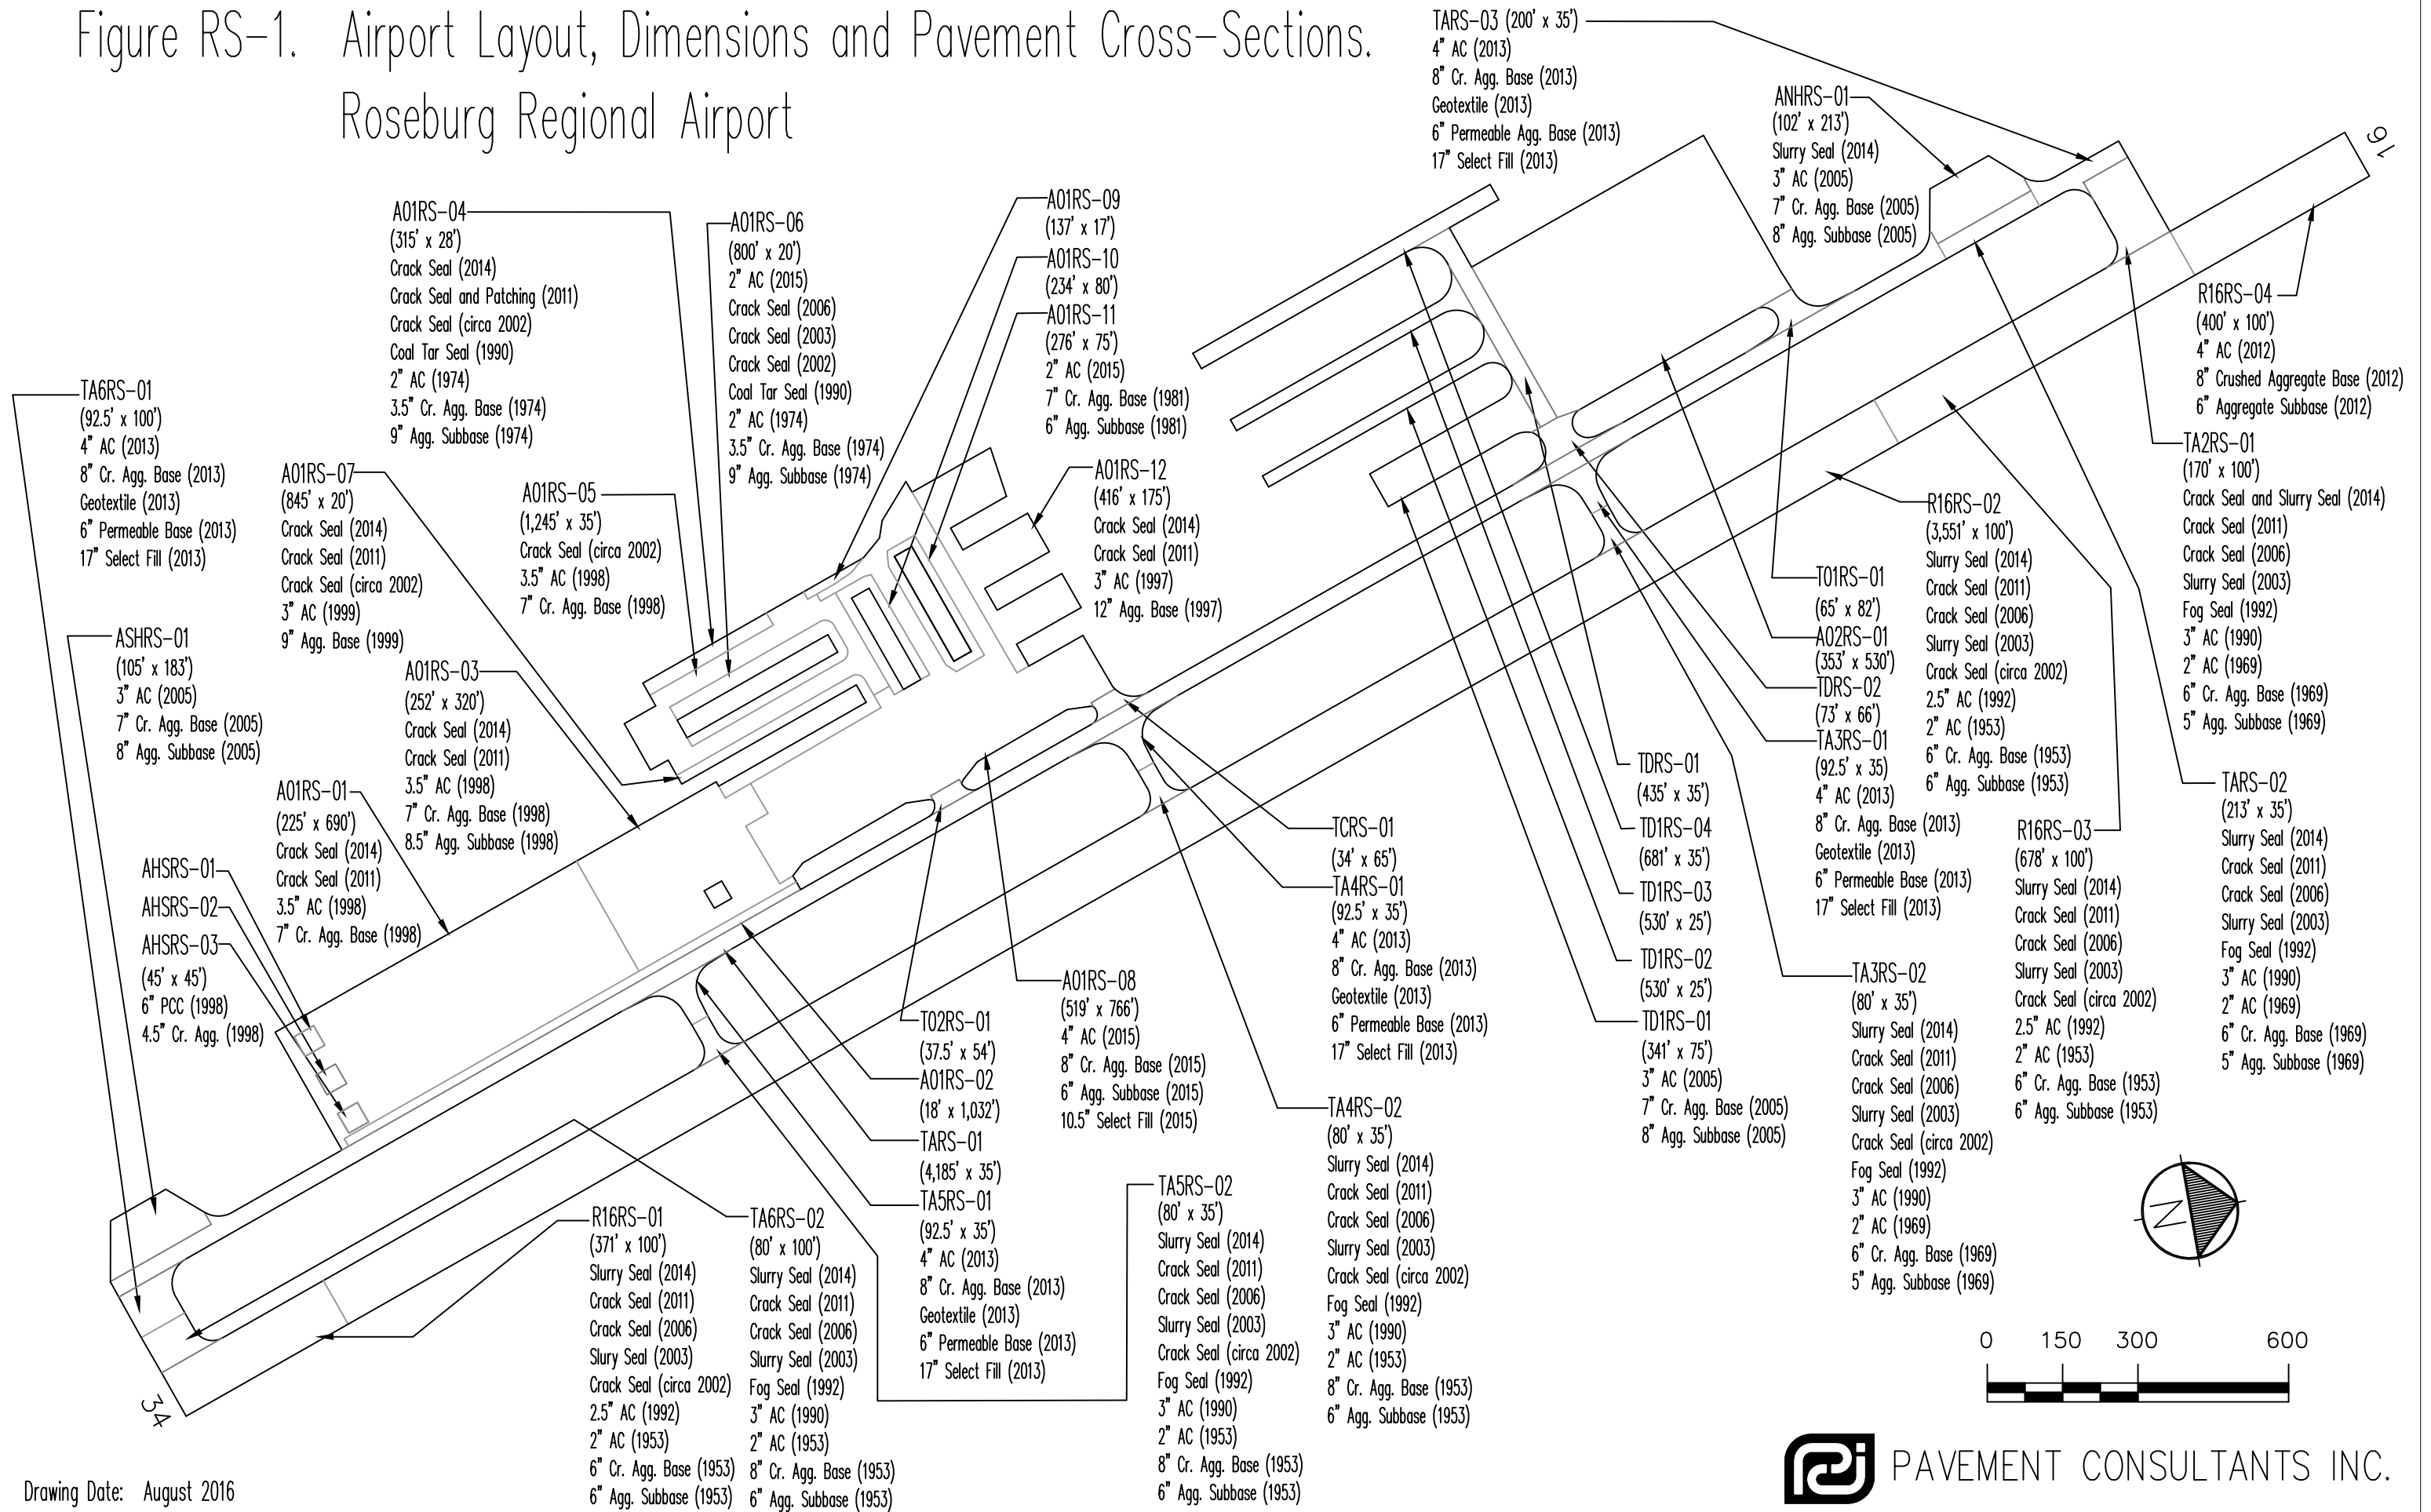
Figure RS-1. Airport Layout, Dimensions and Pavement Cross-Sections.
Roseburg Regional Airport

To determine how your pavements were constructed and their age, a records review was conducted. Figure RS-1 shows the records review results. This figure identifies pavement boundaries, dimensions, pavement layer types, thicknesses and dates of construction. The most recent construction date for each pavement can also be found in the Section Condition Report in Appendix 2. Figure RS-1 and the information contained in Appendices 1, 2 and 4 ensure that your airport complies with the “pavement inventory” requirement of FAA’s PMMP guidelines.

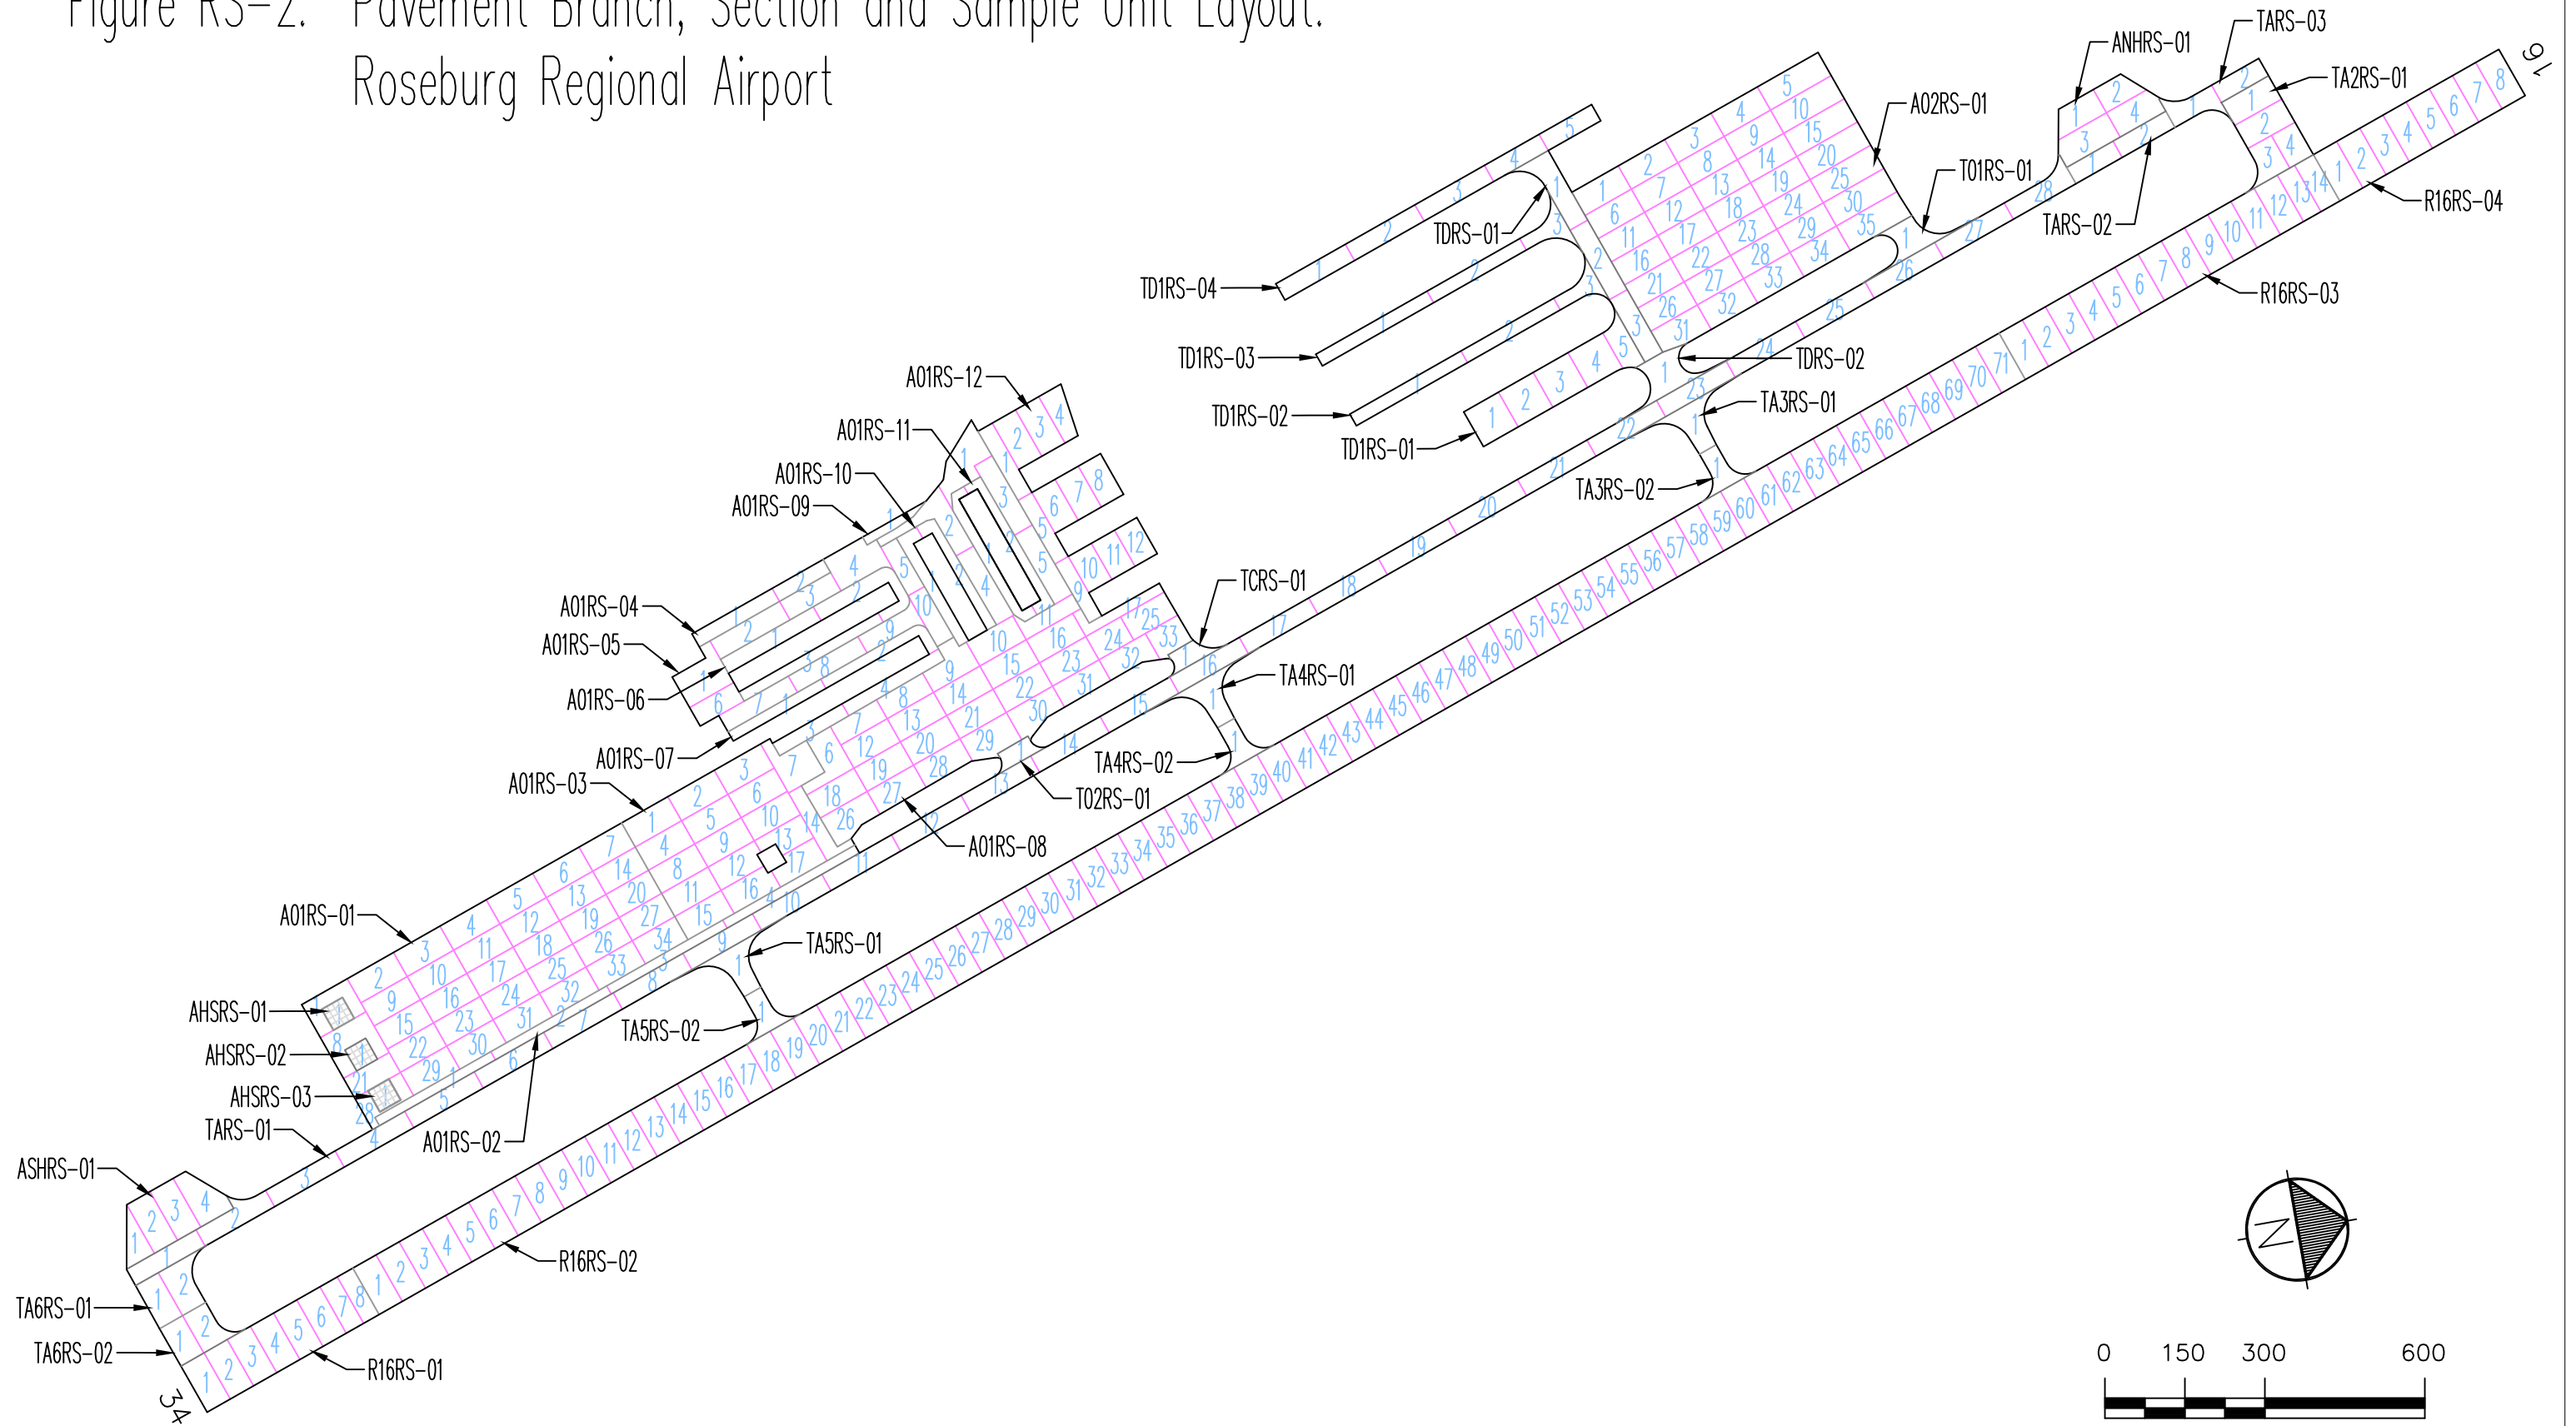
Figure RS-2. Pavement Branch, Section and Sample Unit Layout.
Roseburg Regional Airport

The pavements at your airport were divided into branches, sections and sample units in accordance with the methodology outlined in the current edition of ASTM D5430, *Standard Test Method for Airport Condition Index Surveys*. The branches, sections and sample units established at your airport are shown in Figure RS-2. A Branch Condition Report showing all branches, their associated areas, and their area-weighted average condition is provided in Appendix 1. Additionally, the Appendix 2 Section Condition Report provides information used to define each branch and section in the Micro PAVER database.

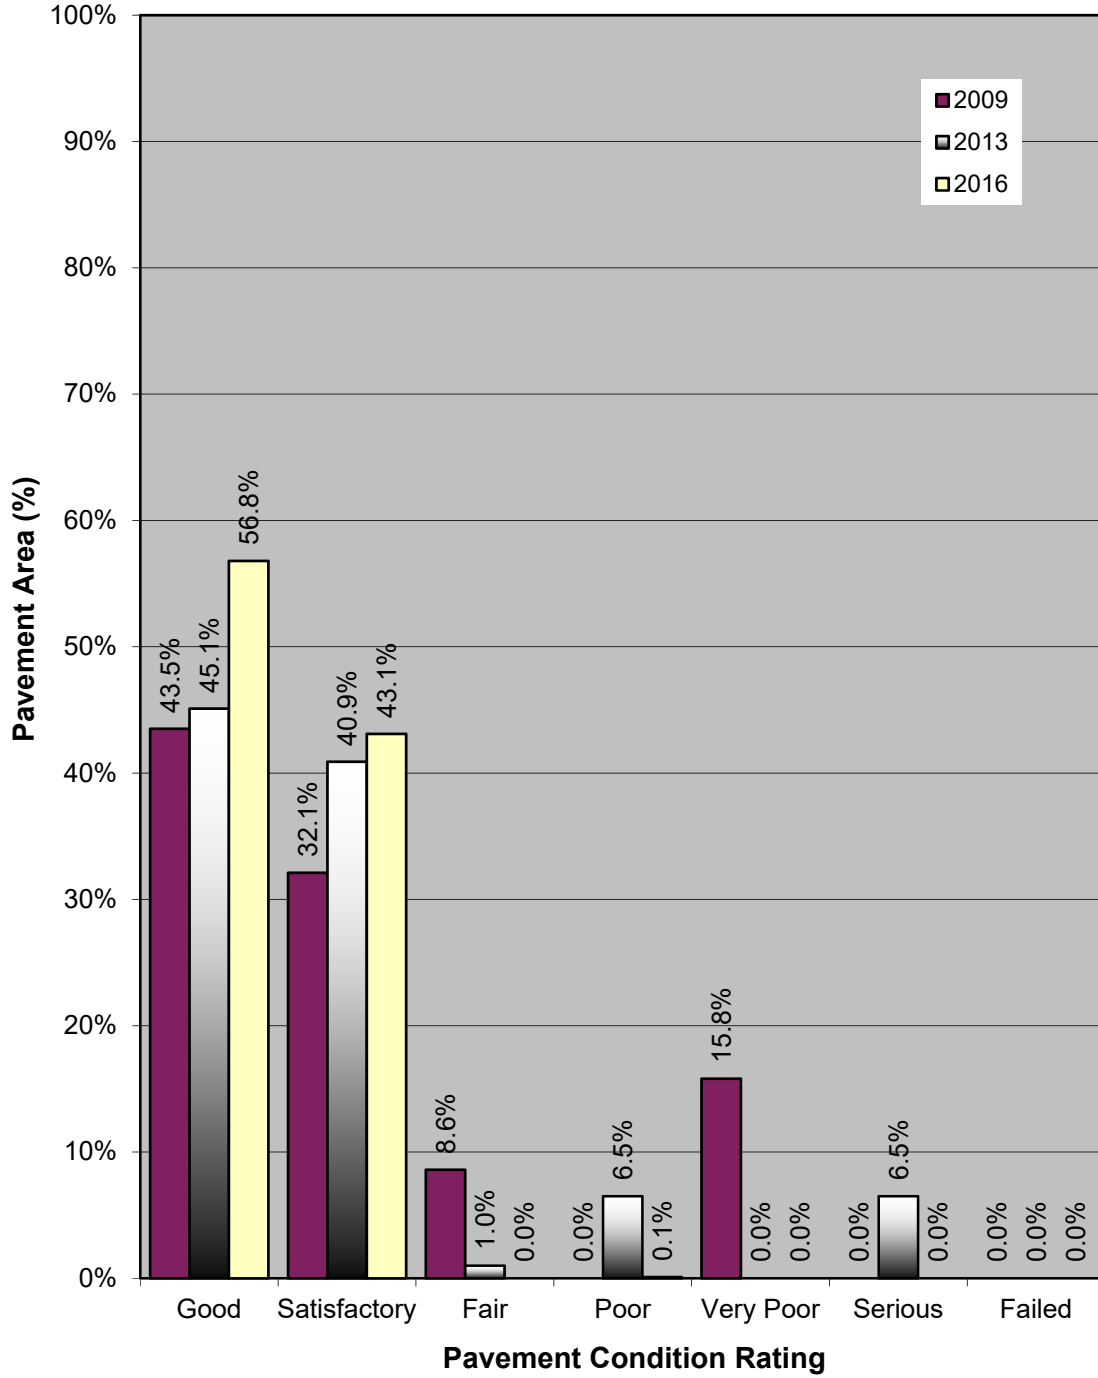
**Figure RS-4. Pavement Condition Distribution
Roseburg Regional Airport**

Section PCIs at Roseburg Regional Airport range from a low of 44 (a PCR of “Serious”) to a high of 100 (a PCR of “Good”). The area-weighted average PCI for all airport pavements is 90, corresponding to an overall PCR of “Good”. Figure RS-4 shows how much pavement area is associated with each Pavement Condition Rating category and also shows pavement condition distribution from the inspections conducted in 2009 and 2013.

The primary distresses observed during the inspection were: longitudinal and transverse cracking, weathering, block cracking, patching, raveling, and joint and corner spalls.
