# BAKER CITY MUNICIPAL AIRPORT

This report describes how your Pavement Maintenance Management Program (PMMP) was developed. Your Program was developed as part of the Oregon Continuous Aviation System Plan sponsored in part by the Oregon Department of Aviation and the Federal Aviation Administration (FAA). The information and data contained in this report ensures you comply with the requirements of FAA Grant Assurance Number 11 which states that any airport requesting federal funds for pavement improvement projects must have implemented a pavement maintenance management program.

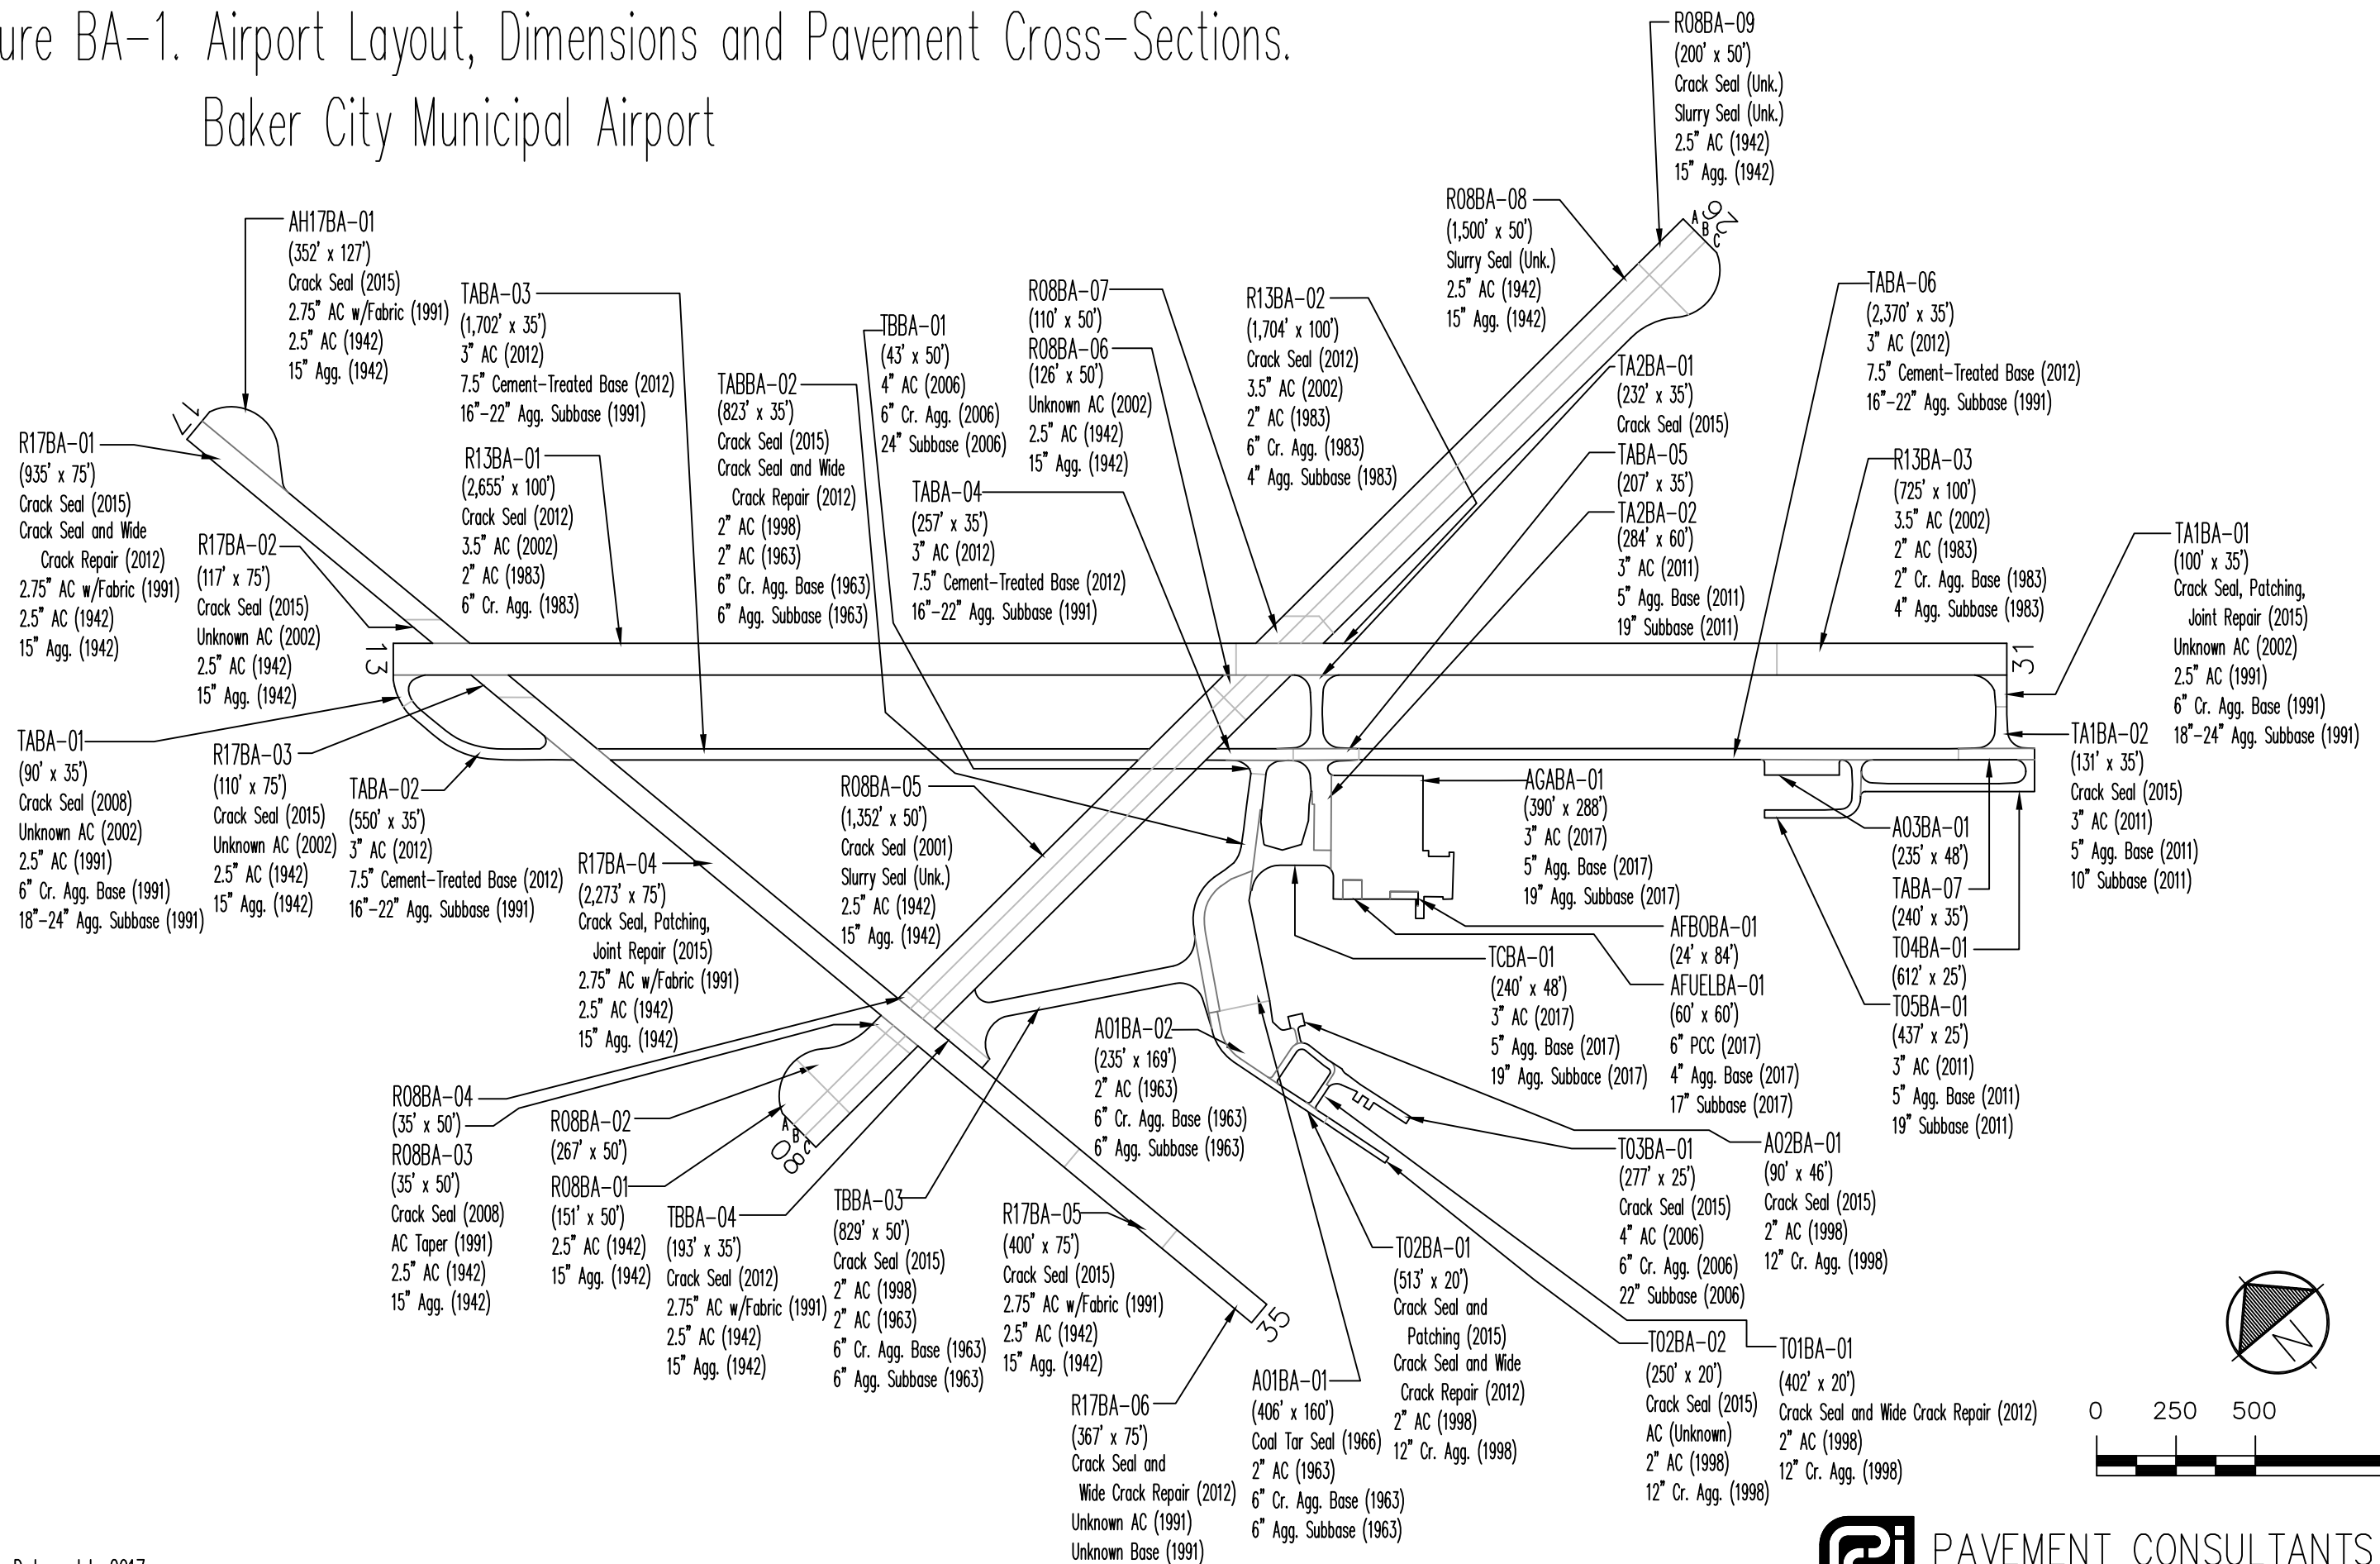
Figure BA-1. Airport Layout, Dimensions and Pavement Cross-Sections.  
Baker City Municipal Airport

To determine how your pavements were constructed and their age, a records review was conducted. Figure BA-1 shows the records review results. This figure identifies pavement boundaries, dimensions, pavement layer types, thicknesses and dates of construction. The most recent construction date for each pavement can also be found in the Section Condition Report in Appendix 2. Figure BA-1 and the information contained in Appendices 1, 2 and 4 ensure that your airport complies with the “pavement inventory” requirement of FAA’s PMMP guidelines.

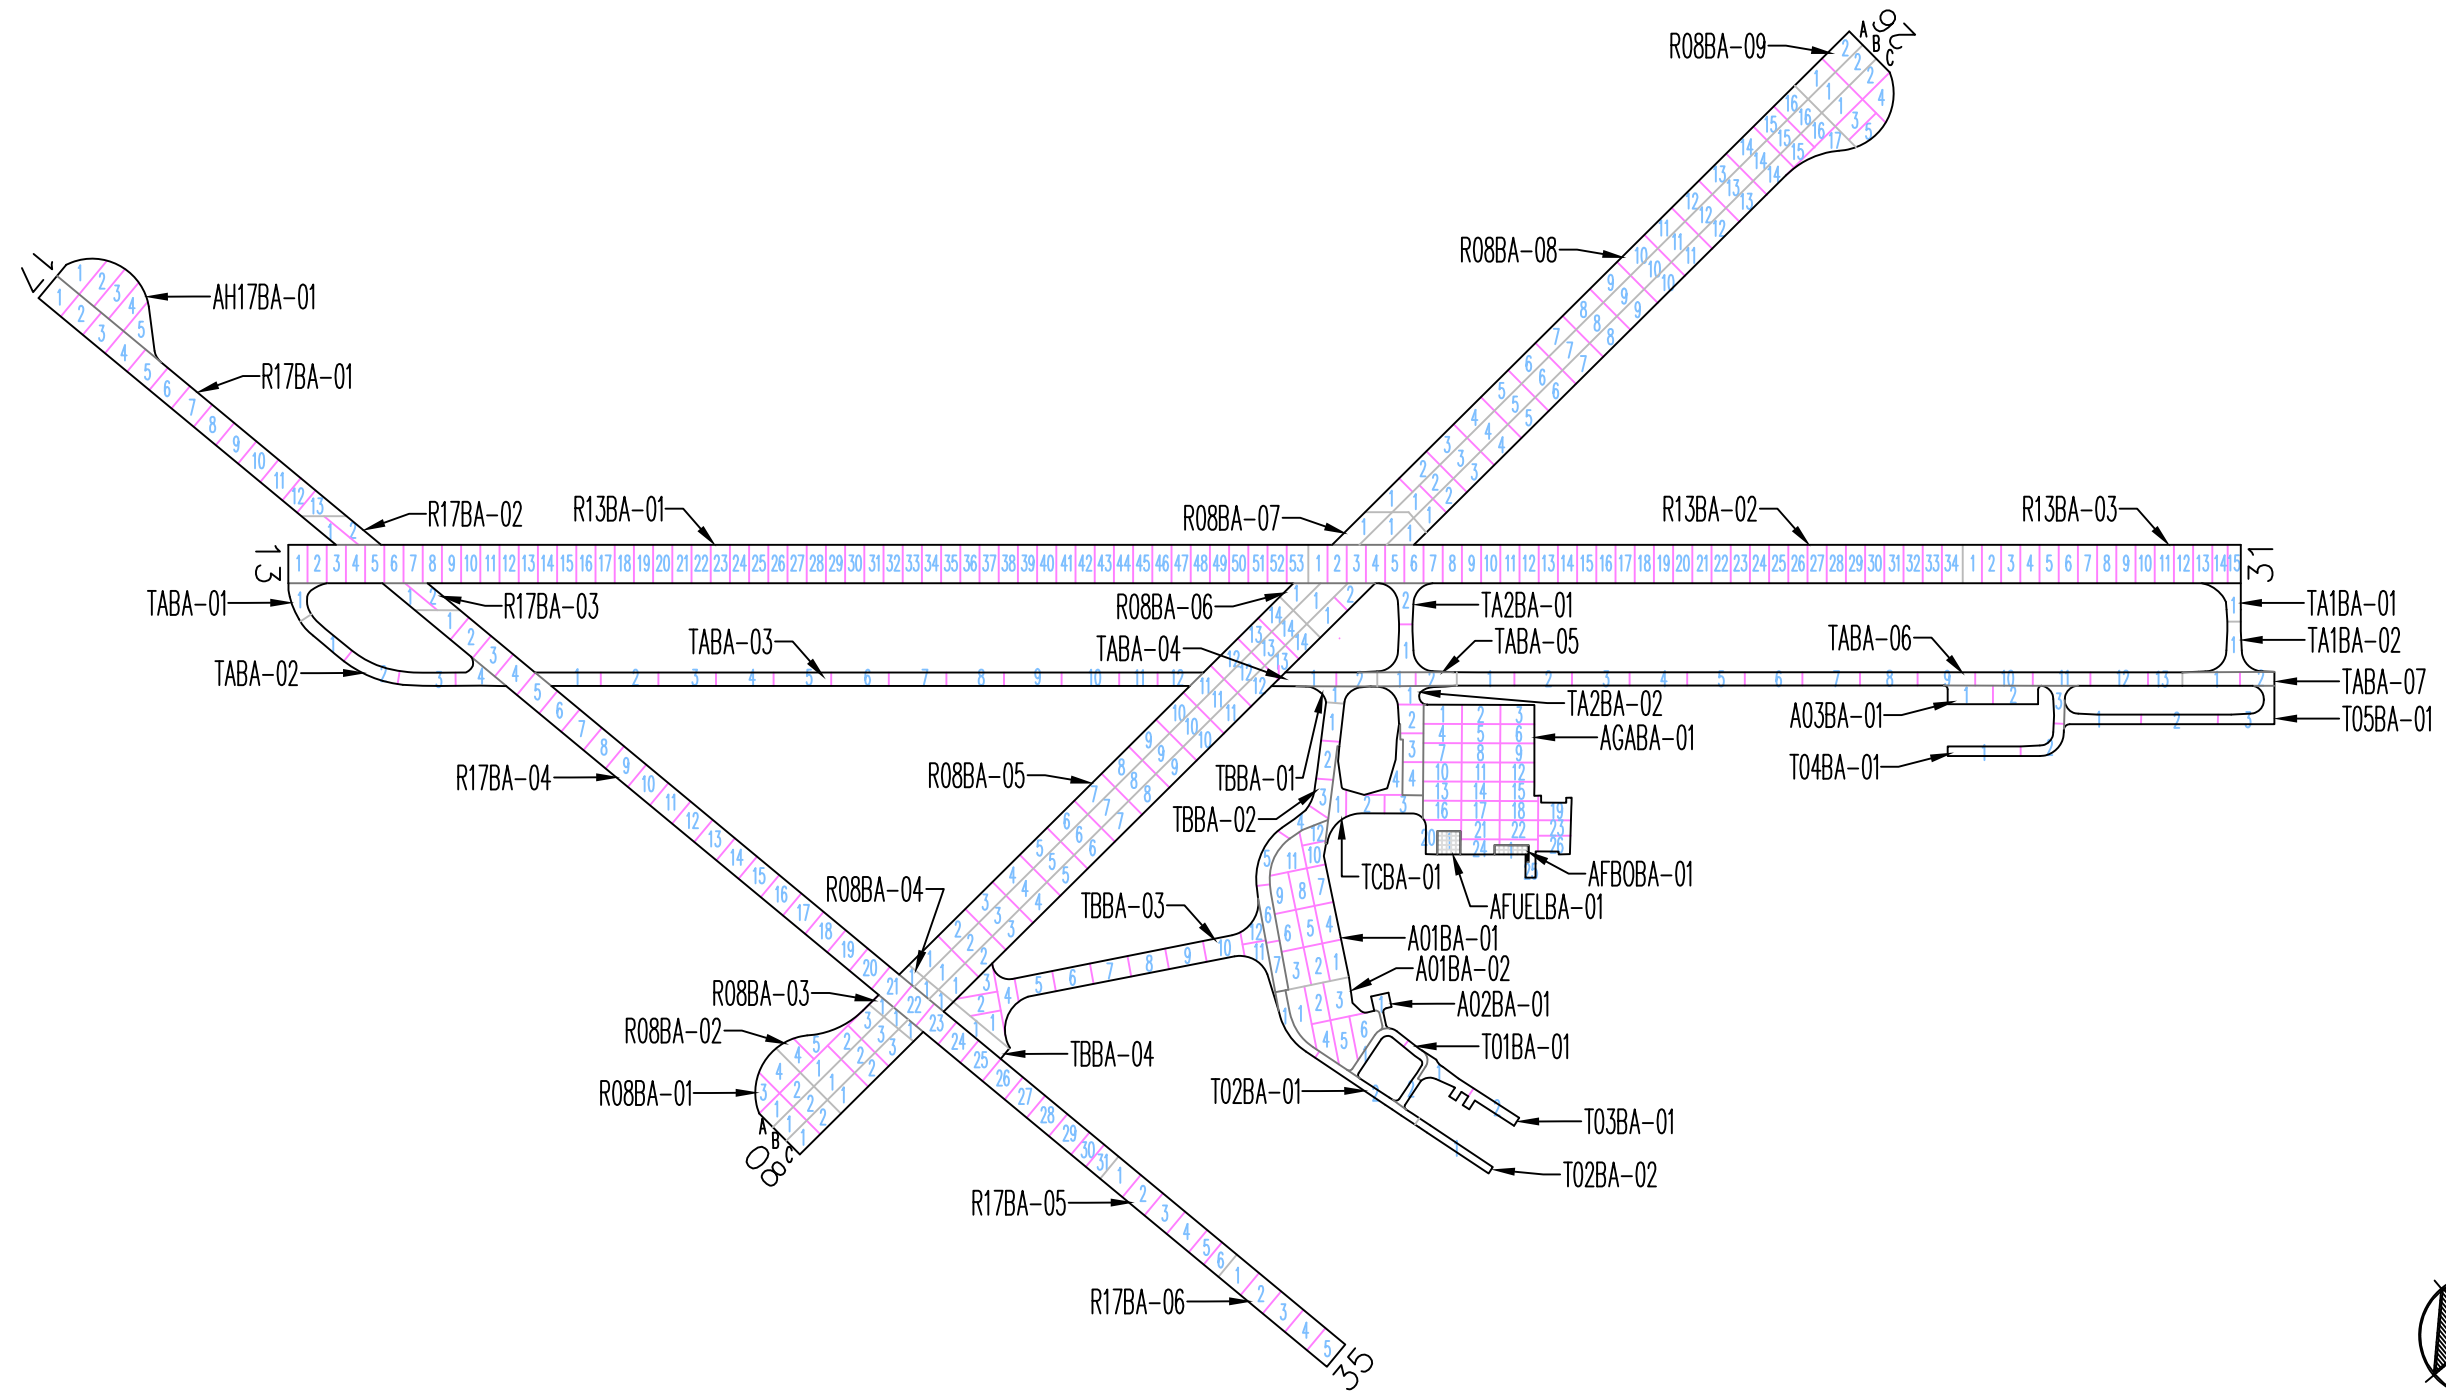
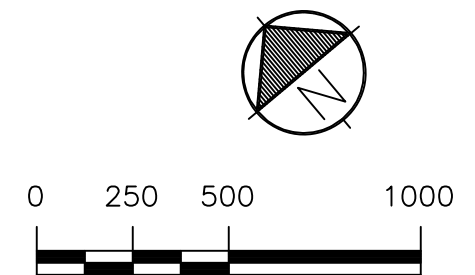
Figure BA-2. Pavement Branch, Section and Sample Unit Layout.  
 Baker City Municipal Airport

The pavements at your airport were divided into branches, sections and sample units in accordance with the methodology outlined in the current edition of ASTM D5430, *Standard Test Method for Airport Condition Index Surveys*. The branches, sections and sample units established at your airport are shown in Figure BA-2. A Branch Condition Report showing all branches, their associated areas, and their area-weighted average condition is provided in Appendix 1. Additionally, the Appendix 2 Section Condition Report provides information used to define each branch and section in the PAVER database.

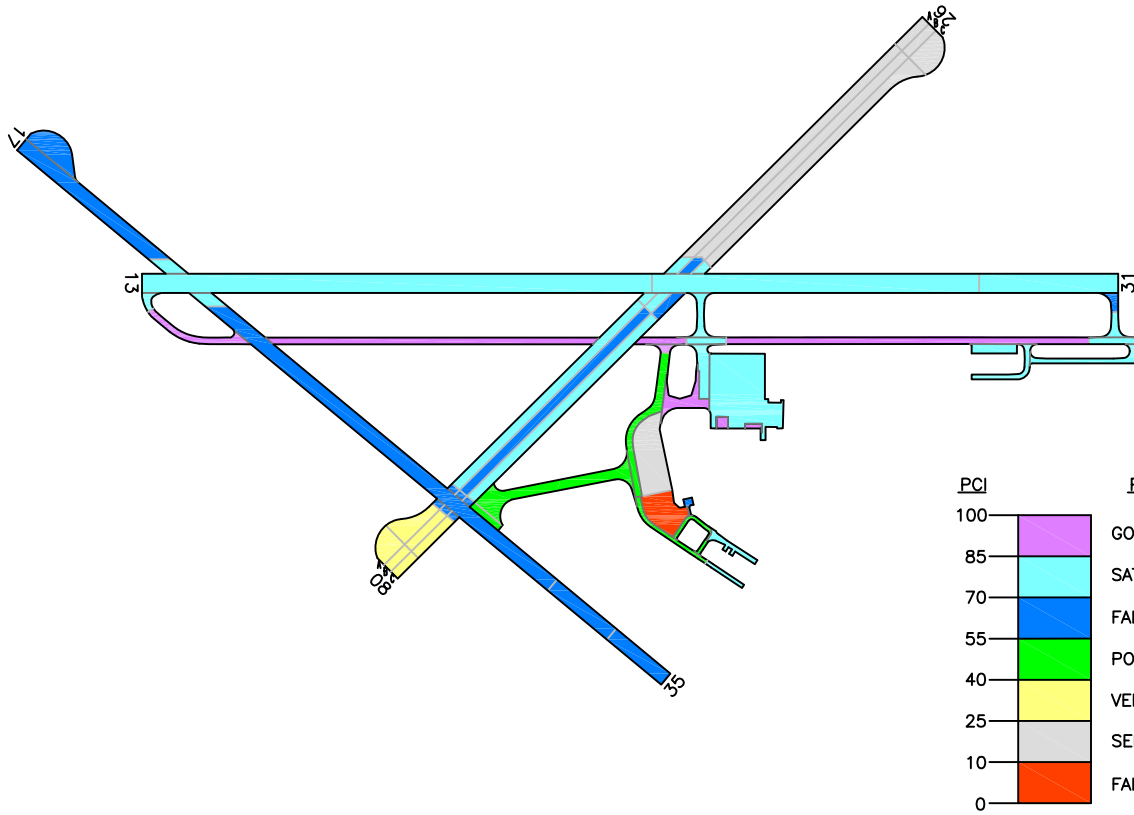
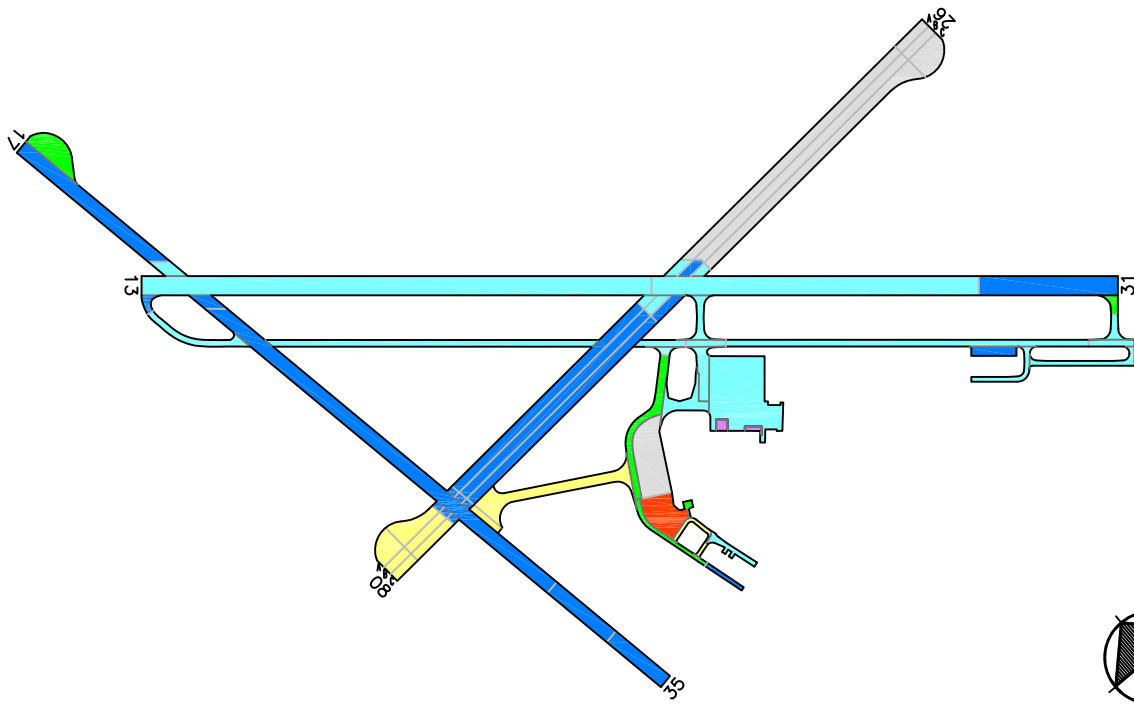
**Figure BA-5. Future Pavement Condition.**

**Predicted Condition in 2022.**

**Predicted Condition in 2027.**
