CONDON STATE AIRPORT – PAULING FIELD

This report describes how your Pavement Maintenance Management Program (PMMP) was developed. Your Program was developed as part of the Oregon Continuous Aviation System Plan sponsored in part by the Oregon Department of Aviation and the Federal Aviation Administration (FAA). The information and data contained in this report ensures you comply with the requirements of FAA Grant Assurance Number 11 which states that any airport requesting federal funds for pavement improvement projects must have implemented a pavement maintenance management program.

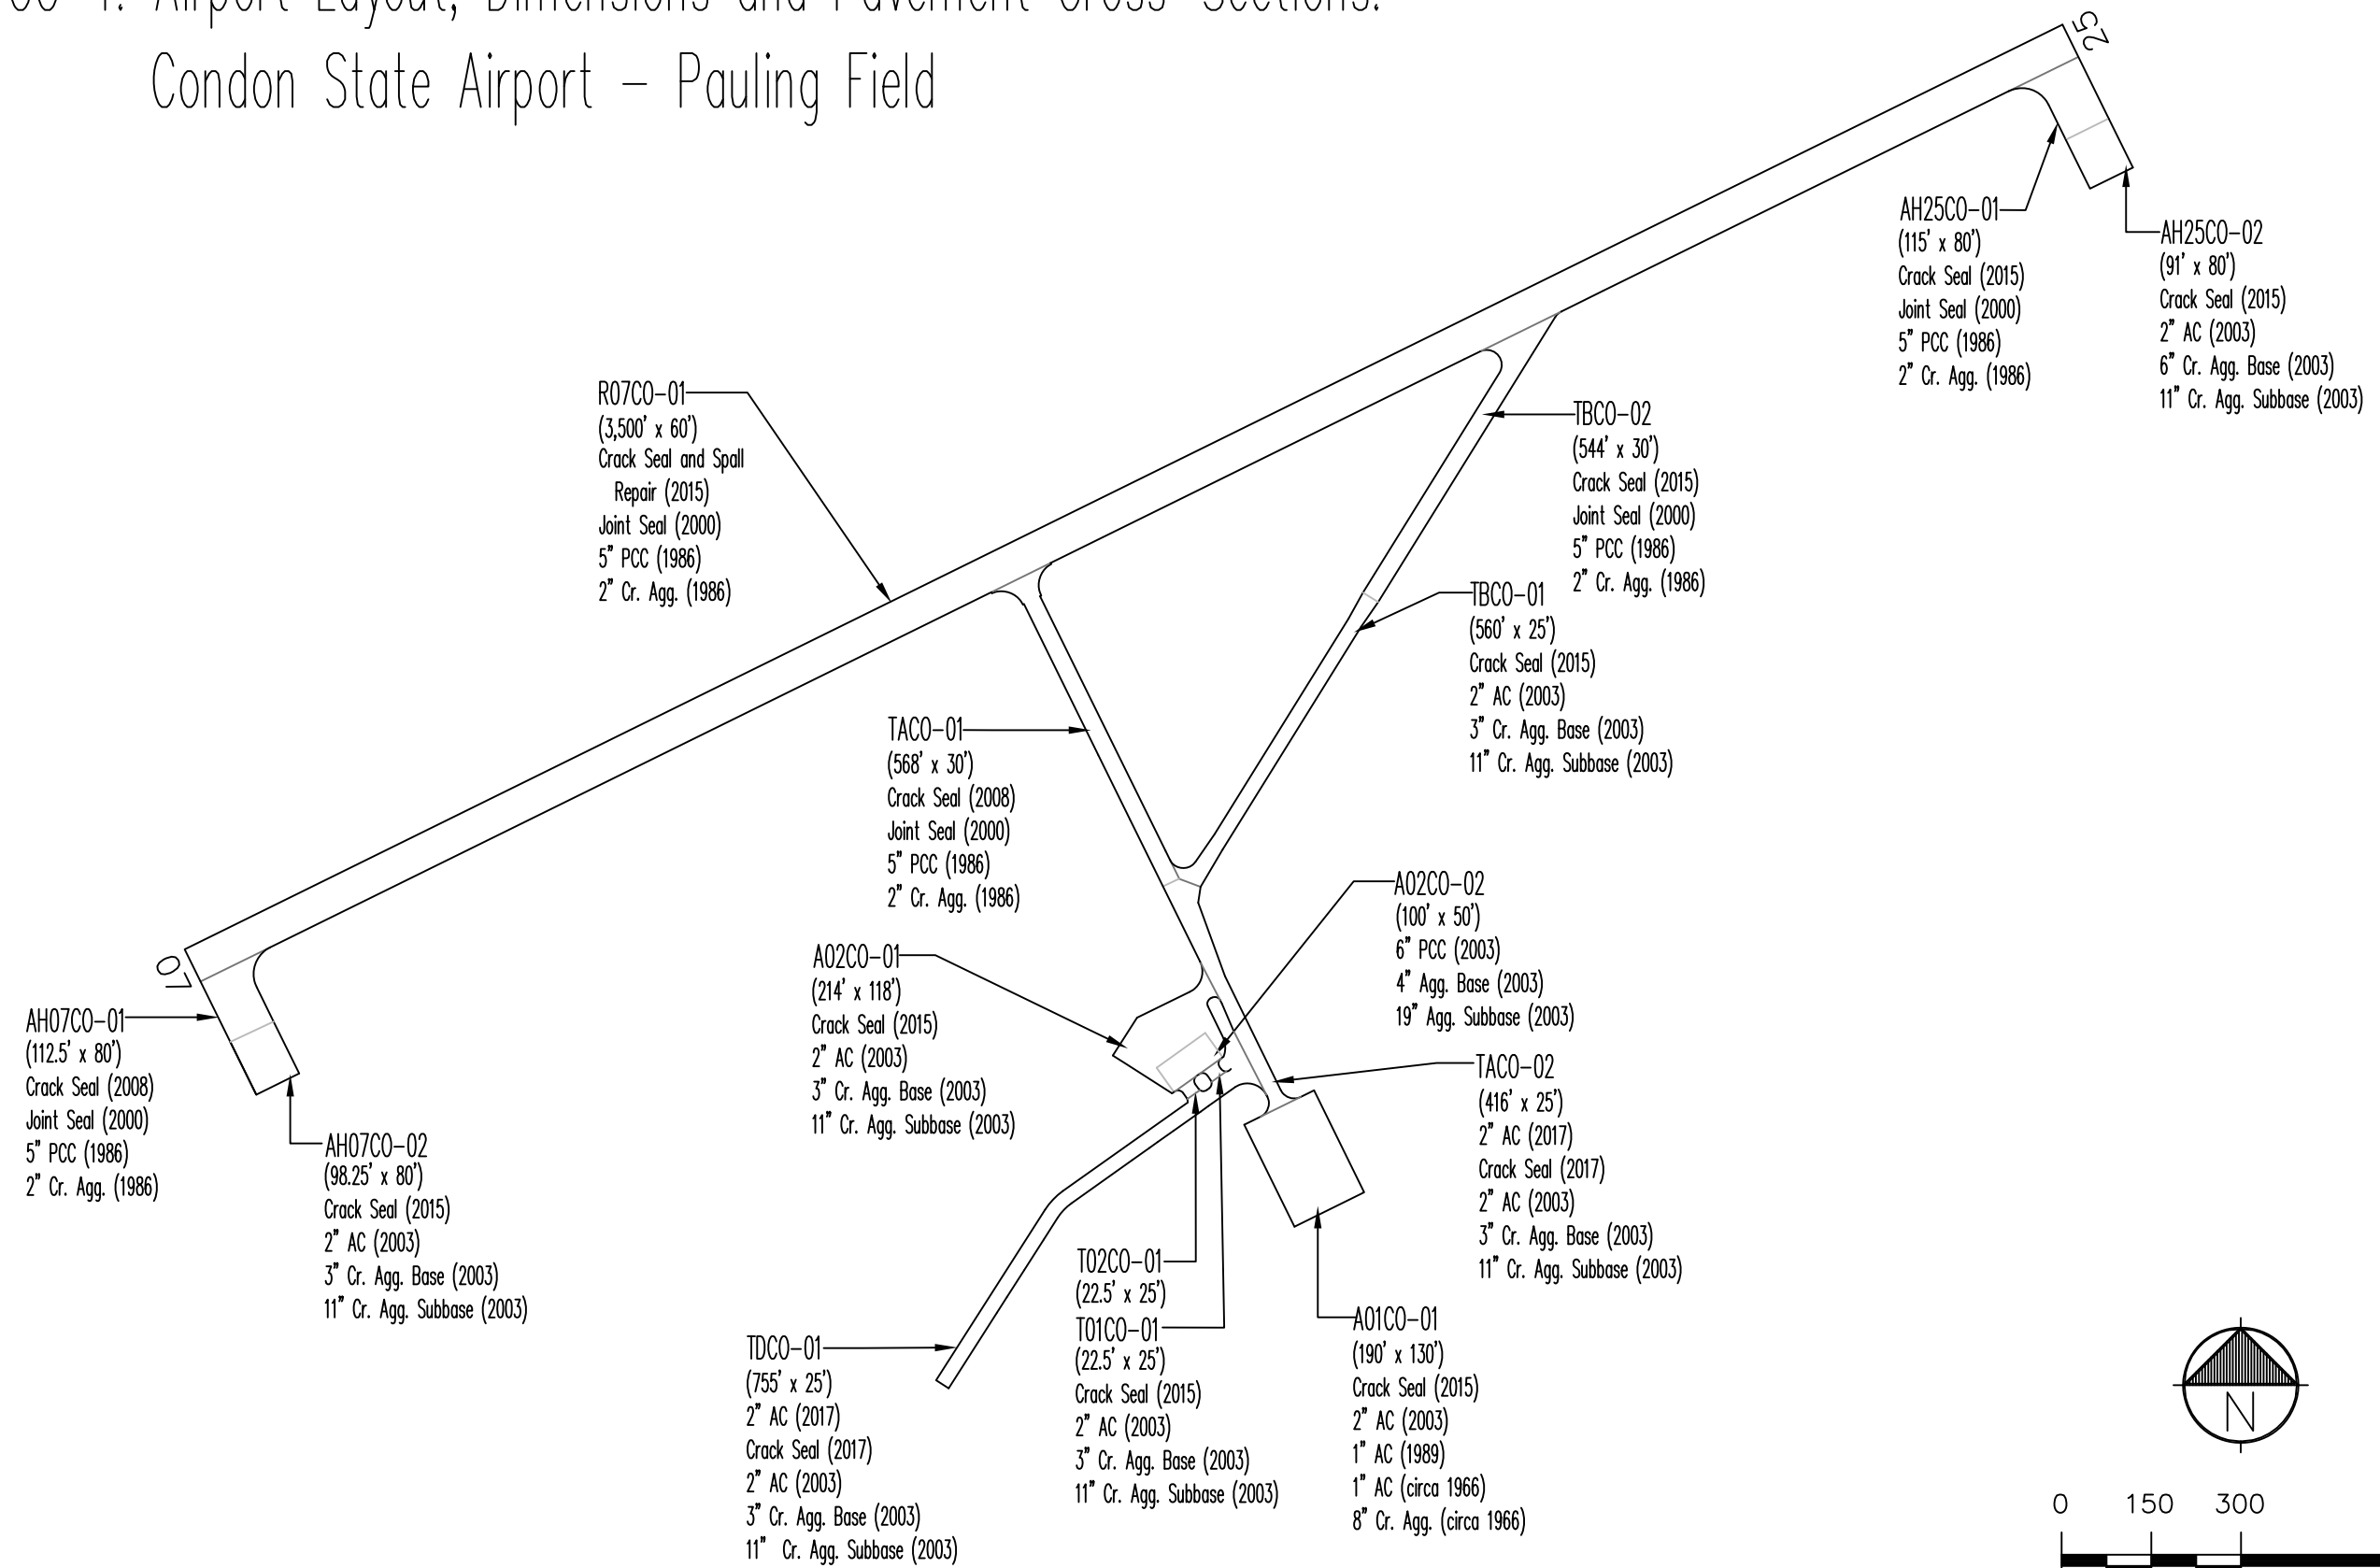
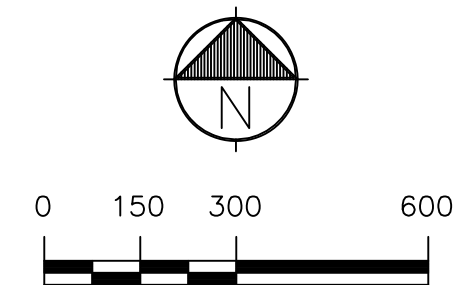
Figure CO-1. Airport Layout, Dimensions and Pavement Cross-Sections.
 Condon State Airport – Pauling Field

To determine how your pavements were constructed and their age, a records review was conducted. Figure CO-1 shows the records review results. This figure identifies pavement boundaries, dimensions, pavement layer types, thicknesses and dates of construction. The most recent construction date for each pavement can also be found in the Section Condition Report in Appendix 2. Figure CO-1 and the information contained in Appendices 1, 2 and 4 ensure that your airport complies with the “pavement inventory” requirement of FAA’s PMMP guidelines.

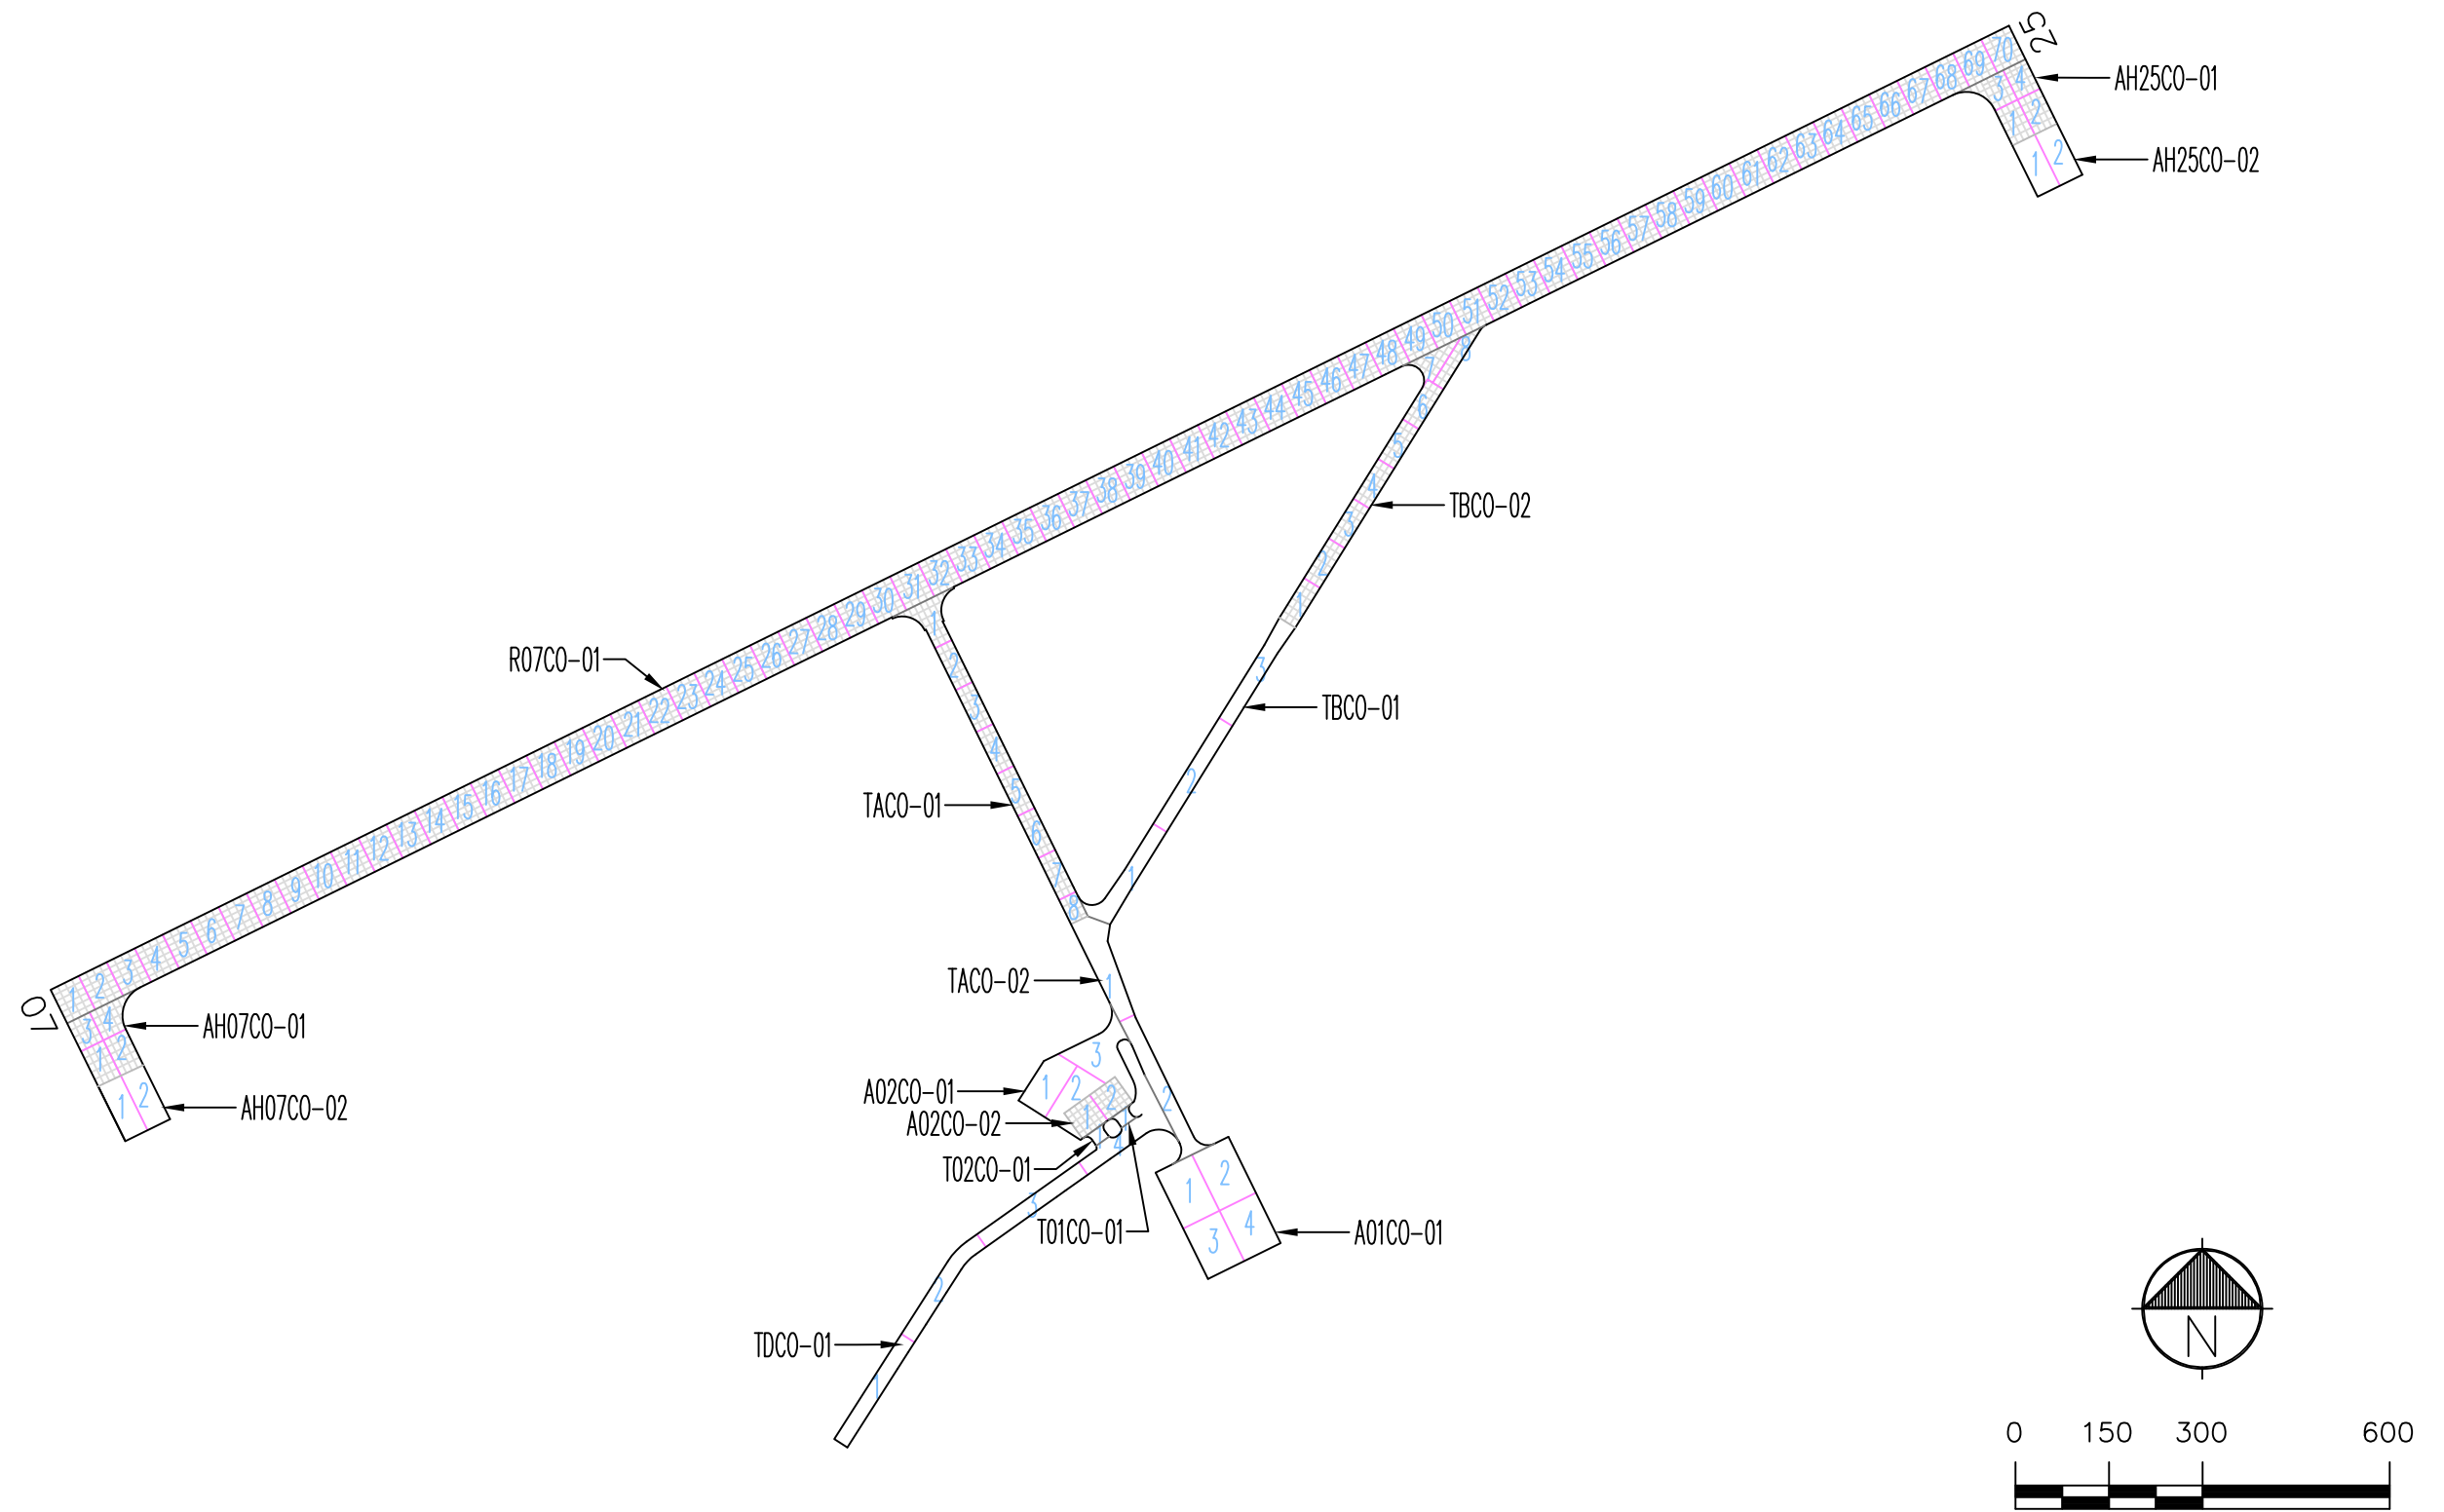
Figure CO-2. Pavement Branch, Section and Sample Unit Layout.
 Condon State Airport – Pauling Field

The pavements at your airport were divided into branches, sections and sample units in accordance with the methodology outlined in the current edition of ASTM D5430, *Standard Test Method for Airport Condition Index Surveys*. The branches, sections and sample units established at your airport are shown in Figure CO-2. A Branch Condition Report showing all branches, their associated areas, and their area-weighted average condition is provided in Appendix 1. Additionally, the Appendix 2 Section Condition Report provides information used to define each branch and section in the PAVER database.
