ENTERPRISE MUNICIPAL AIRPORT

Figure EN-1. Airport Layout, Dimensions and Pavement Cross-Sections.
Enterprise Municipal Airport

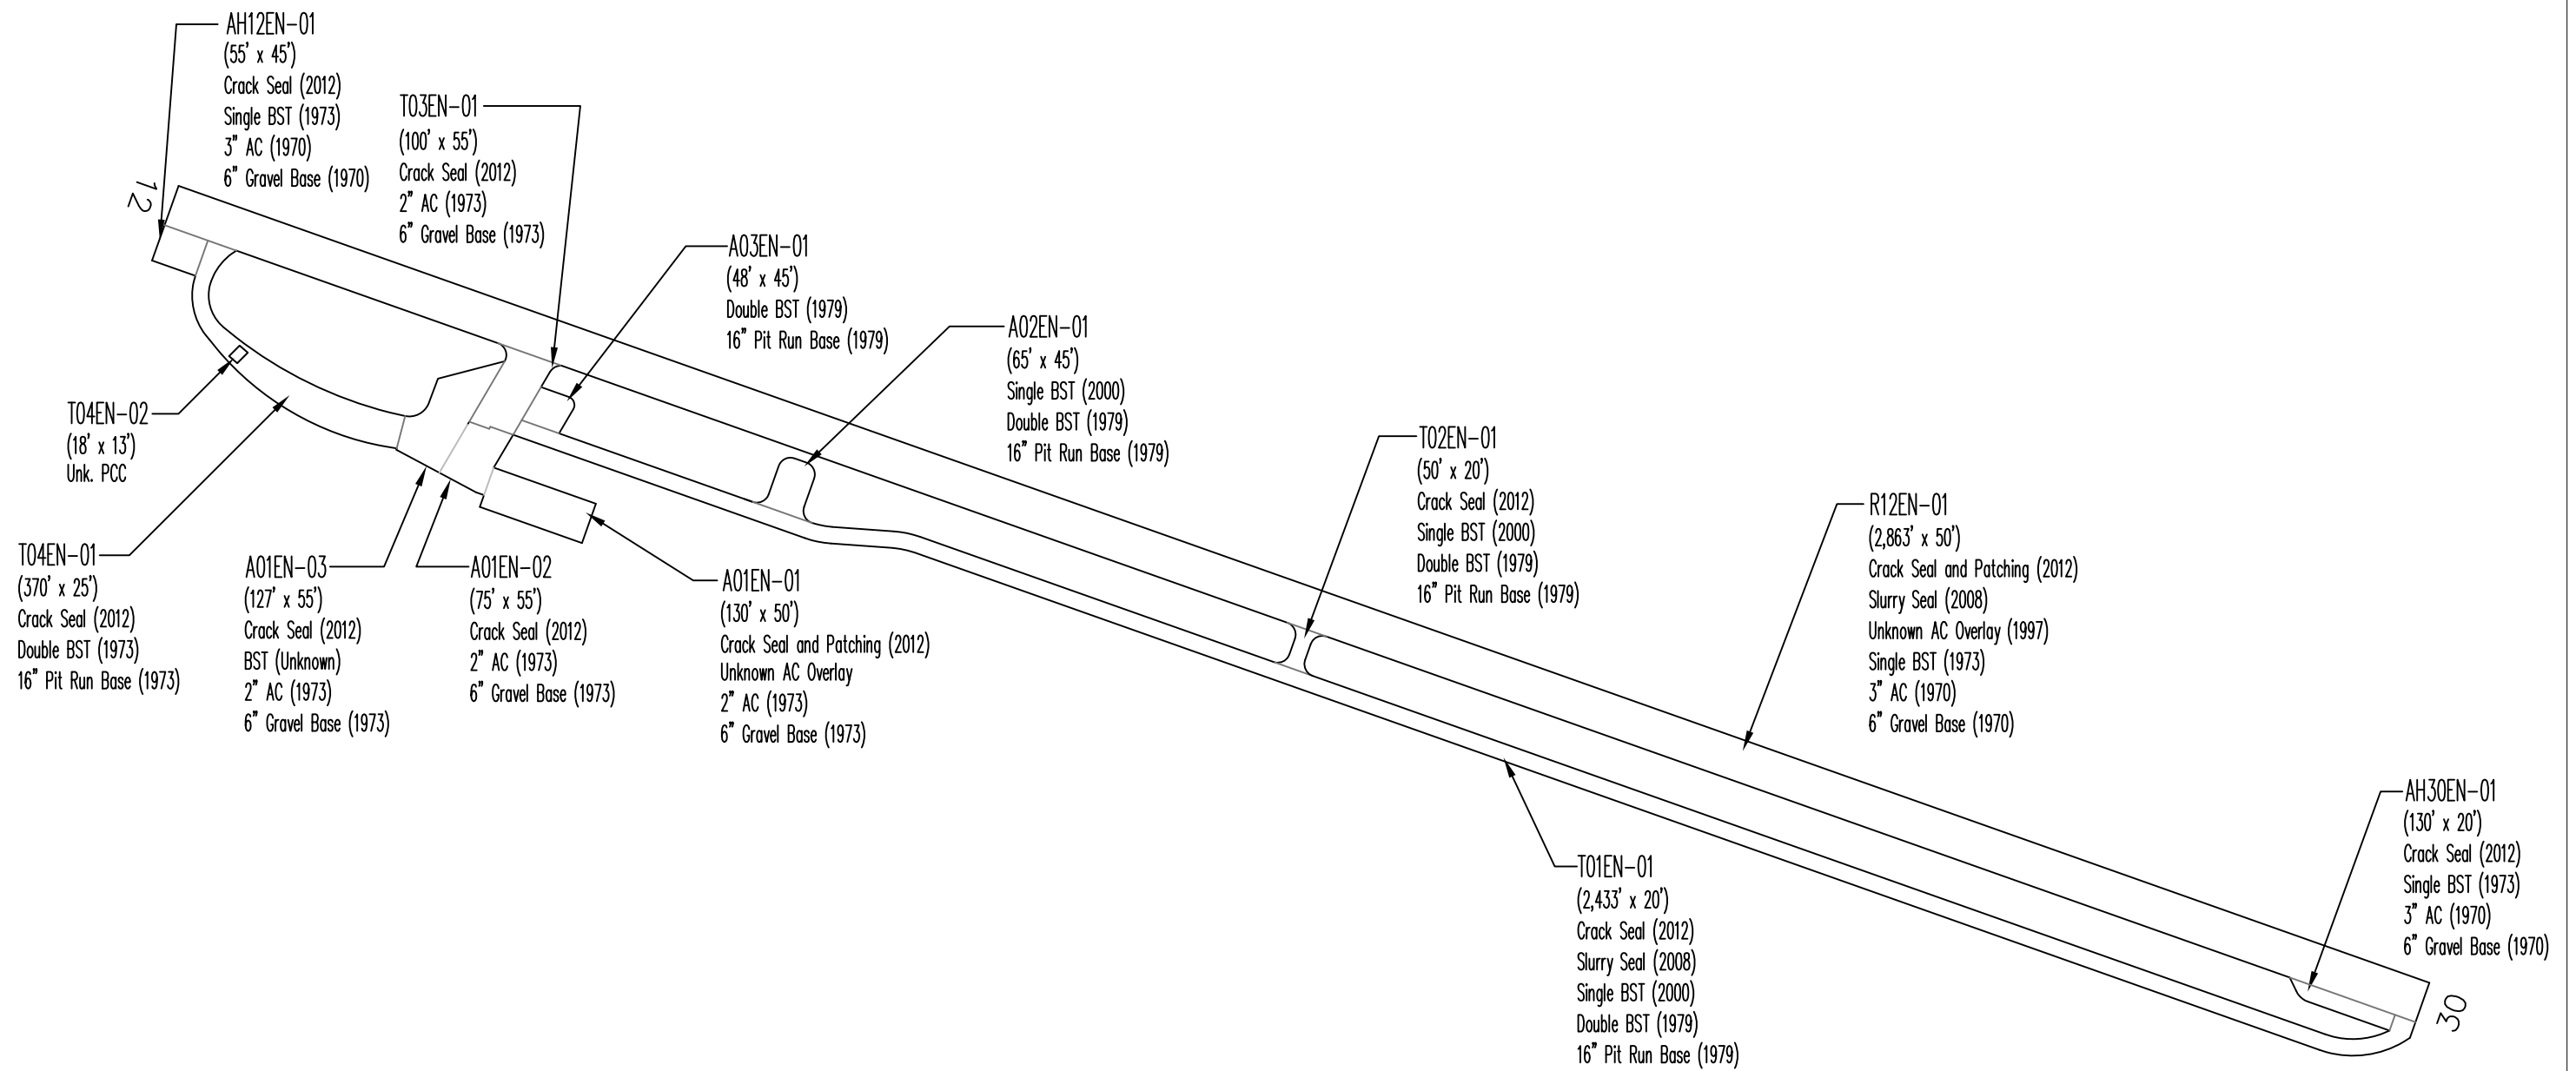
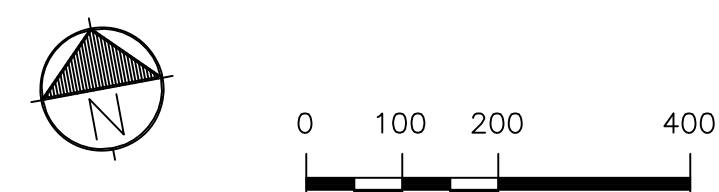
To determine how your pavements were constructed and their age, a records review was conducted. Figure EN-1 shows the records review results. This figure identifies pavement boundaries, dimensions, pavement layer types, thicknesses and dates of construction. The most recent construction date for each pavement can also be found in the Section Condition Report in Appendix 2. Figure EN-1 and the information contained in Appendices 1, 2 and 4 ensure that your airport complies with the “pavement inventory” requirement of FAA’s PMMP guidelines.

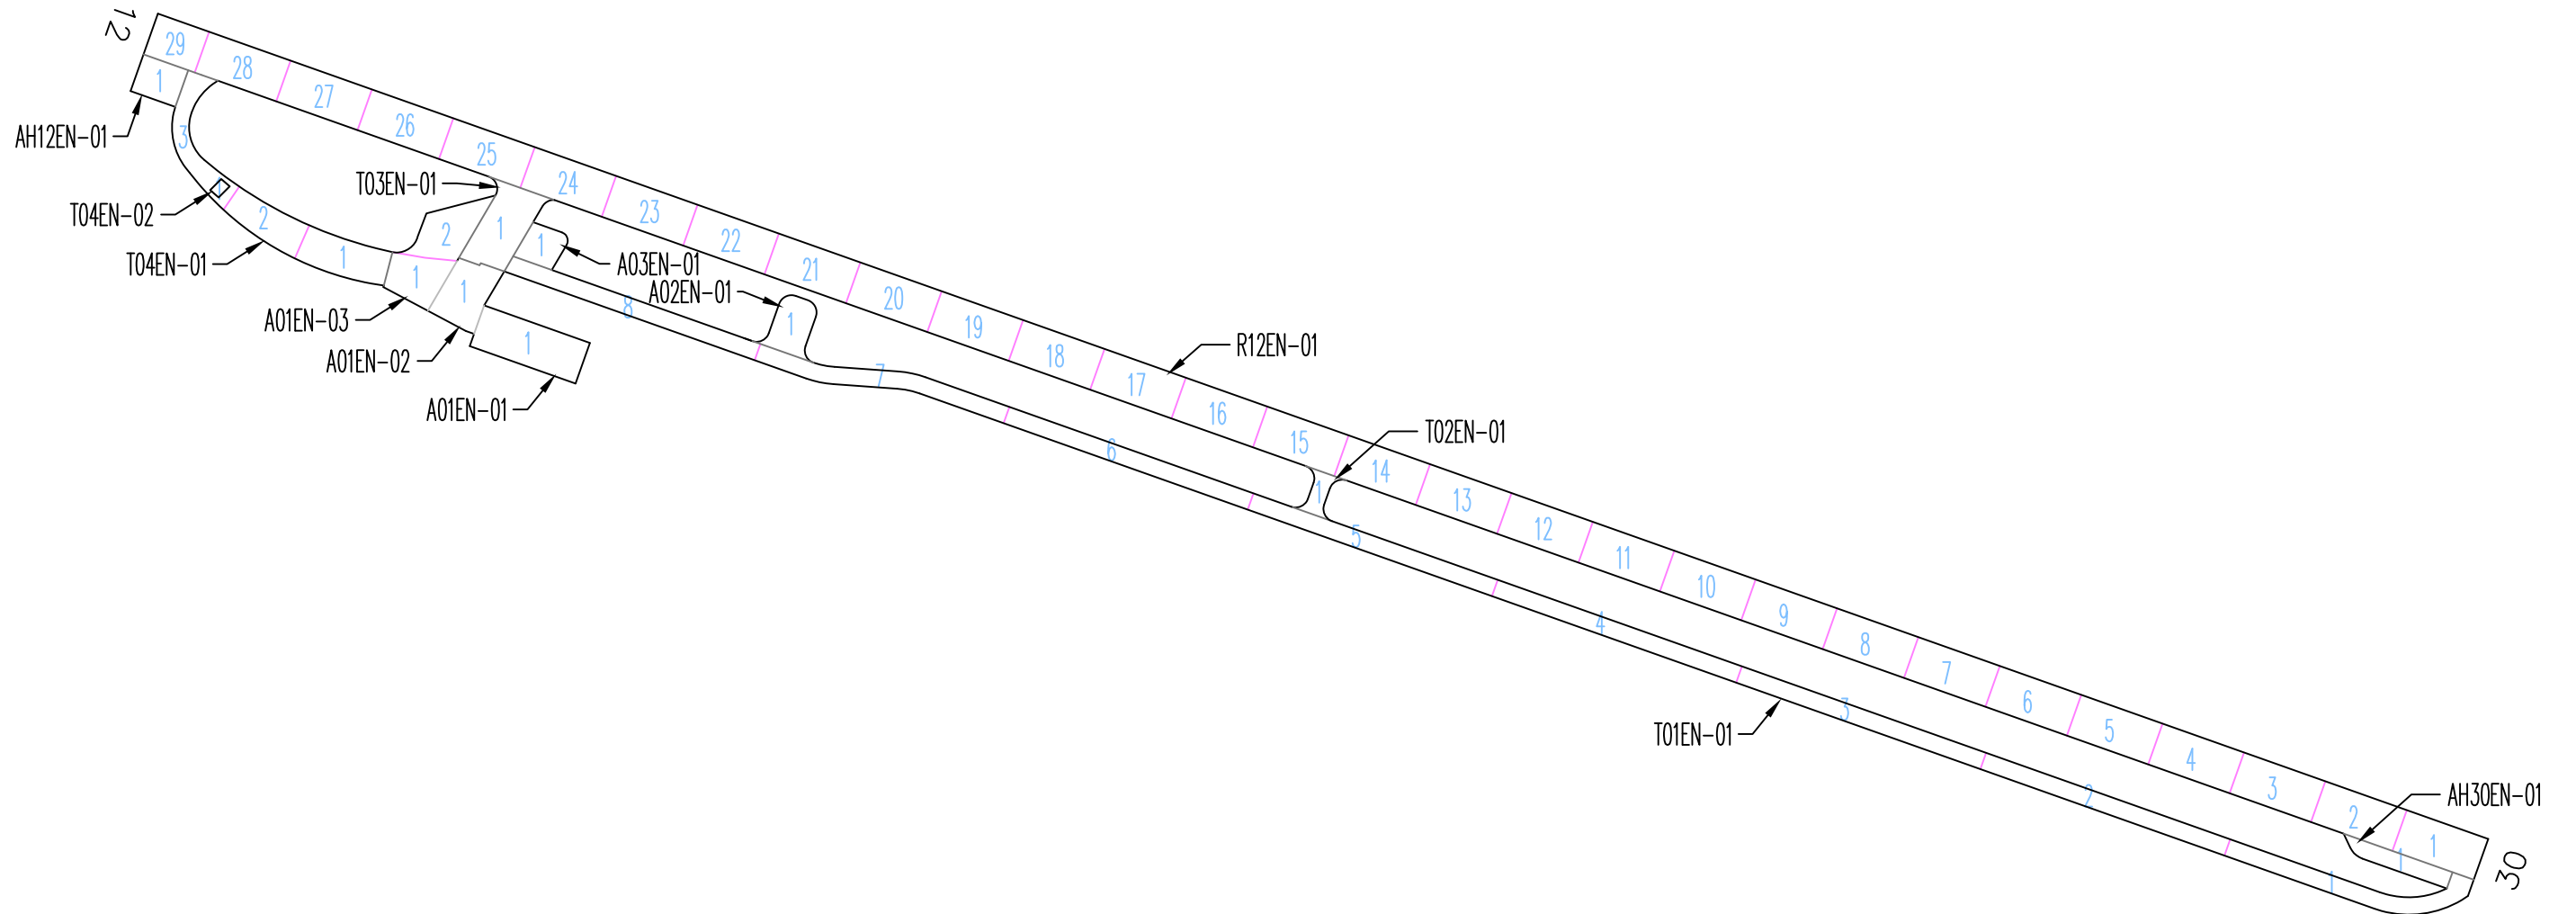
Figure EN-2. Pavement Branch, Section and Sample Unit Layout.
Enterprise Municipal Airport

The pavements at your airport were divided into branches, sections and sample units in accordance with the methodology outlined in the current edition of ASTM D5430, *Standard Test Method for Airport Condition Index Surveys*. The branches, sections and sample units established at your airport are shown in Figure EN-2. A Branch Condition Report showing all branches, their associated areas, and their area-weighted average condition is provided in Appendix 1. Additionally, the Appendix 2 Section Condition Report provides information used to define each branch and section in the PAVER database.

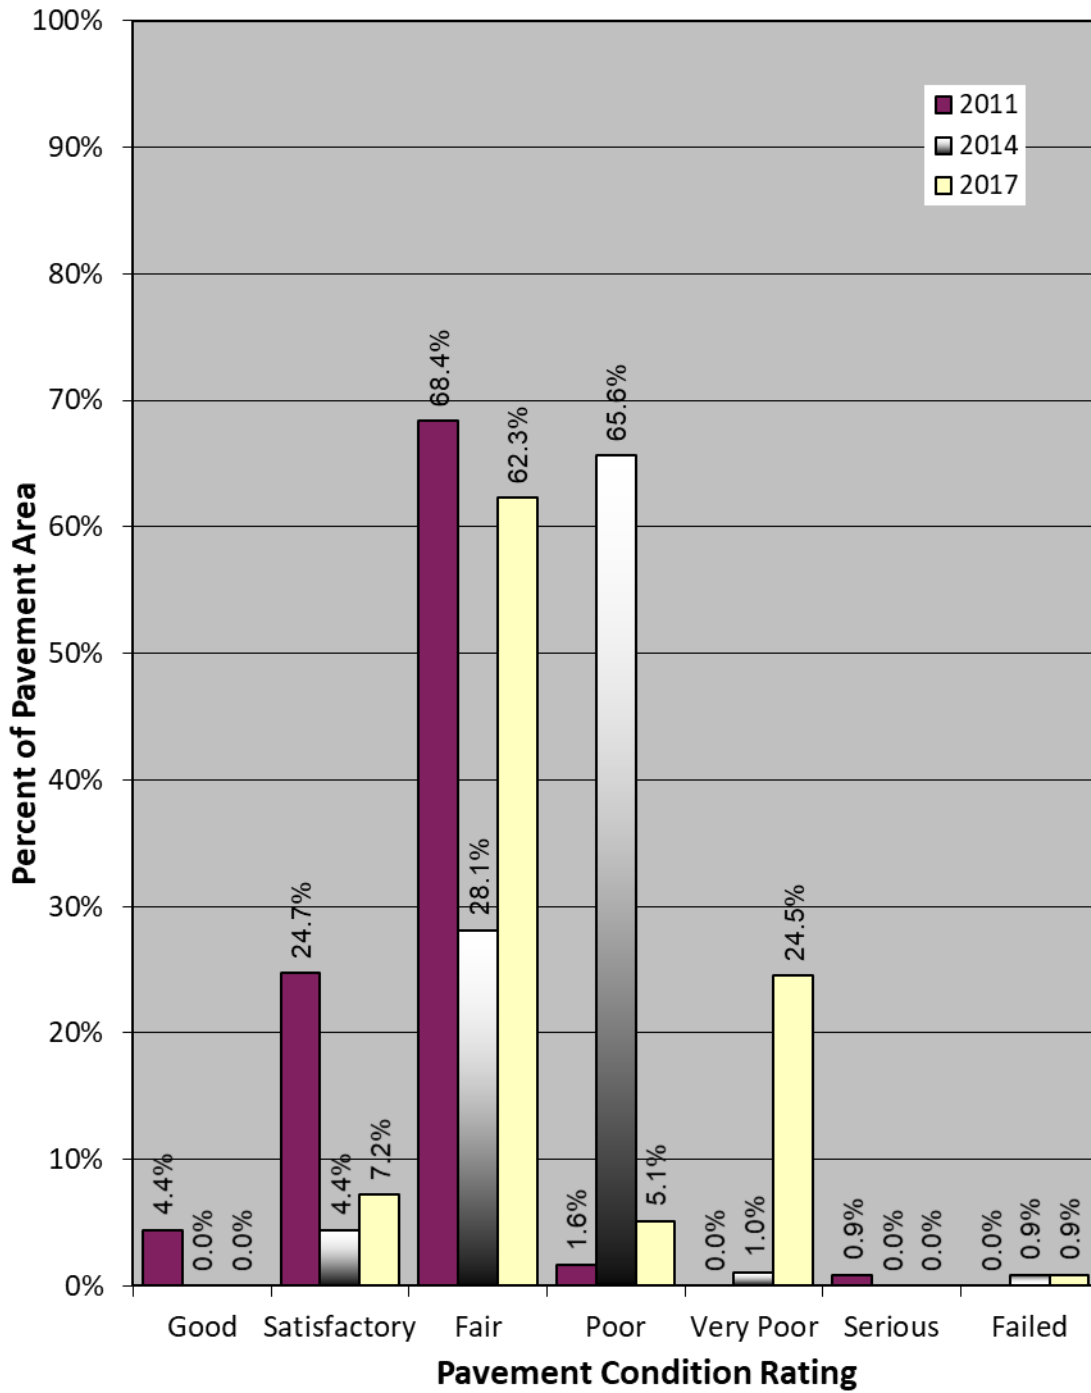
**Figure EN-4. Distribution of Pavement Condition
Enterprise Municipal Airport**

Section PCIs at Enterprise Municipal Airport range from a low of 1 (a PCR of “Failed”) to a high of 78 (a PCR of “Satisfactory”). The area-weighted average PCI for all airport pavements is 52, corresponding to an overall PCR of “Poor”. Figure EN-4 shows how much pavement area is associated with each Pavement Condition Rating category and also shows pavement condition distribution from the inspections conducted in 2011 and 2014.
