# GRANT COUNTY REGIONAL AIRPORT / OGILVIE FIELD

This report describes how your Pavement Maintenance Management Program (PMMP) was developed. Your Program was developed as part of the Oregon Continuous Aviation System Plan sponsored in part by the Oregon Department of Aviation and the Federal Aviation Administration (FAA). The information and data contained in this report ensures you comply with the requirements of FAA Grant Assurance Number 11 which states that any airport requesting federal funds for pavement improvement projects must have implemented a pavement maintenance management program.

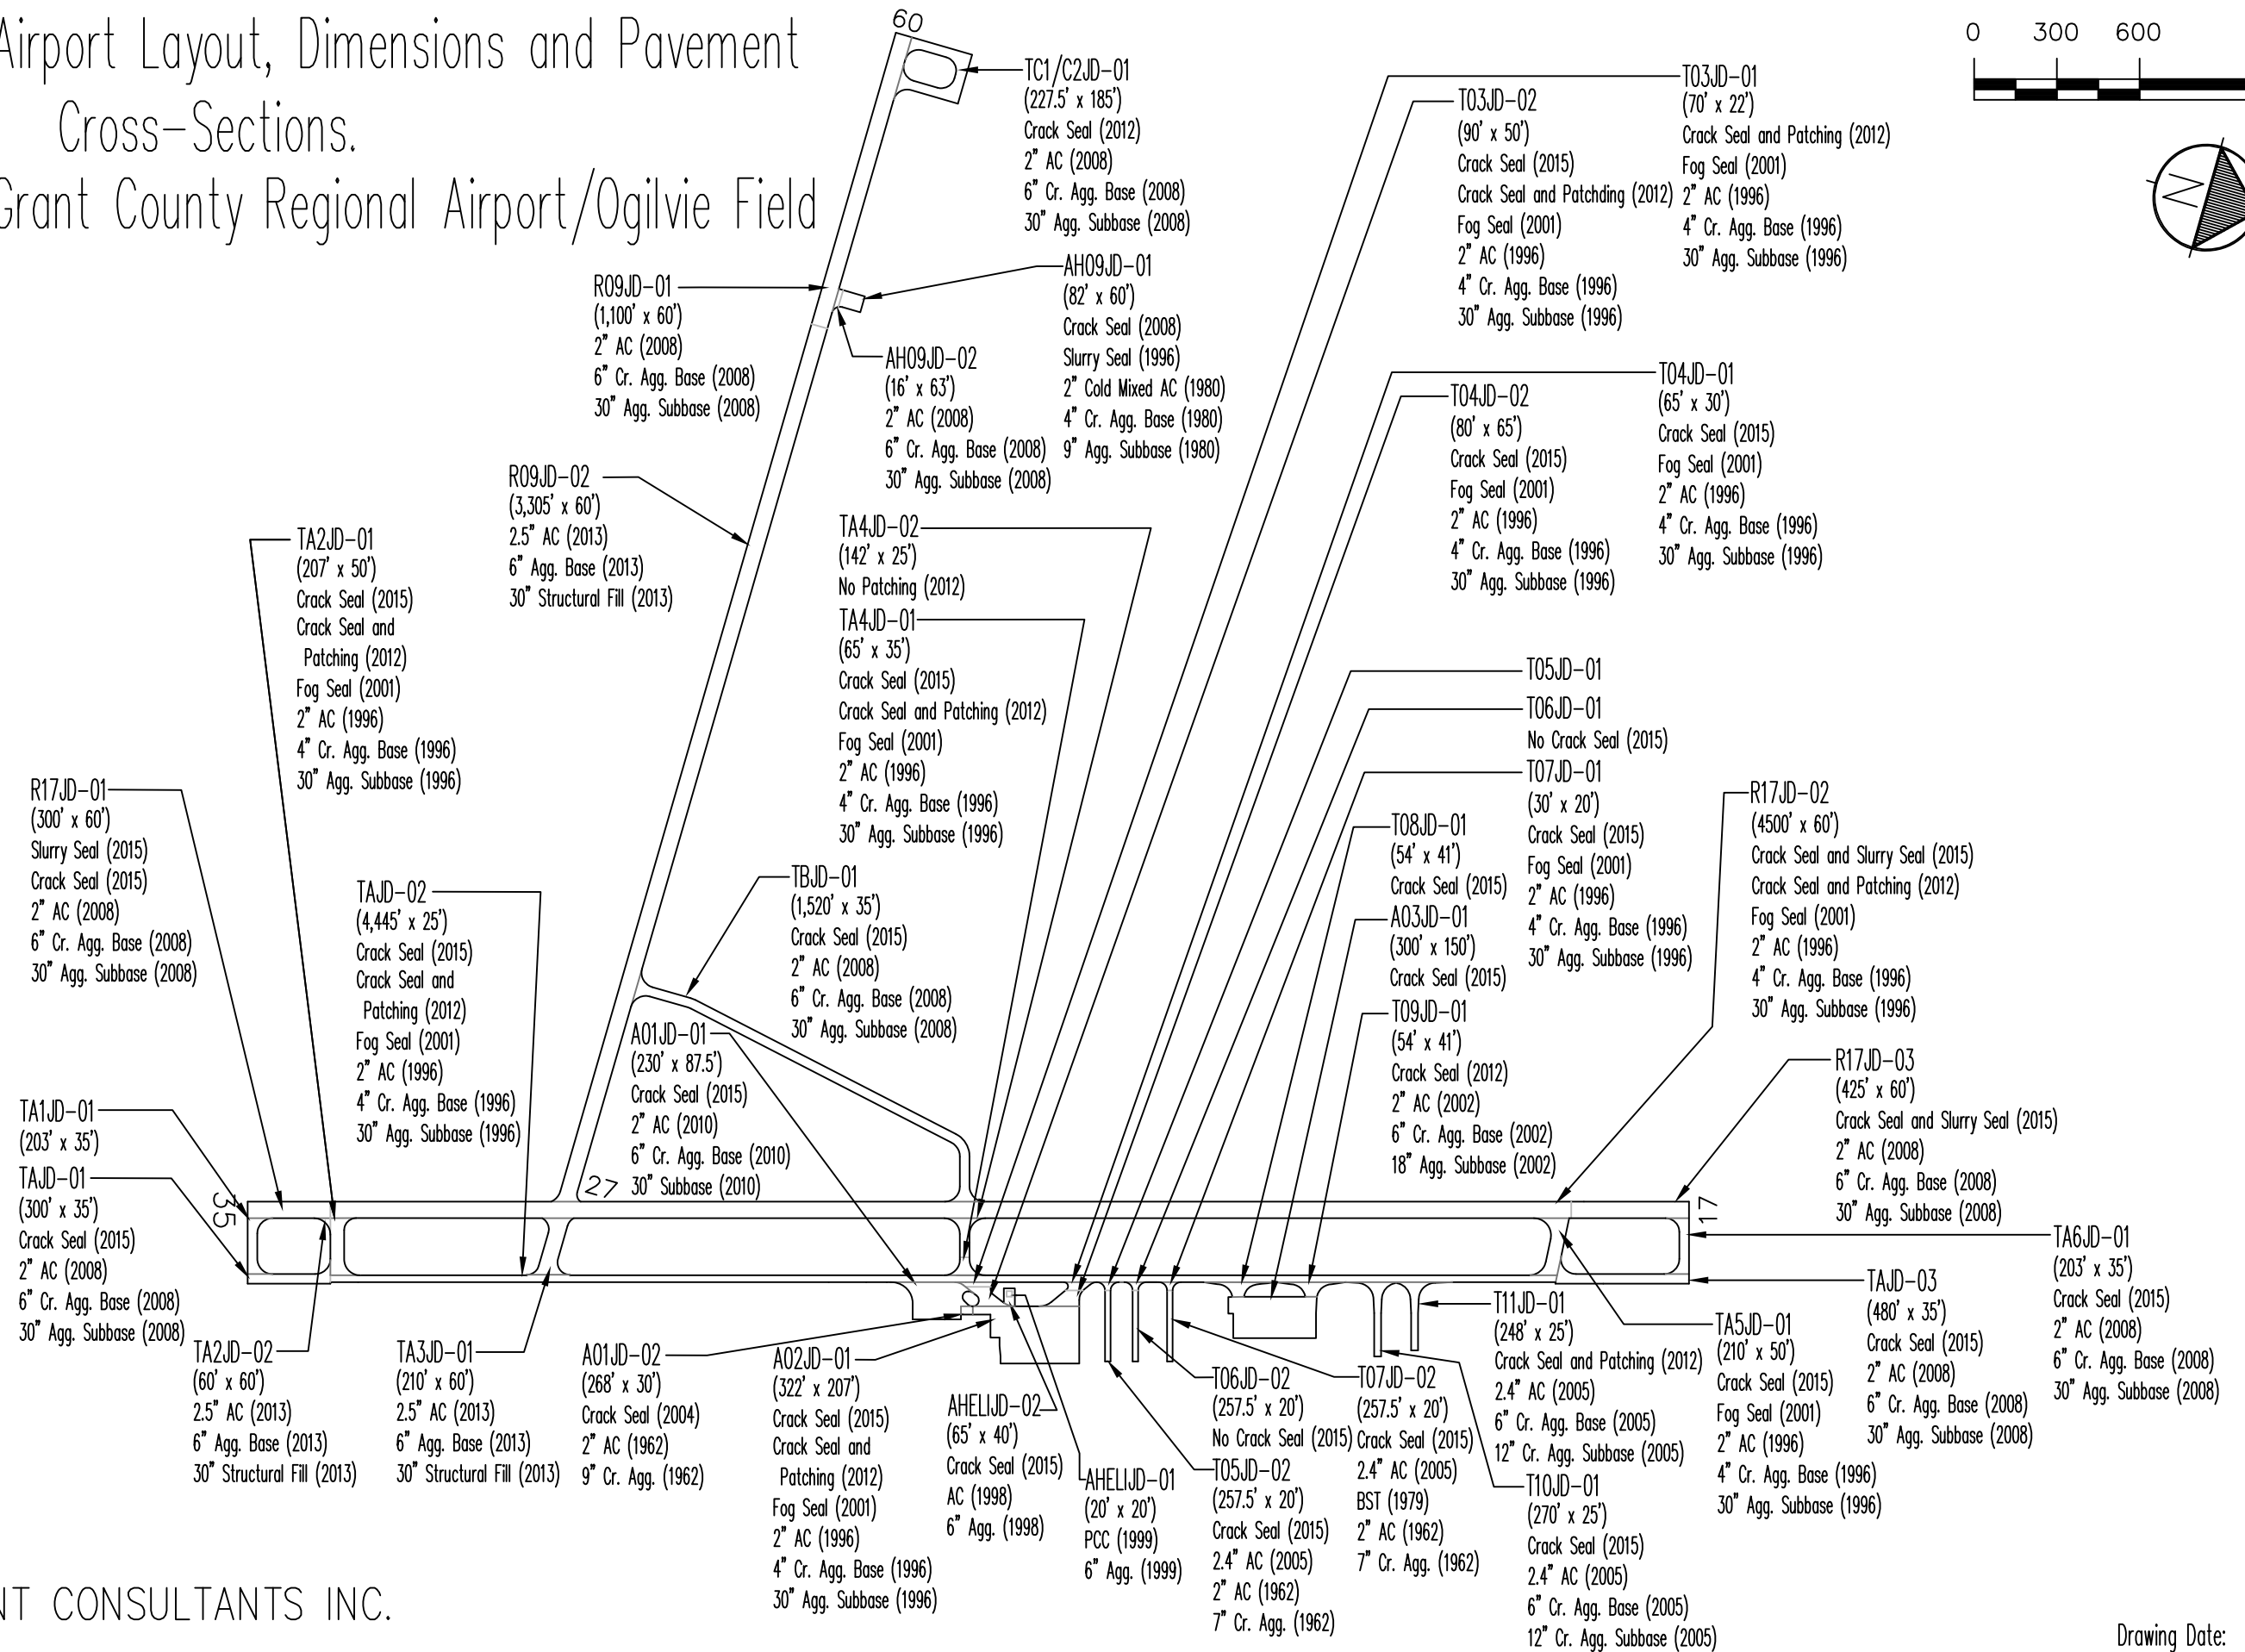
Figure JD-1. Airport Layout, Dimensions and Pavement Cross-Sections.  
Grant County Regional Airport/Ogilvie Field

To determine how your pavements were constructed and their age, a records review was conducted. Figure JD-1 shows the records review results. This figure identifies pavement boundaries, dimensions, pavement layer types, thicknesses and dates of construction. The most recent construction date for each pavement can also be found in the Section Condition Report in Appendix 2. Figure JD-1 and the information contained in Appendices 1, 2 and 4 ensure that your airport complies with the “pavement inventory” requirement of FAA’s PMMP guidelines.

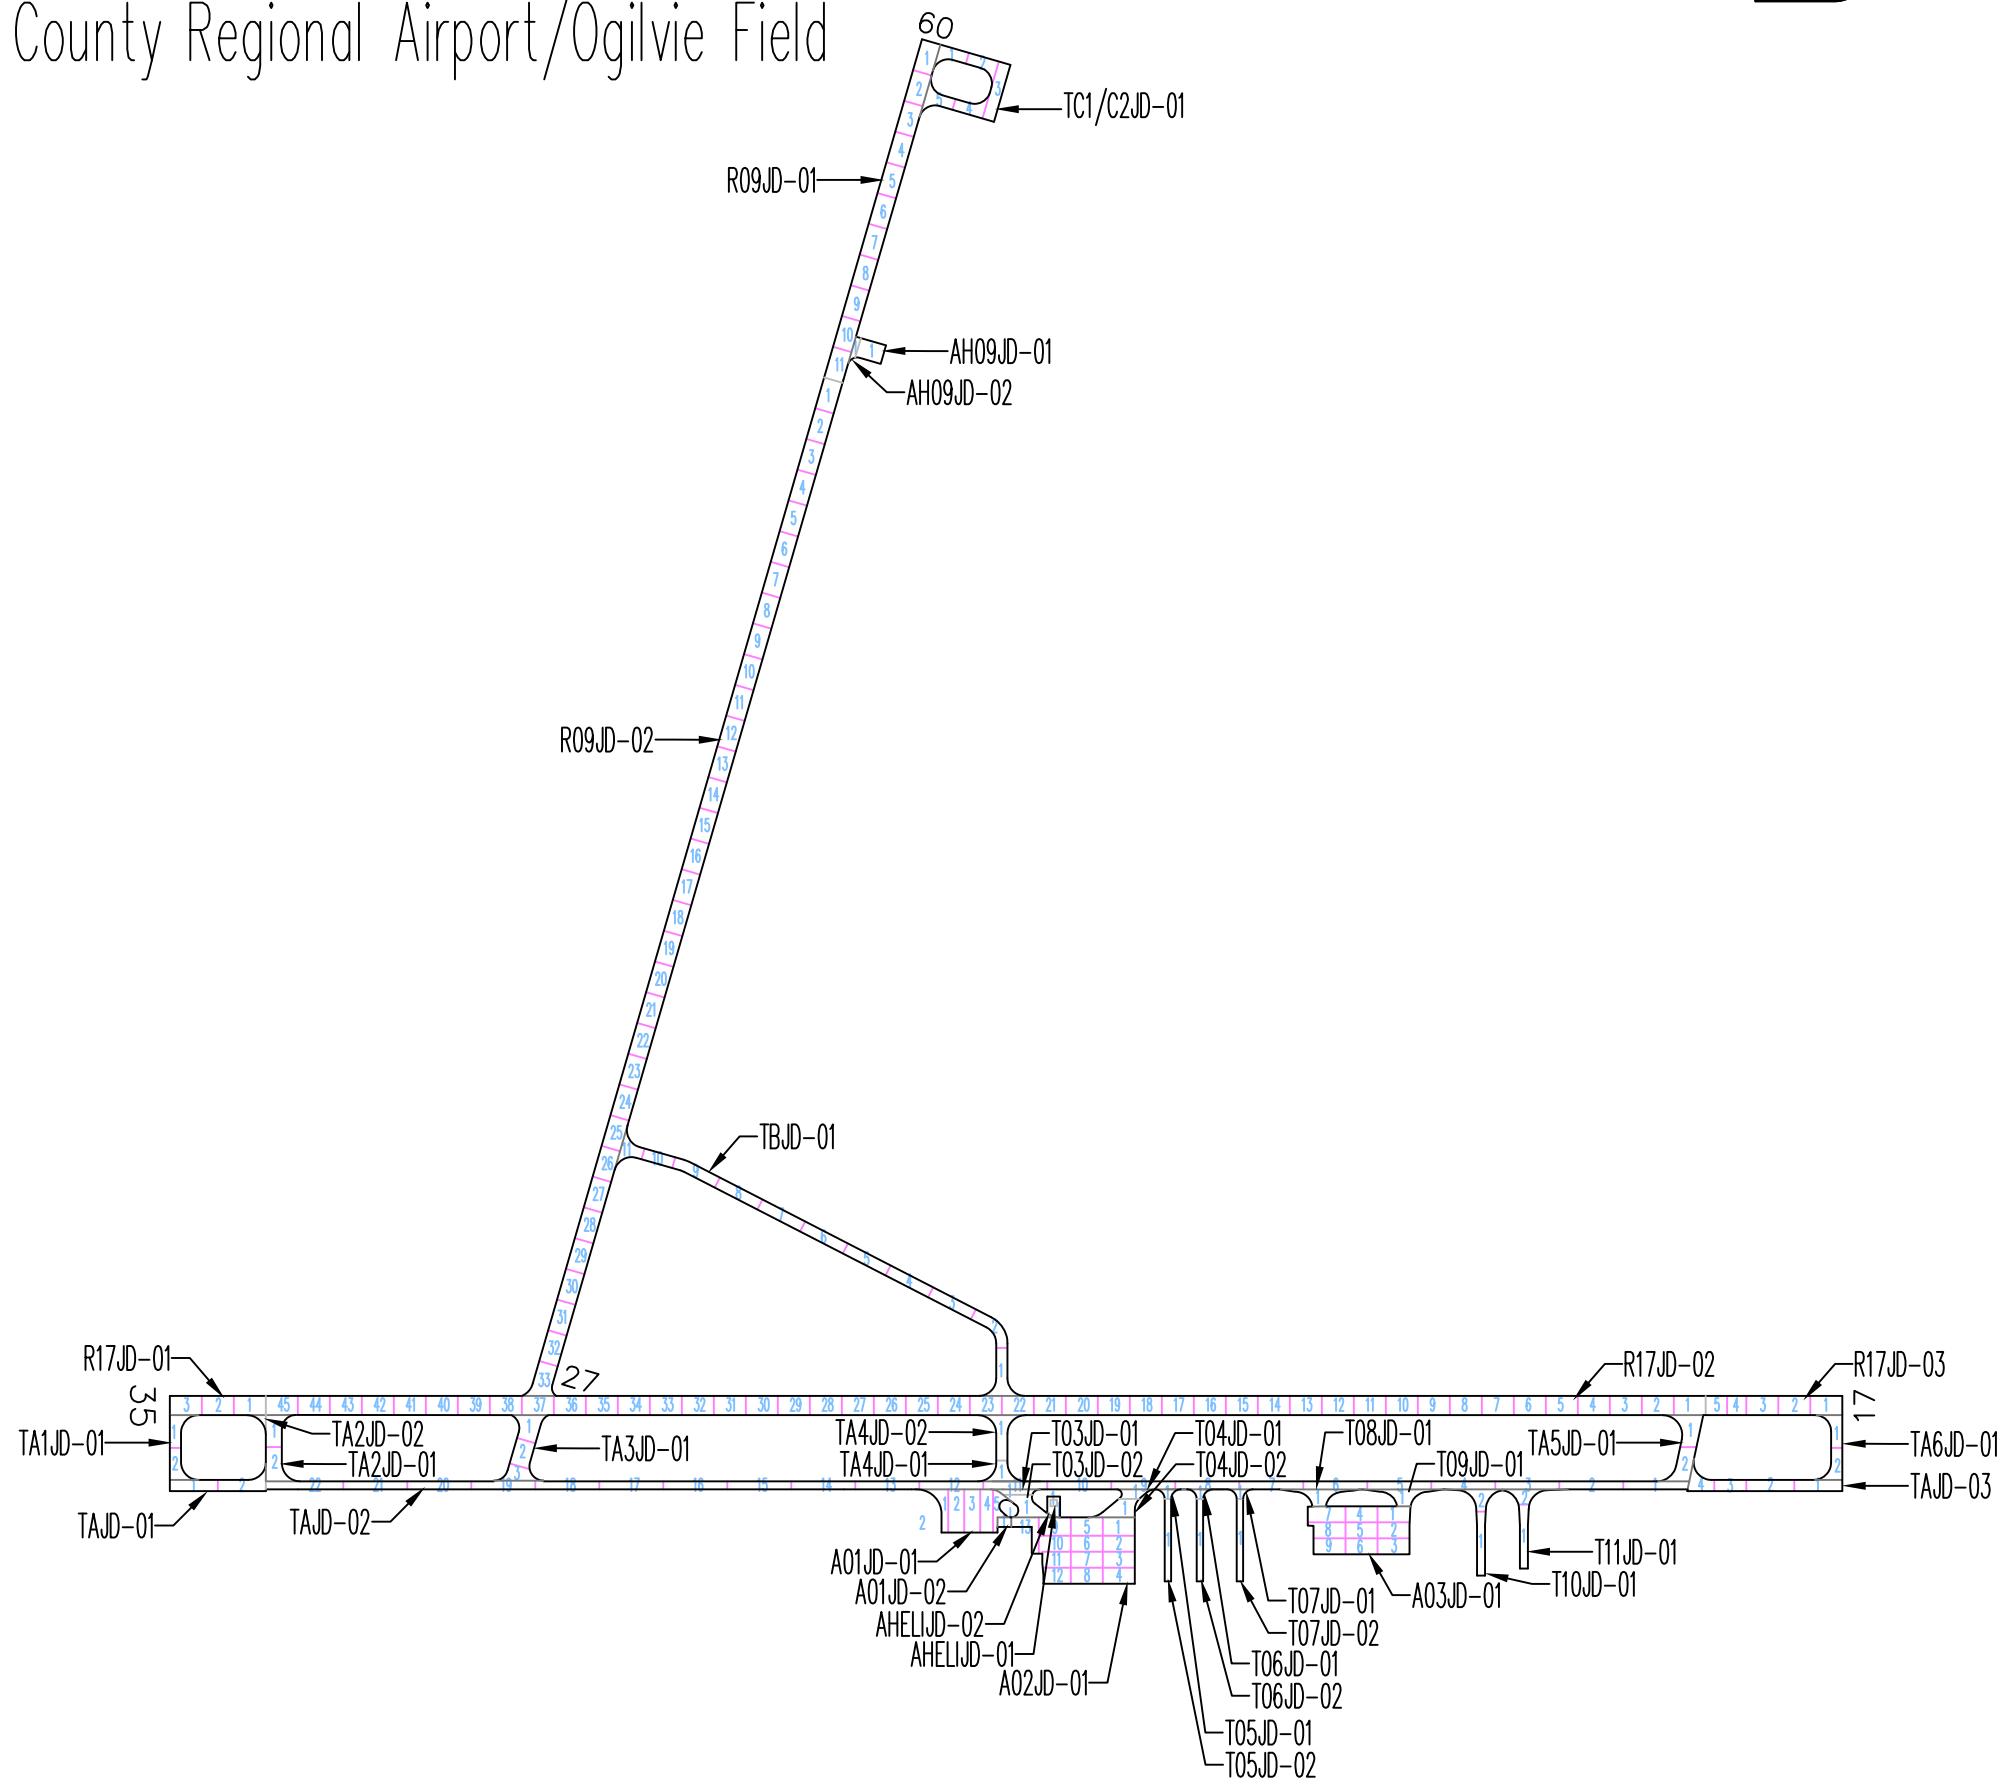
Figure JD-2. Pavement Branch, Section and Sample Unit Layout.  
Grant County Regional Airport/Ogilvie Field

The pavements at your airport were divided into branches, sections and sample units in accordance with the methodology outlined in the current edition of ASTM D5430, *Standard Test Method for Airport Condition Index Surveys*. The branches, sections and sample units established at your airport are shown in Figure JD-2. A Branch Condition Report showing all branches, their associated areas, and their area-weighted average condition is provided in Appendix 1. Additionally, the Appendix 2 Section Condition Report provides information used to define each branch and section in the PAVER database.

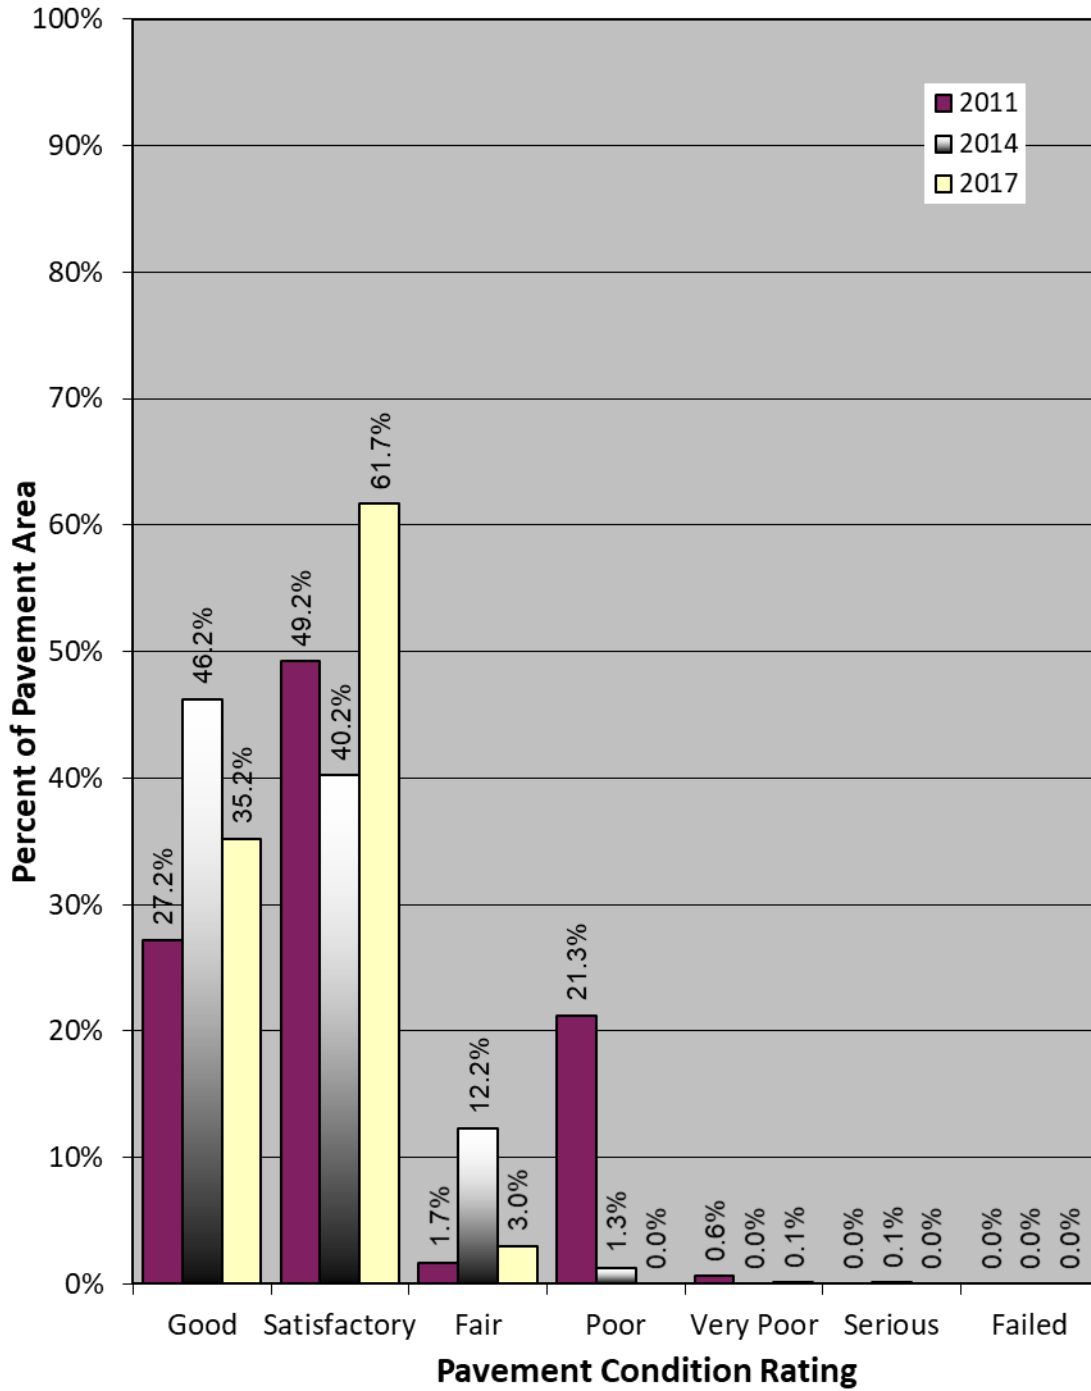
**Figure JD-4. Distribution of Pavement Condition  
Grant County Regional Airport/Ogilvie Field**

Section PCIs at Grant County Regional Airport/Ogilvie Field range from a low of 39 (a PCR of “Very Poor”) to a high of 100 (a PCR of “Good”). The area-weighted average PCI for all airport pavements is 82, corresponding to an overall PCR of “Satisfactory”. Figure JD-4 shows how much pavement area is associated with each Pavement Condition Rating category and also shows pavement condition distribution from the inspections conducted in 2011 and 2014.
