HERMISTON MUNICIPAL AIRPORT

This report describes how your Pavement Maintenance Management Program (PMMP) was developed. Your Program was developed as part of the Oregon Continuous Aviation System Plan sponsored in part by the Oregon Department of Aviation and the Federal Aviation Administration (FAA). The information and data contained in this report ensures you comply with the requirements of FAA Grant Assurance Number 11 which states that any airport requesting federal funds for pavement improvement projects must have implemented a pavement maintenance management program.

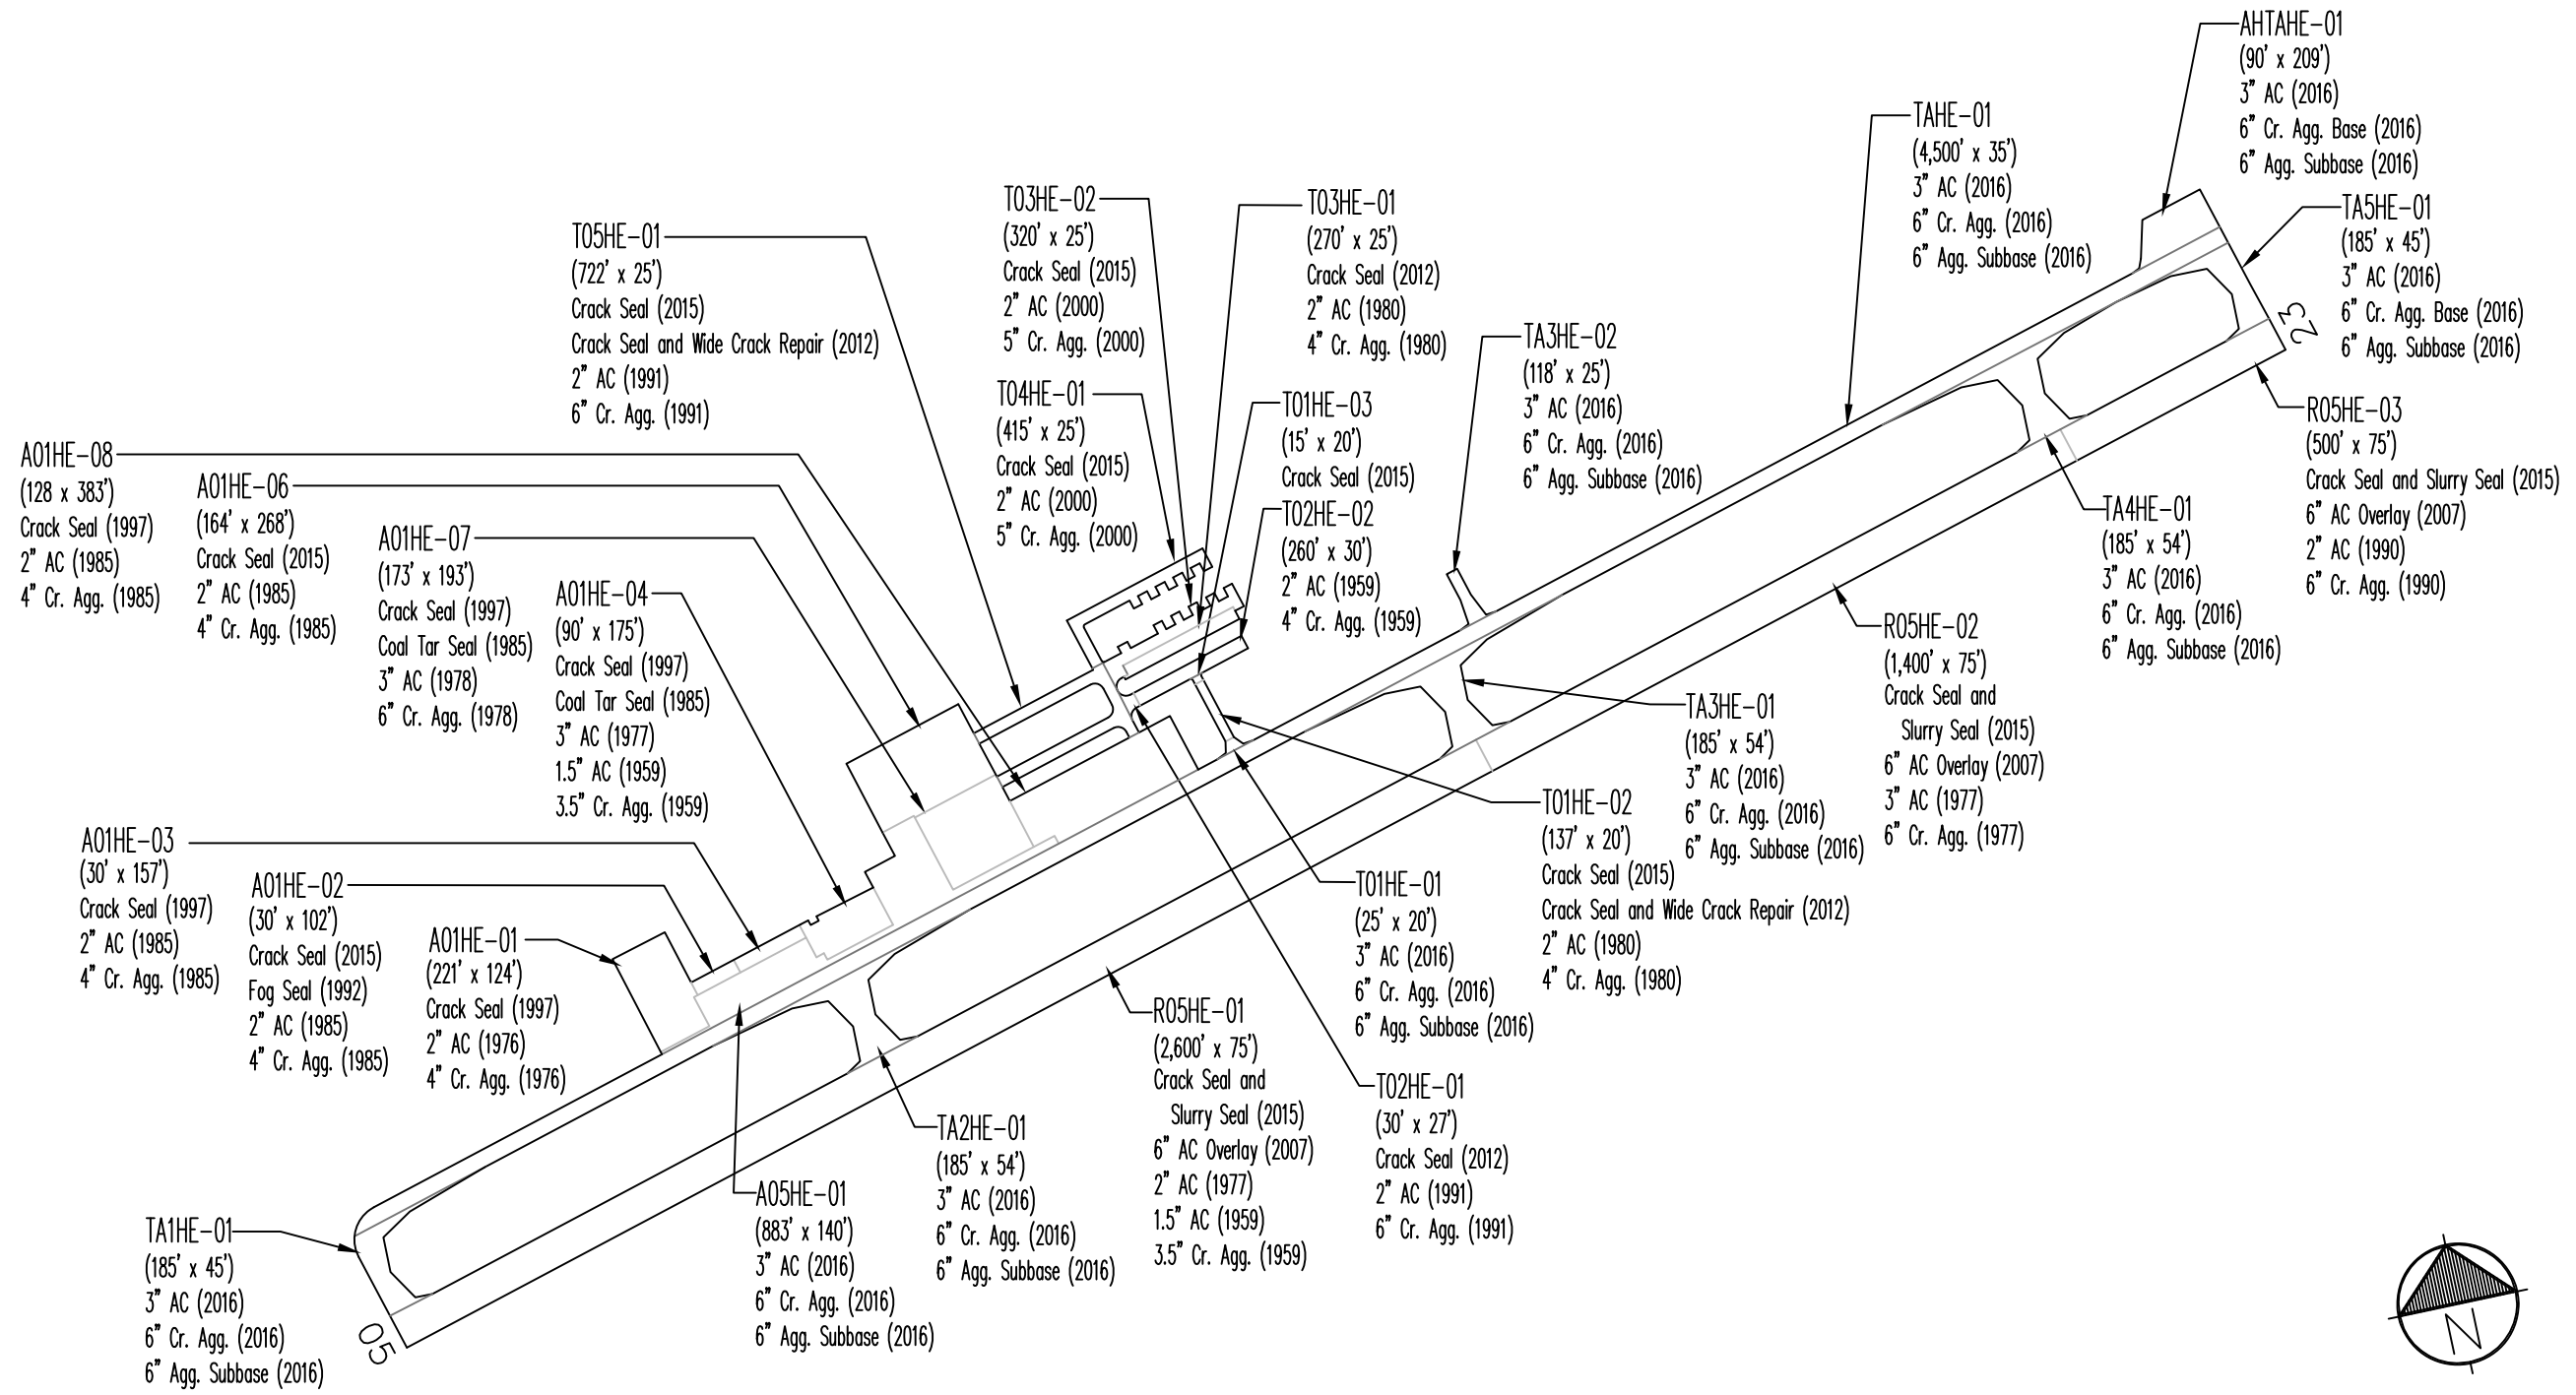
Figure HE-1. Airport Layout, Dimensions and Pavement Cross-Sections.
Hermiston Municipal Airport

To determine how your pavements were constructed and their age, a records review was conducted. Figure HE-1 shows the records review results. This figure identifies pavement boundaries, dimensions, pavement layer types, thicknesses and dates of construction. The most recent construction date for each pavement can also be found in the Section Condition Report in Appendix 2. Figure HE-1 and the information contained in Appendices 1, 2 and 4 ensure that your airport complies with the “pavement inventory” requirement of FAA’s PMMP guidelines.

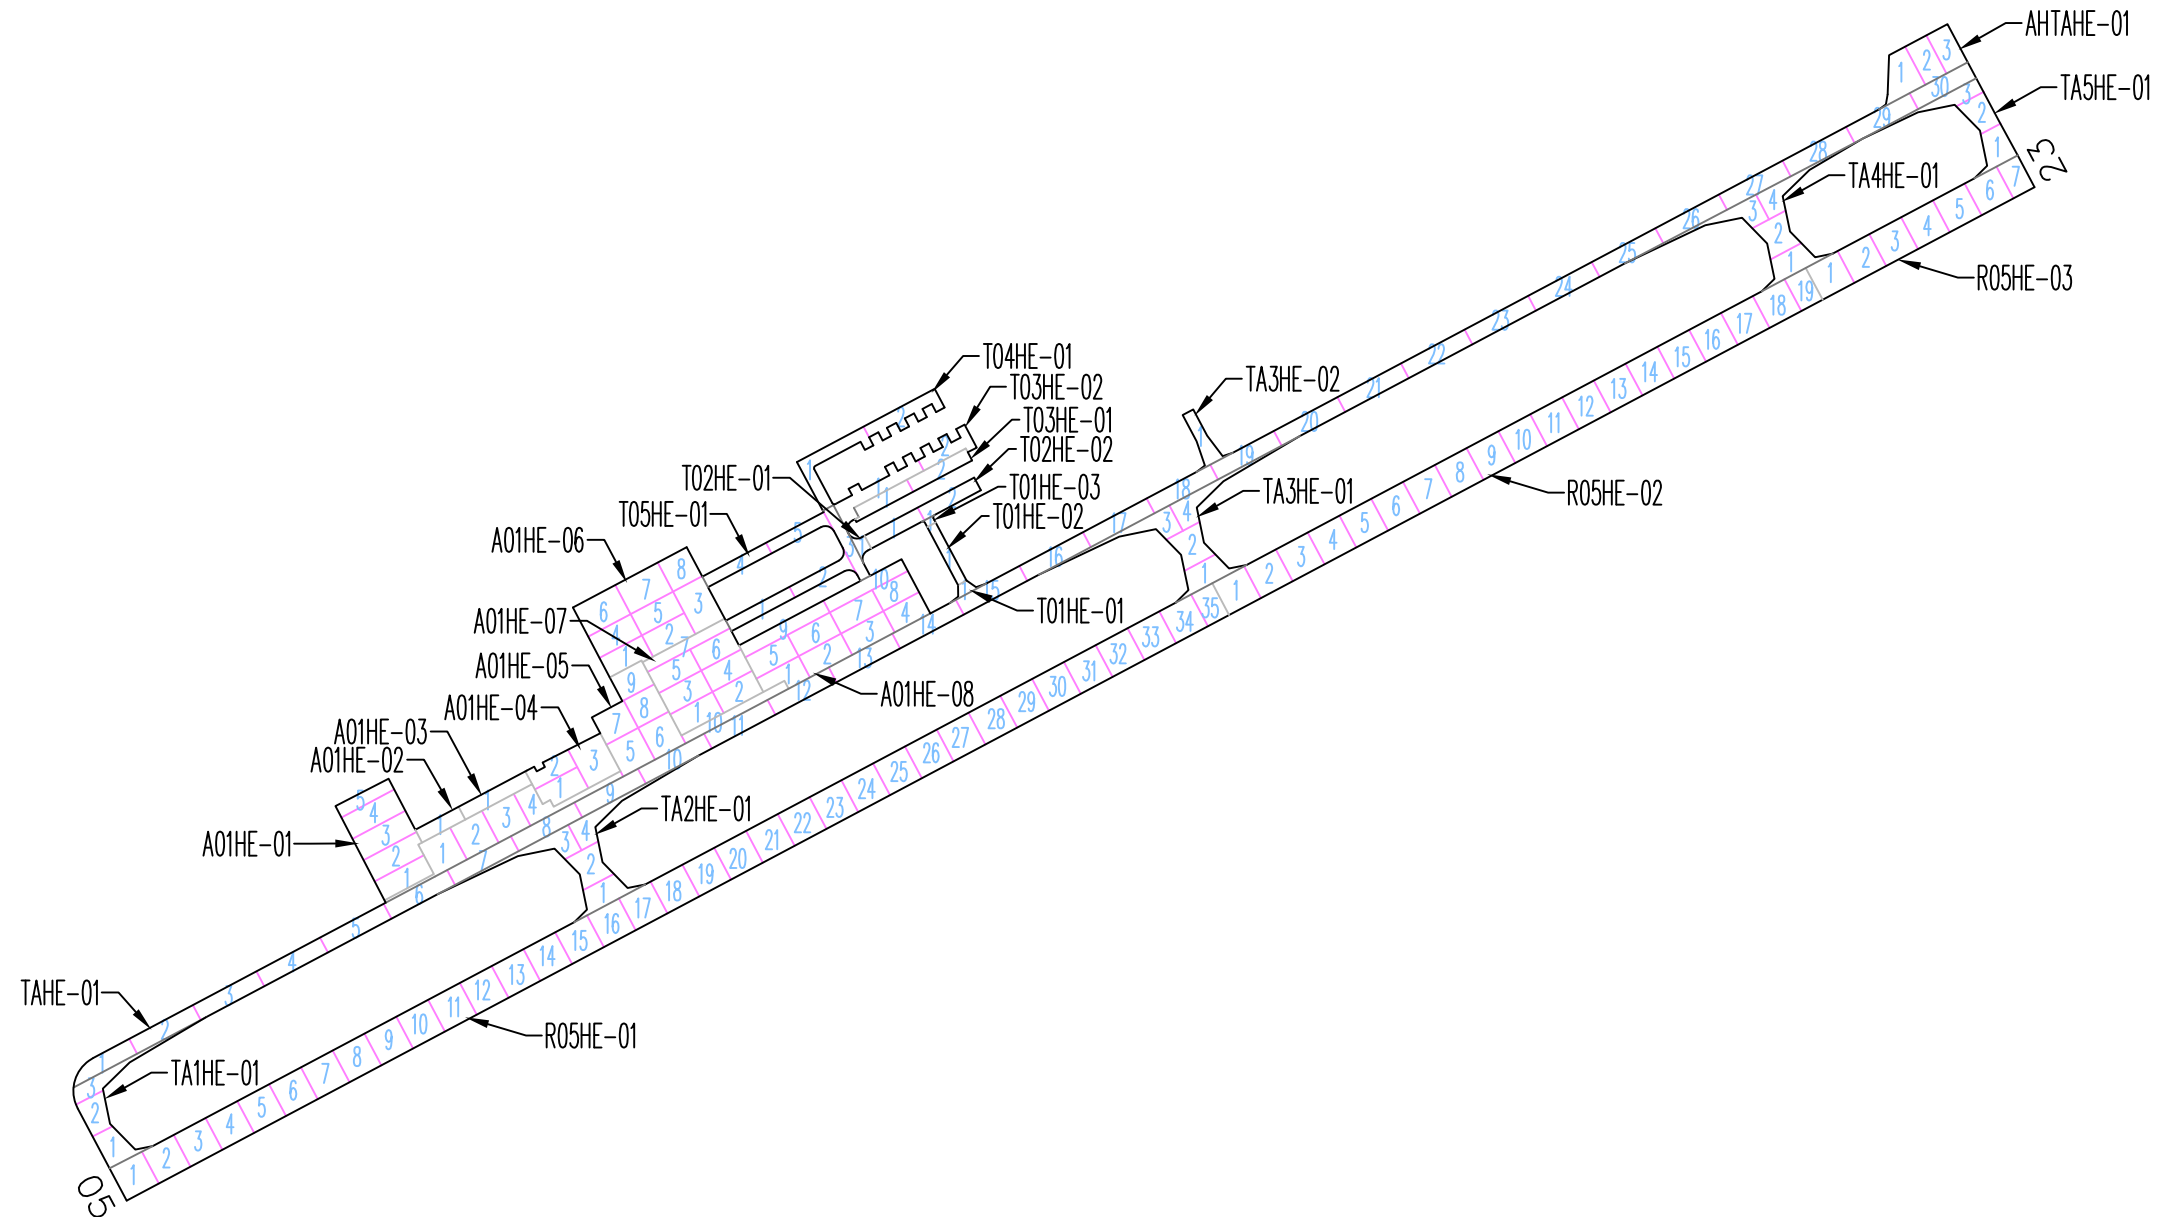
Figure HE-2. Pavement Branch, Section and Sample Unit Layout.
Hermiston Municipal Airport

The pavements at your airport were divided into branches, sections and sample units in accordance with the methodology outlined in the current edition of ASTM D5430, *Standard Test Method for Airport Condition Index Surveys*. The branches, sections and sample units established at your airport are shown in Figure HE-2. A Branch Condition Report showing all branches, their associated areas, and their area-weighted average condition is provided in Appendix 1. Additionally, the Appendix 2 Section Condition Report provides information used to define each branch and section in the PAVER database.
