KEN JERNSTEDT AIRFIELD

Figure HR-1. Airport Layout, Dimensions and Pavement Cross-Sections.
Ken Jernstedt Airfield

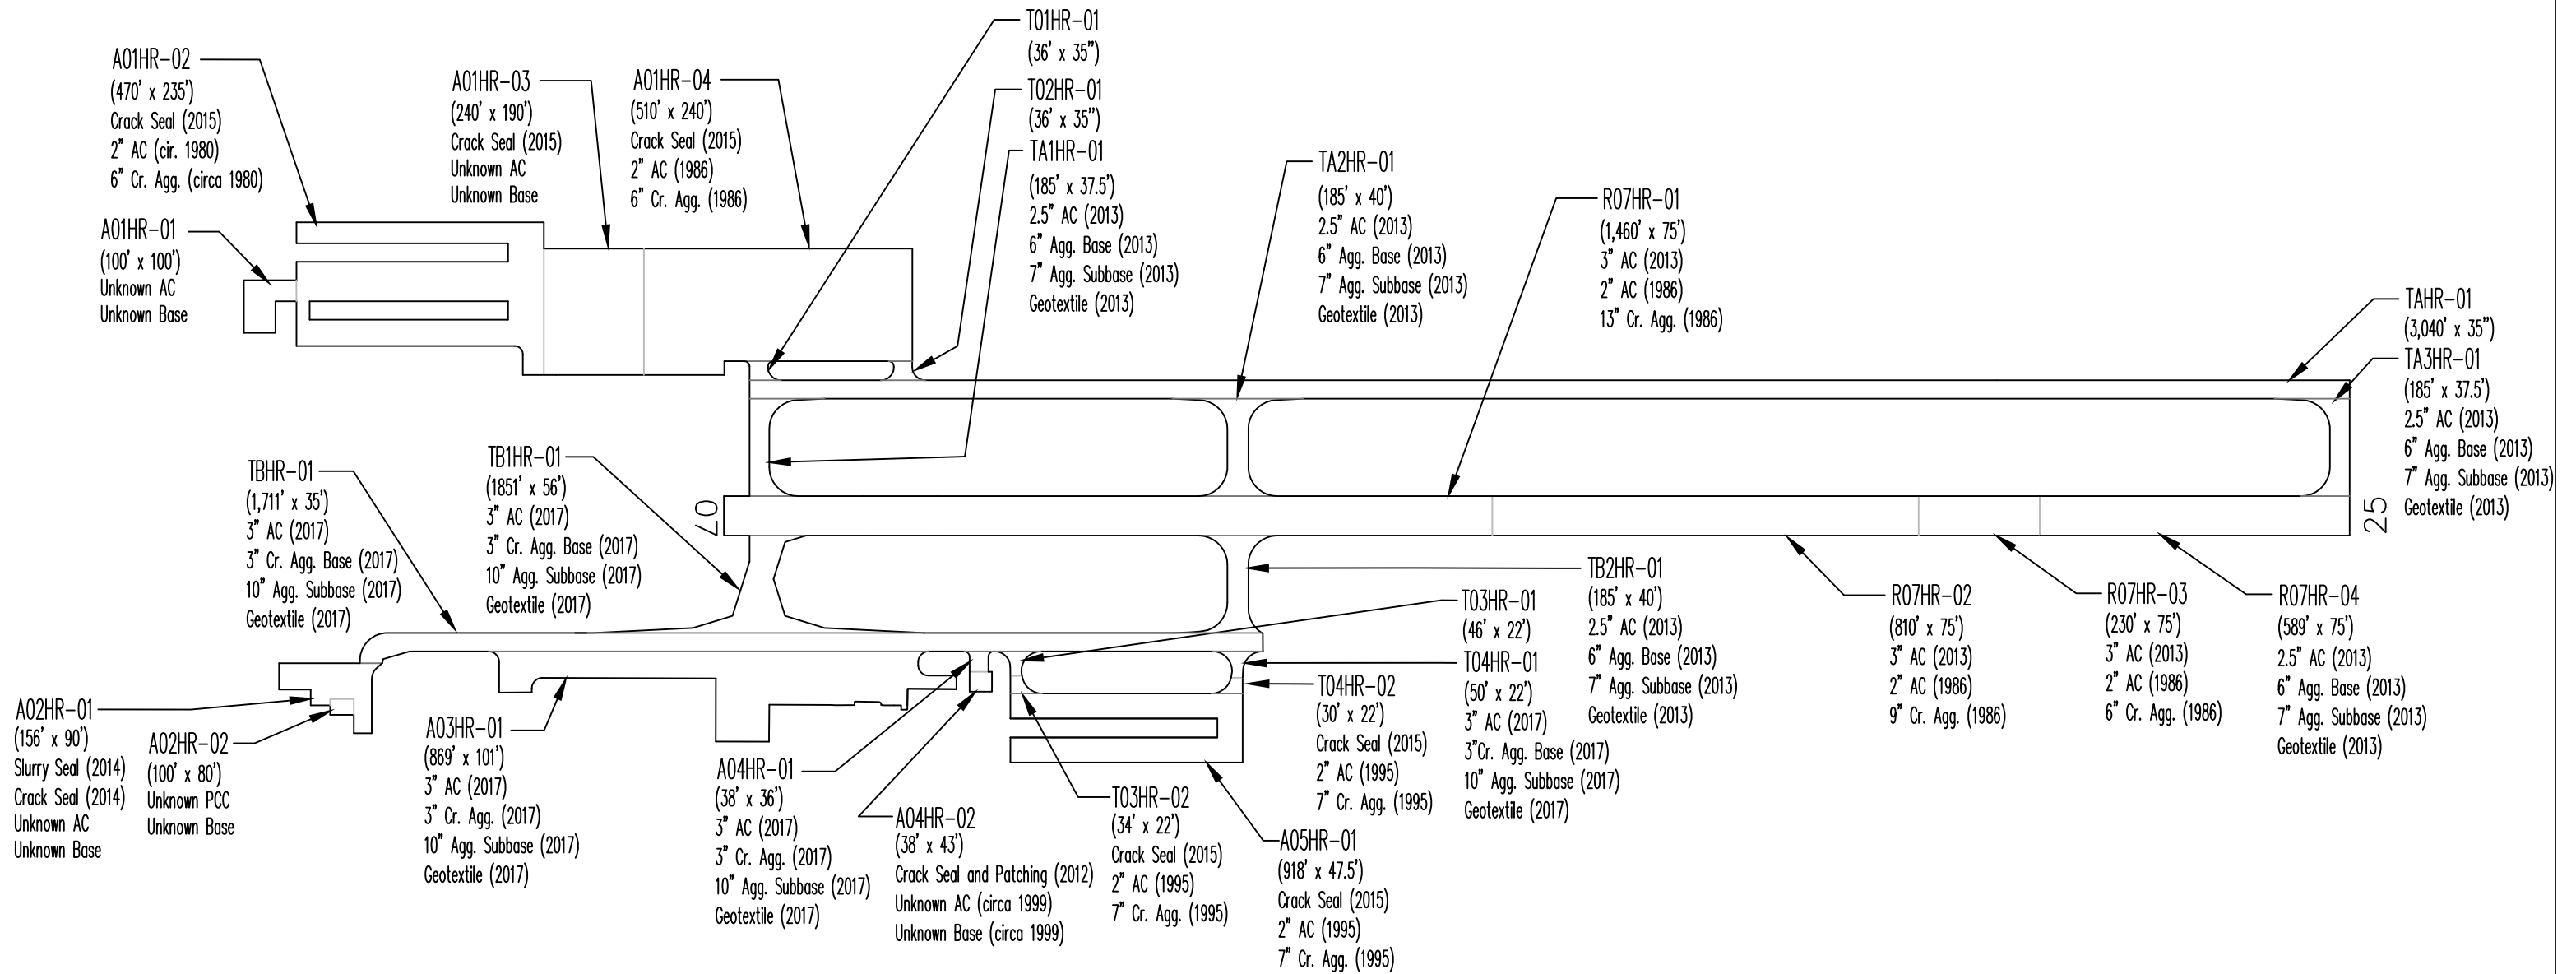
To determine how your pavements were constructed and their age, a records review was conducted. Figure HR-1 shows the records review results. This figure identifies pavement boundaries, dimensions, pavement layer types, thicknesses and dates of construction. The most recent construction date for each pavement can also be found in the Section Condition Report in Appendix 2. Figure HR-1 and the information contained in Appendices 1, 2 and 4 ensure that your airport complies with the “pavement inventory” requirement of FAA’s PMMP guidelines.

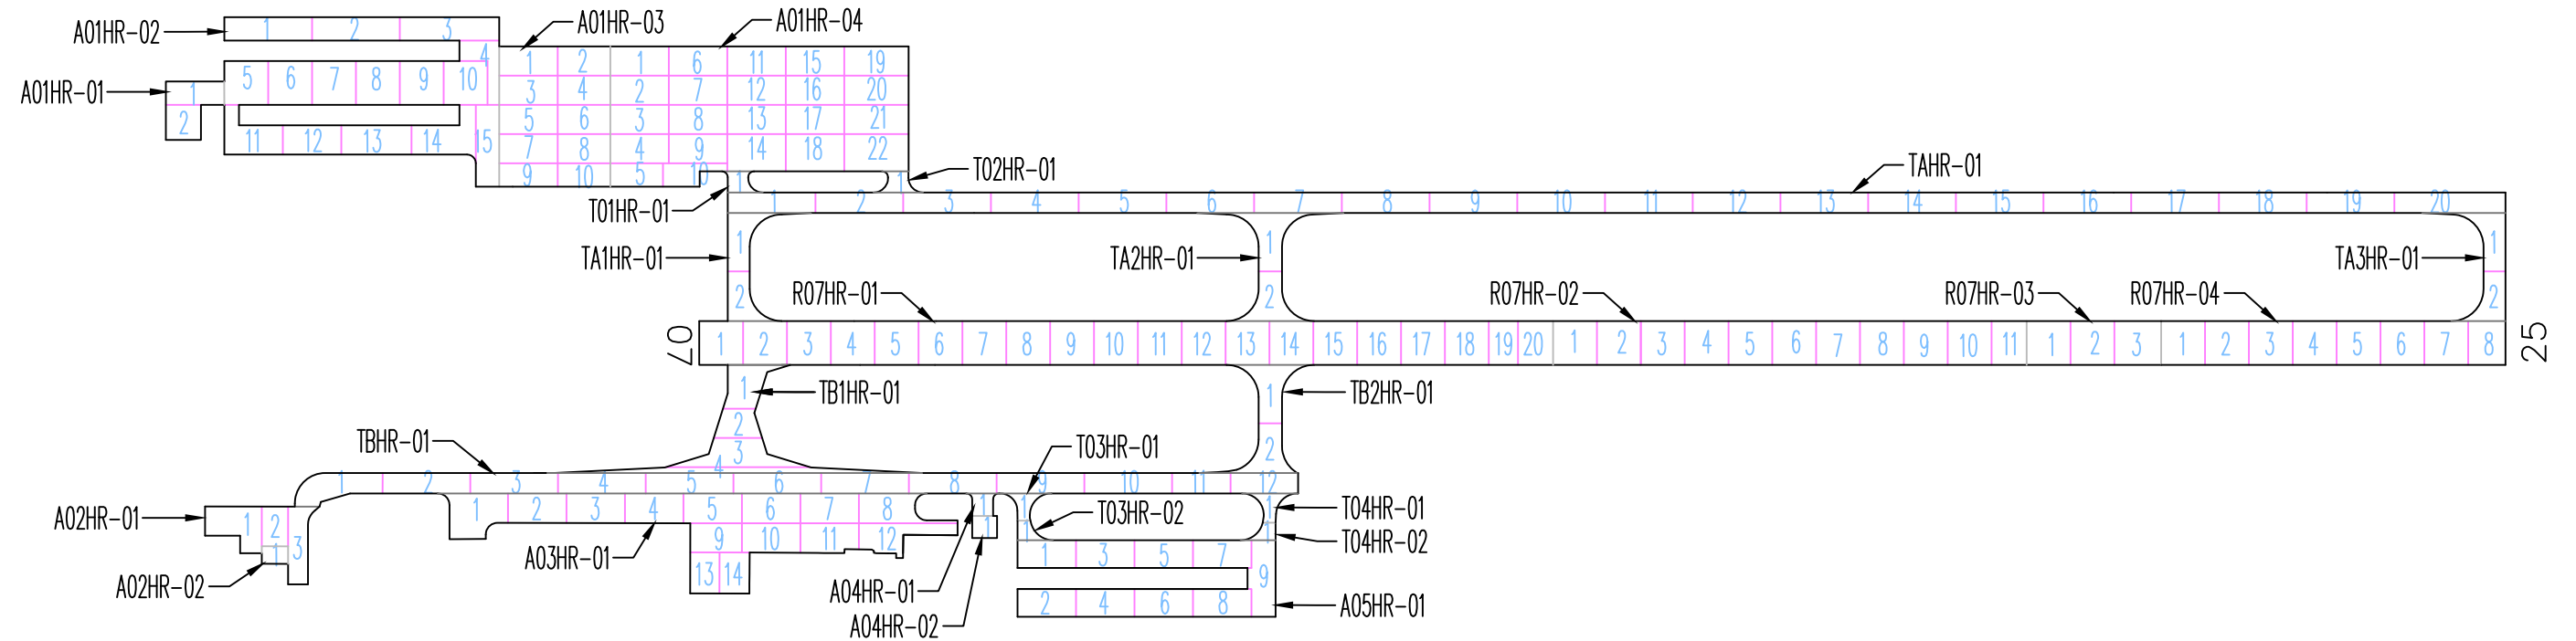
Figure HR-2. Pavement Branch, Section and Sample Unit Layout.
Ken Jernstedt Airfield

The pavements at your airport were divided into branches, sections and sample units in accordance with the methodology outlined in the current edition of ASTM D5430, *Standard Test Method for Airport Condition Index Surveys*. The branches, sections and sample units established at your airport are shown in Figure HR-2. A Branch Condition Report showing all branches, their associated areas, and their area-weighted average condition is provided in Appendix 1. Additionally, the Appendix 2 Section Condition Report provides information used to define each branch and section in the PAVER database.
