AURORA STATE AIRPORT

This report describes how your Pavement Maintenance Management Program (PMMP) was developed. Your Program was developed as part of the Oregon Continuous Aviation System Plan sponsored in part by the Oregon Department of Aviation and the Federal Aviation Administration (FAA). The information and data contained in this report ensures you comply with the requirements of FAA Grant Assurance Number 11 which states that any airport requesting federal funds for pavement improvement projects must have implemented a pavement maintenance management program.

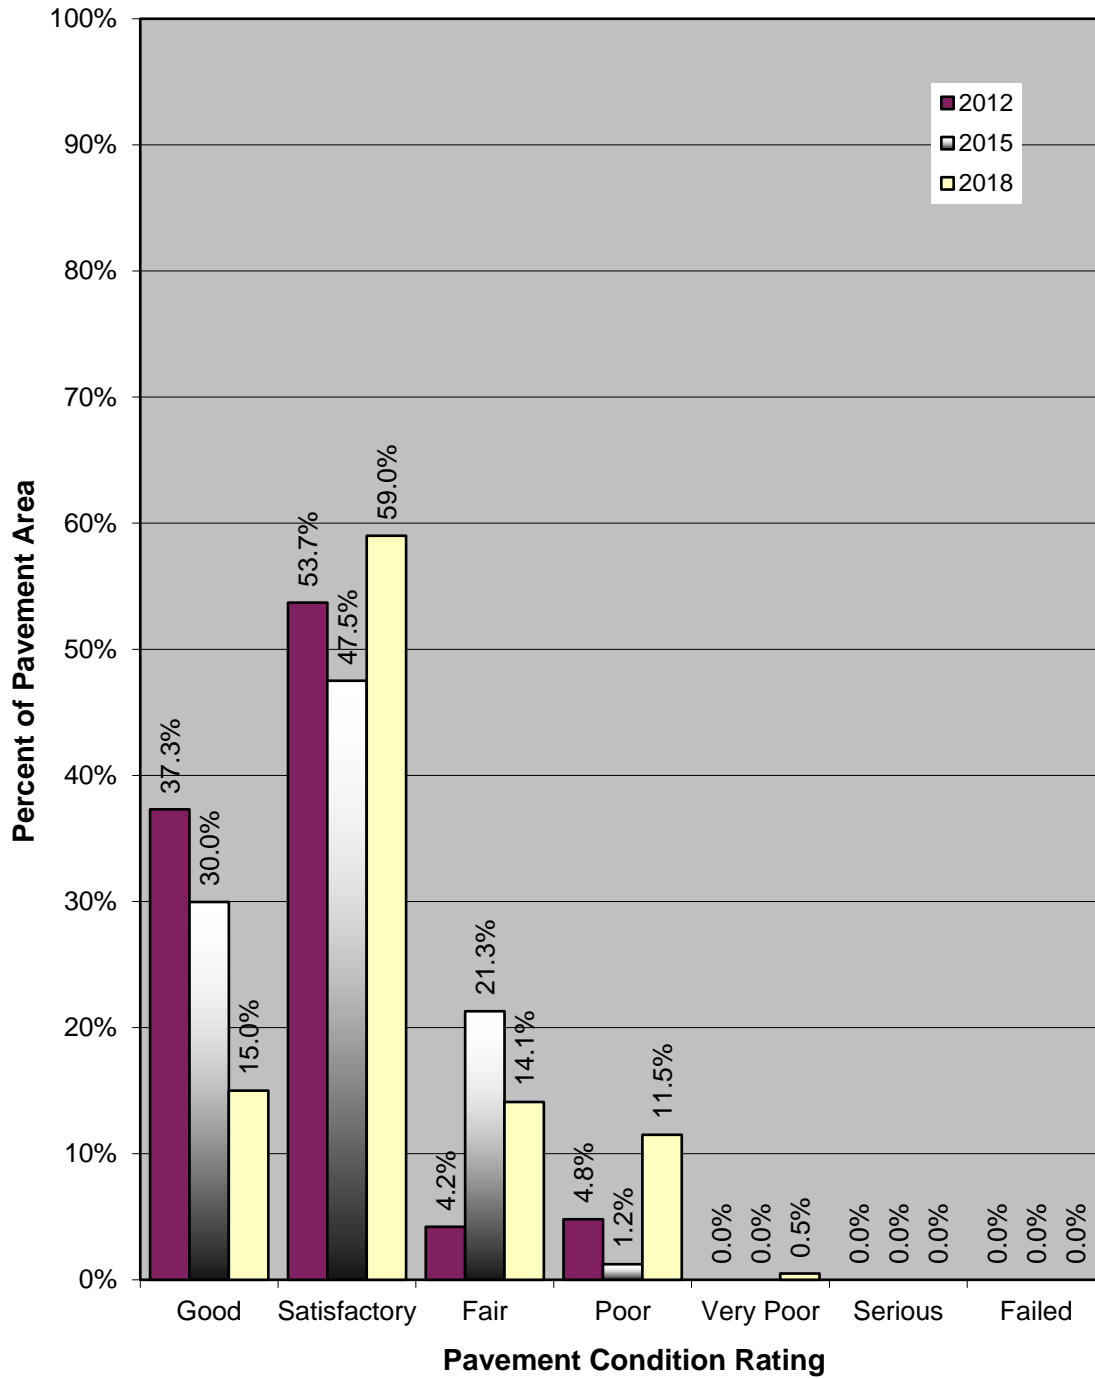
**Figure AU-4. Pavement Condition Distribution
Aurora State Airport**

Section PCIs at Aurora State Airport range from a low of 40 (a PCR of “Very Poor”) to a high of 100 (a PCR of “Good”). The area-weighted average PCI for all airport pavements is 77, corresponding to an overall PCR of “Satisfactory”. Figure AU-4 shows how much pavement area is associated with each Pavement Condition Rating category and also shows pavement condition distribution from the inspections conducted in 2012 and 2015.

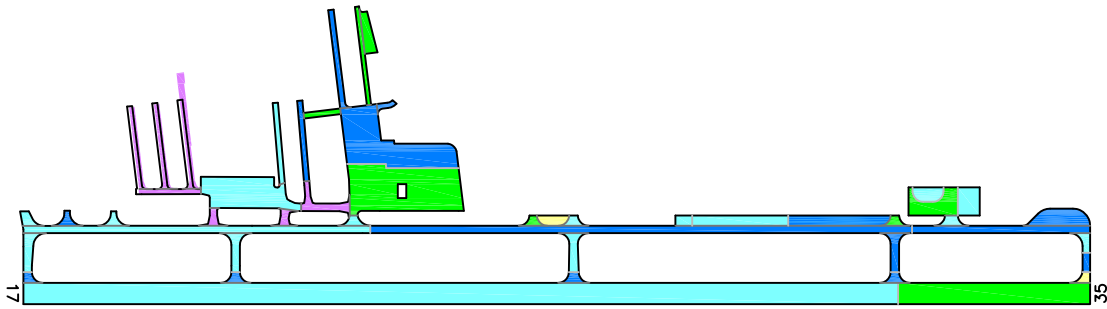
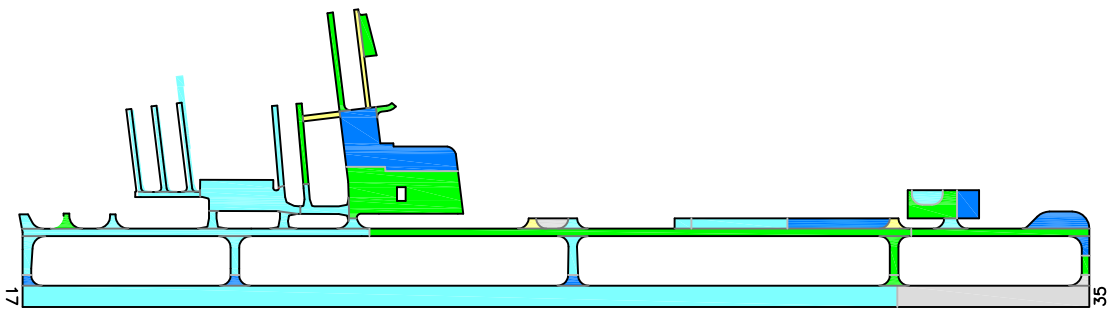
Figure AU-5. Future Pavement Condition.

Using the data collected during the visual inspection, the PAVER software was used to calculate an area-weighted average Pavement Condition Index (PCI) for each pavement section inspected using the sample units evaluated. Using each section’s PCI, a Pavement Condition Rating (PCR) was assigned. The PCIs measured during this inspection are shown in Table 1. The table also contains PCIs from past inspections as well as projected PCIs for 2023 and 2028. The projections were based on pavement deterioration models developed by PAVER using the inspection data from other pavements in the same airport category as your airport, located in the same climatic region, and with the same surface type and use.
