CORVALLIS MUNICIPAL AIRPORT

Figure CR-1A. Airport Layout, Dimensions and Pavement Cross-Sections.
Runways and Aprons
Corvallis Municipal Airport

Figure CR-2. Pavement Branch, Section and Sample Unit Layout.
Corvallis Municipal Airport

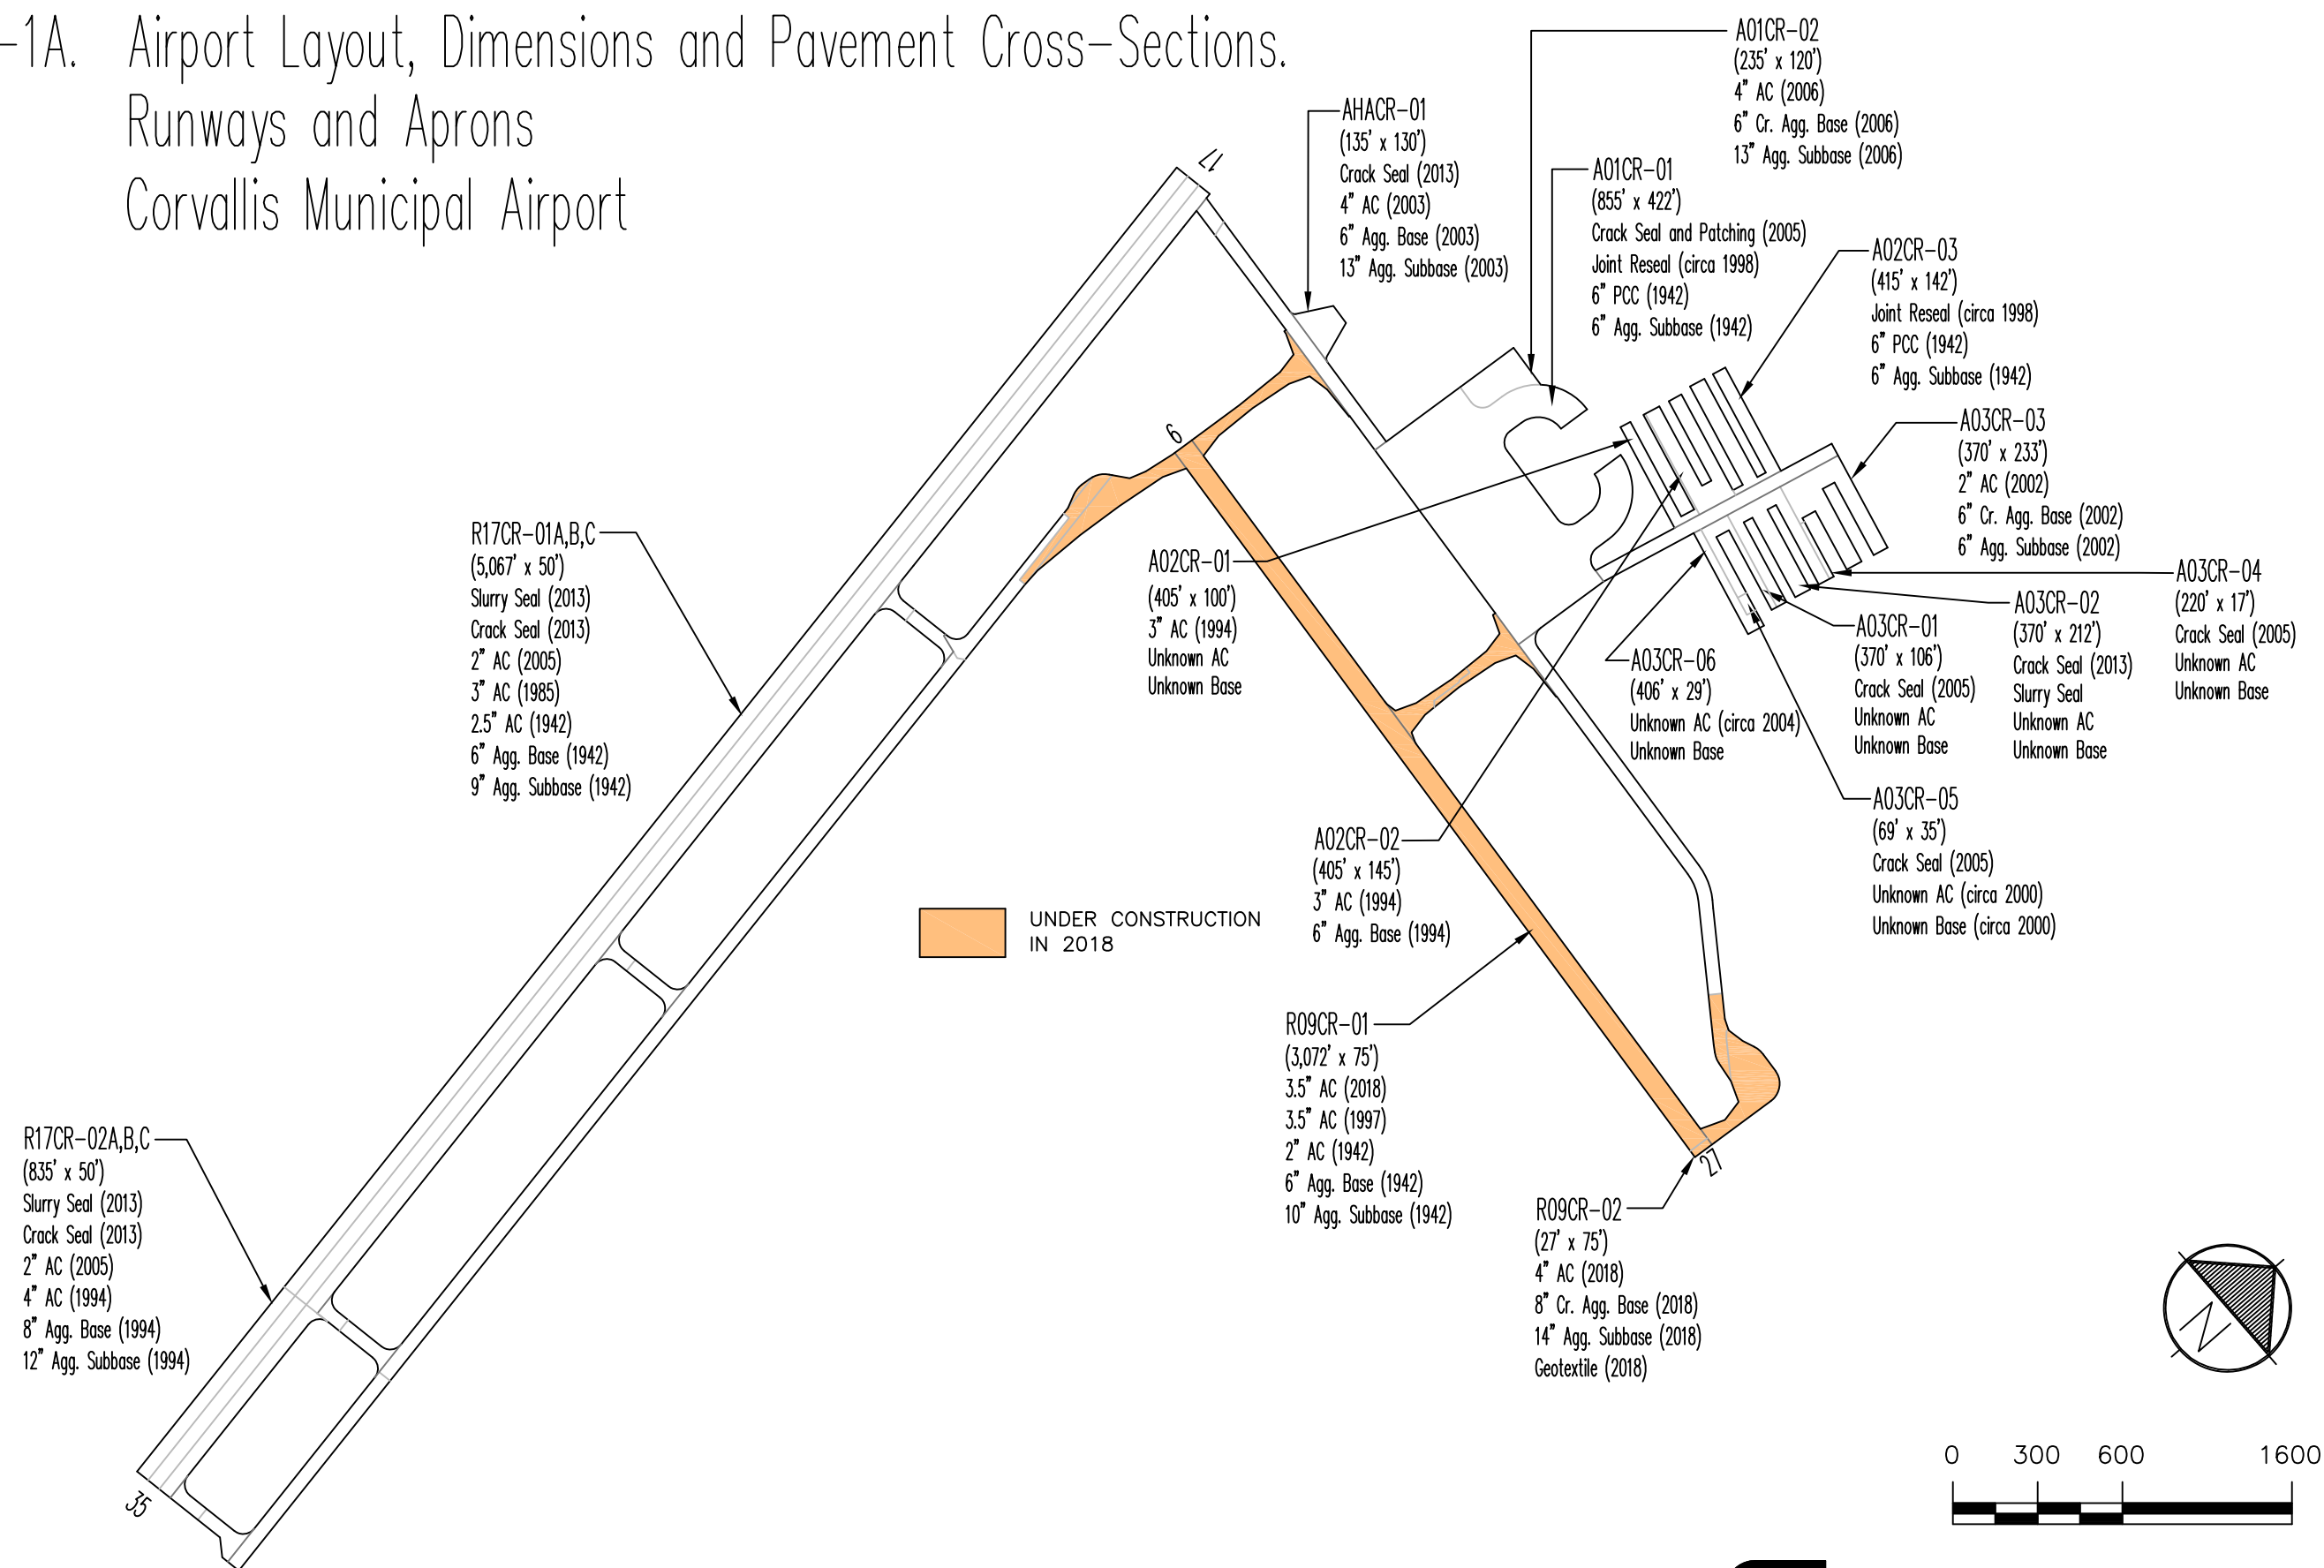
To determine how your pavements were constructed and their age, a records review was conducted. Figures CR-1A and CR-1B show the records review results. These figures identify pavement boundaries, dimensions, pavement layer types, thicknesses and dates of construction. The most recent construction date for each pavement can also be found in the Section Condition Report in Appendix 2. Figures CR-1A and CR-1B and the information contained in Appendices 1, 2 and 4 ensure that your airport complies with the “pavement inventory” requirement of FAA’s PMMP guidelines.

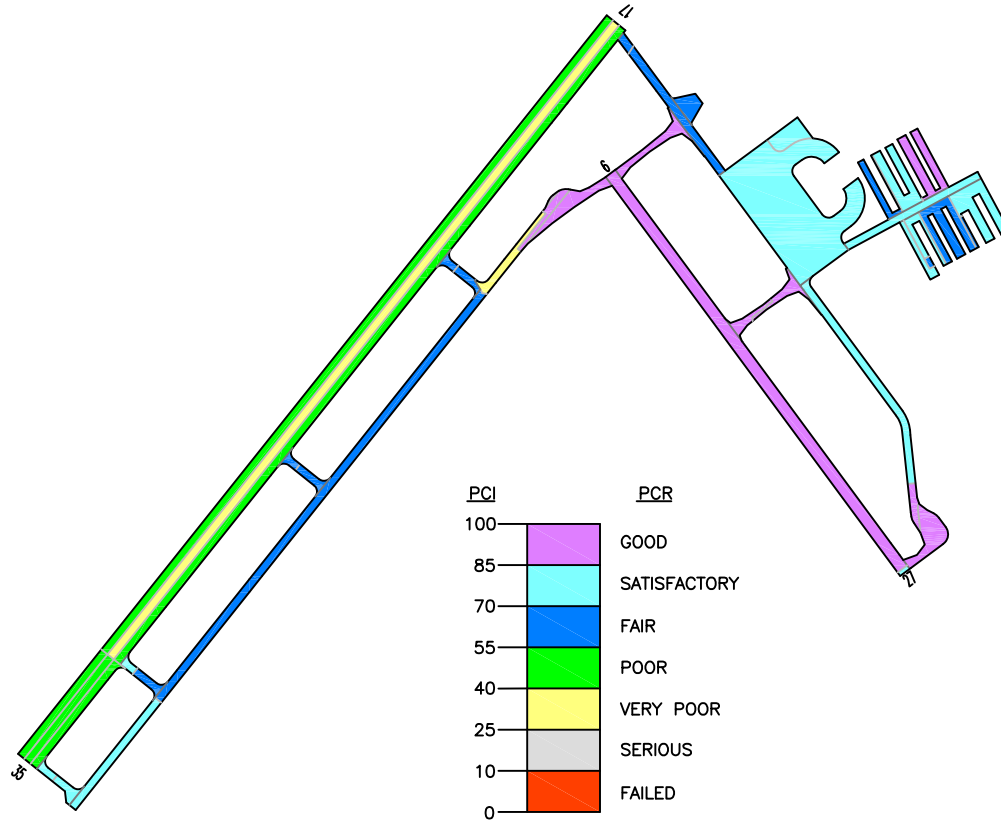
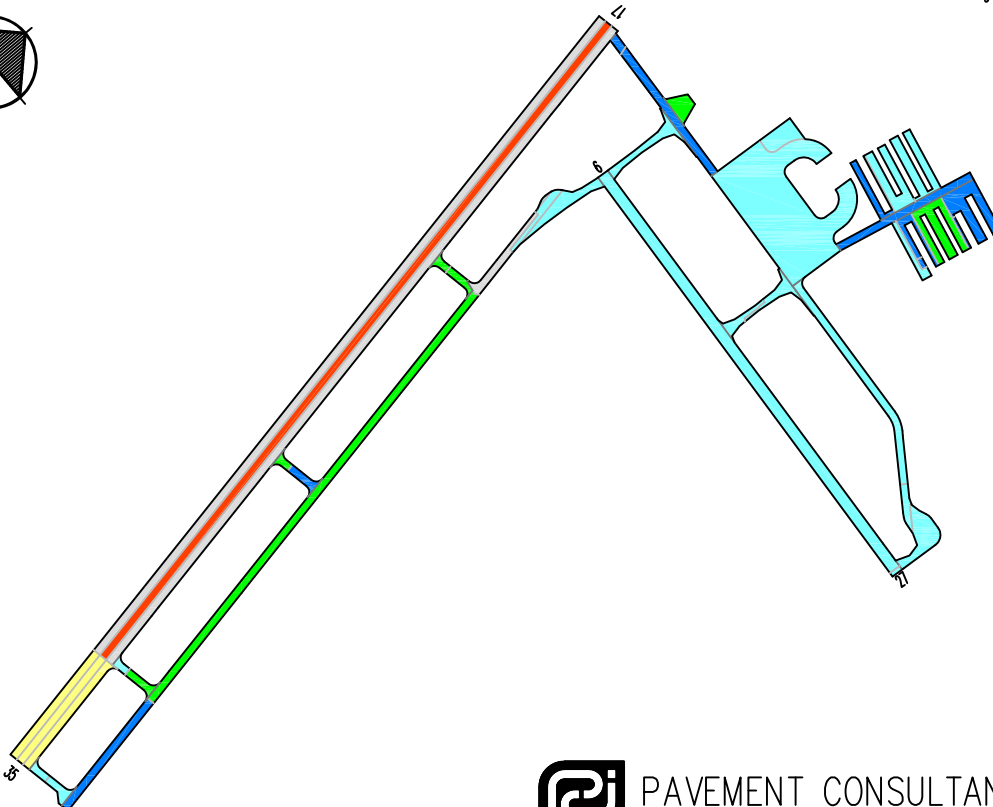
Figure CR-5. Future Pavement Condition.

A graphical representation of the projected PCIs listed in Table 1 is shown in Figure CR-5.
