LENHARDT AIRPARK

This report describes how your Pavement Maintenance Management Program (PMMP) was developed. Your Program was developed as part of the Oregon Continuous Aviation System Plan sponsored in part by the Oregon Department of Aviation and the Federal Aviation Administration (FAA). The information and data contained in this report ensures you comply with the requirements of FAA Grant Assurance Number 11 which states that any airport requesting federal funds for pavement improvement projects must have implemented a pavement maintenance management program.

Using the branch, section and sample unit divisions established, a visual condition survey was conducted at Lenhardt Airpark in May 2018. During the inspection, pavement defects were identified and measured in accordance with the methodology outlined in ASTM D5430. This inspection ensures your airport complies with the “detailed inspection” requirement of FAA’s PMMP guidelines. After collection, the data were entered into the PAVER software for analysis. These data are reproduced in the Re-Inspection Report attached as Appendix 4.

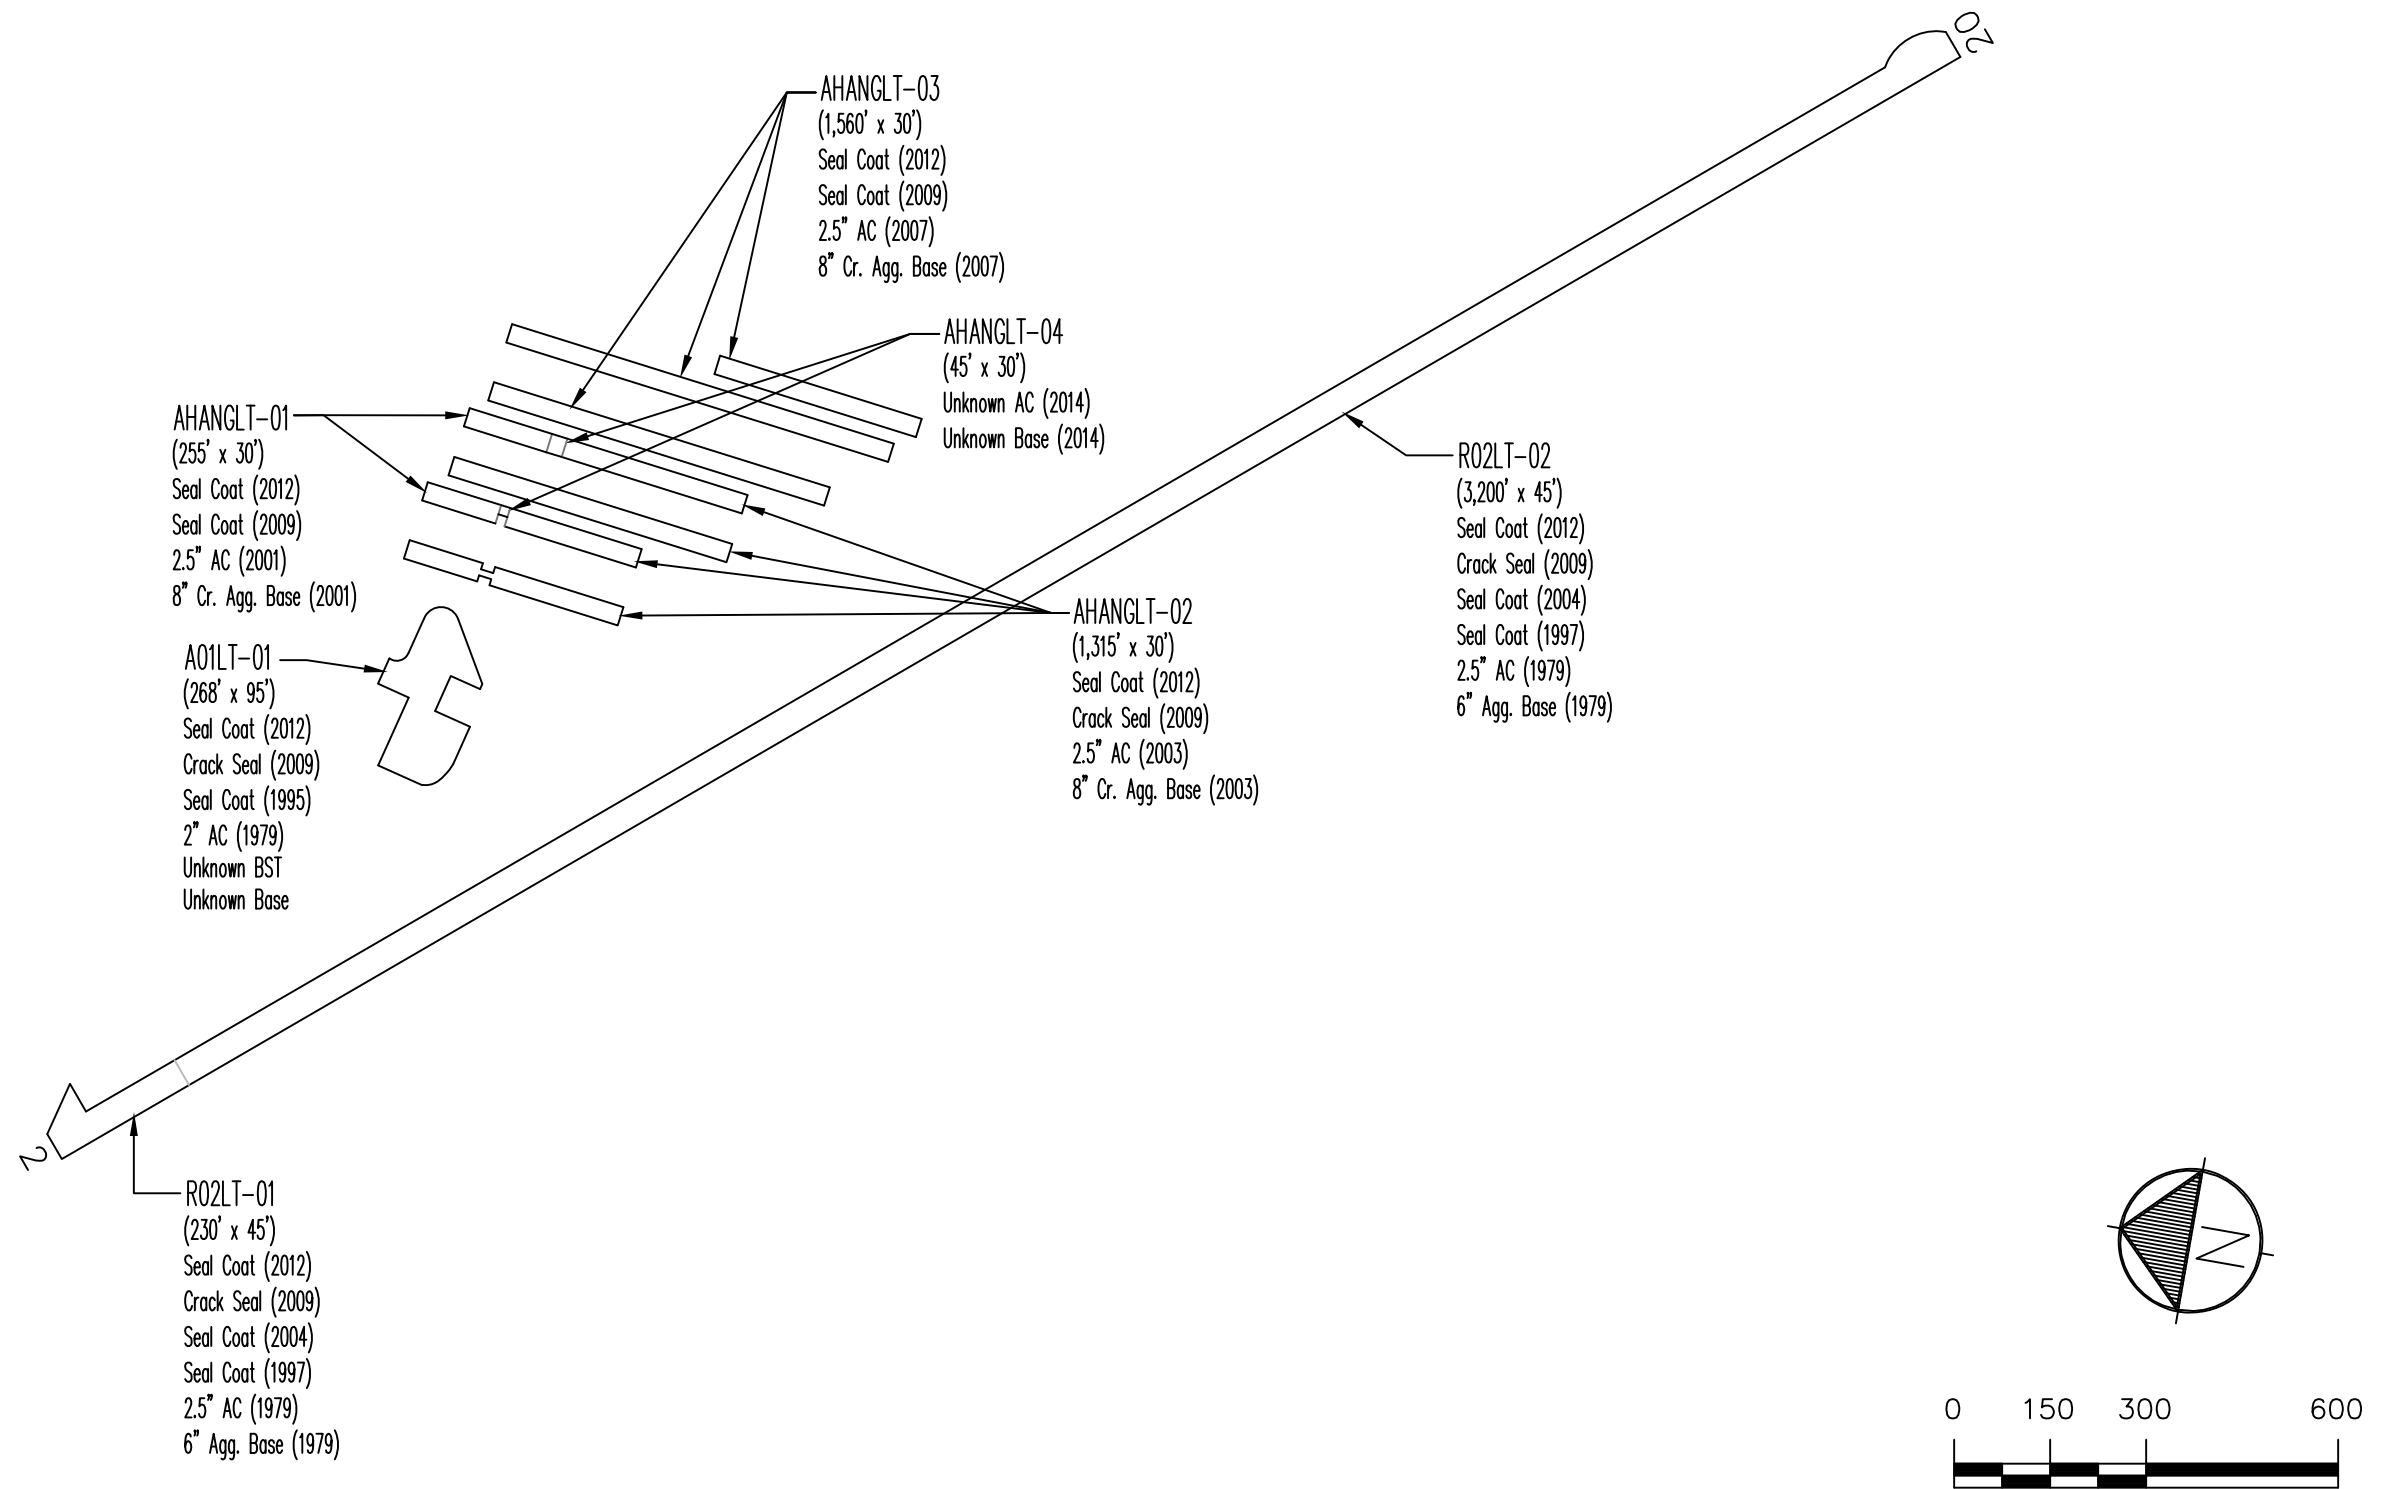
Figure LT-1. Airport Layout, Dimensions and Pavement Cross-Sections.
 Lenhardt Airpark

To determine how your pavements were constructed and their age, a records review was conducted. Figure LT-1 shows the records review results. This figure identifies pavement boundaries, dimensions, pavement layer types, thicknesses and dates of construction. The most recent construction date for each pavement can also be found in the Section Condition Report in Appendix 2. Figure LT-1 and the information contained in Appendices 1, 2 and 4 ensure that your airport complies with the “pavement inventory” requirement of FAA’s PMMP guidelines.

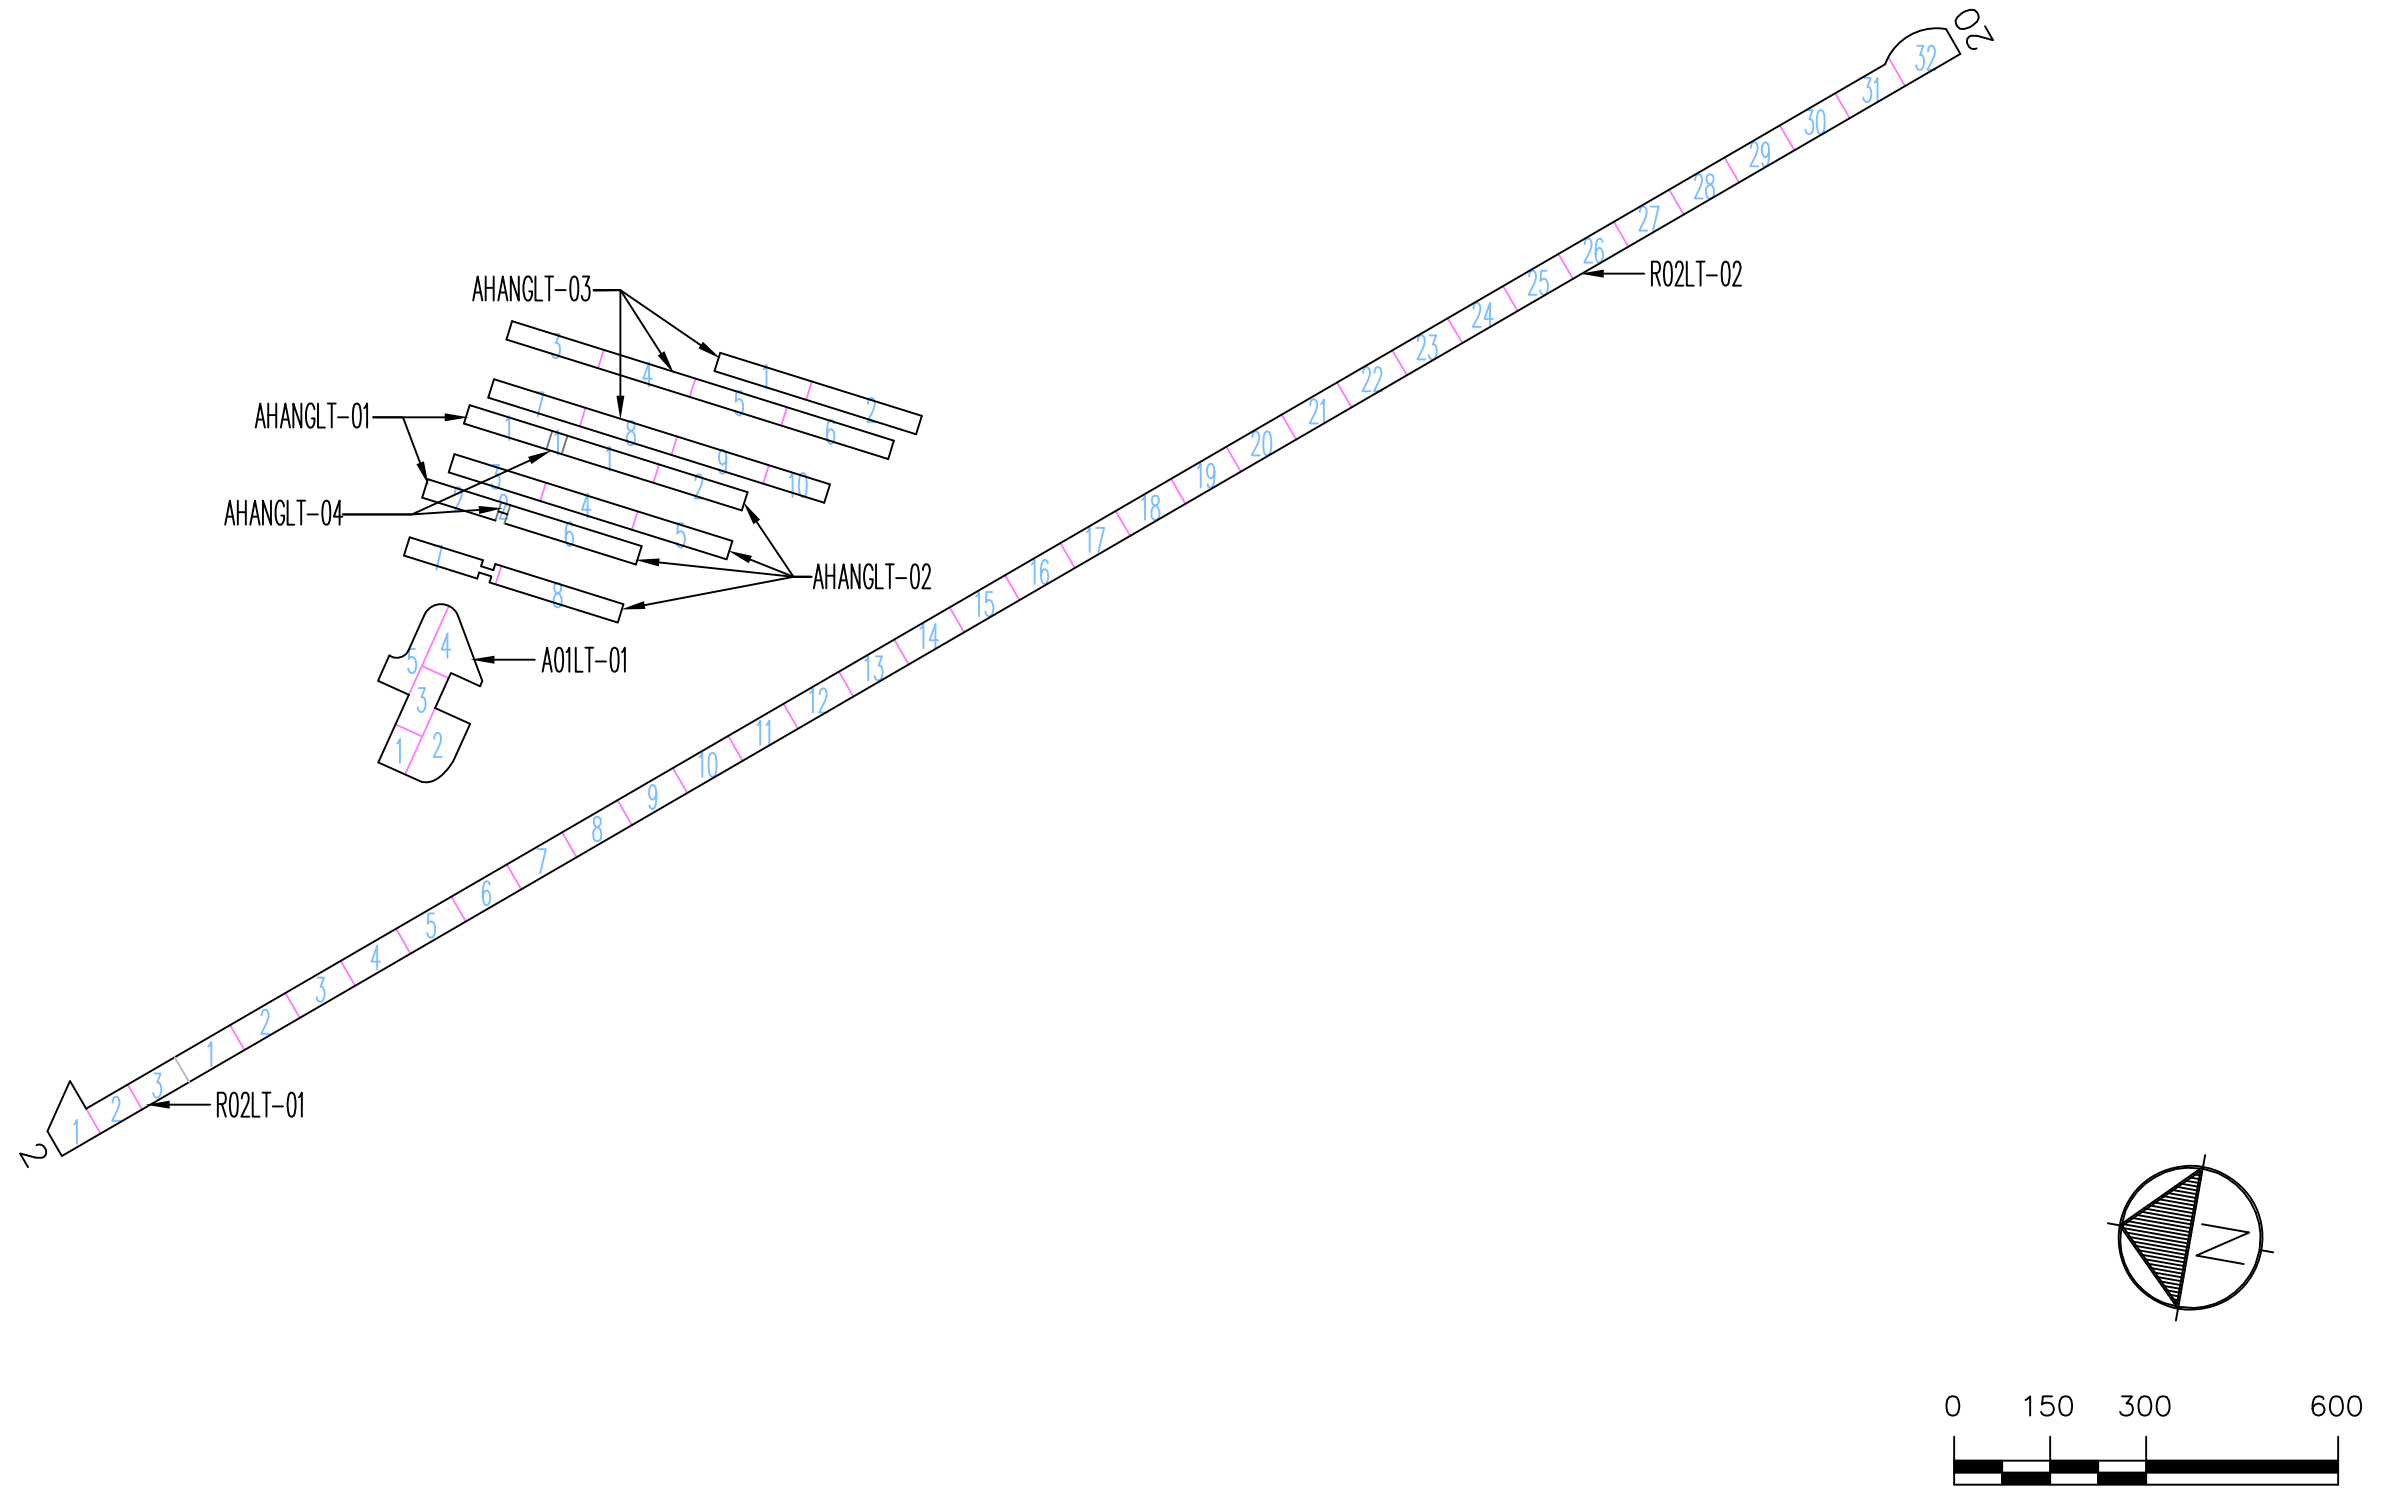
Figure LT-2. Pavement Branch, Section and Sample Unit Layout.
Lenhardt Airpark

The pavements at your airport were divided into branches, sections and sample units in accordance with the methodology outlined in the current edition of ASTM D5430, *Standard Test Method for Airport Condition Index Surveys*. The branches, sections and sample units established at your airport are shown in Figure LT-2. A Branch Condition Report showing all branches, their associated areas, and their area-weighted average condition is provided in Appendix 1. Additionally, the Appendix 2 Section Condition Report provides information used to define each branch and section in the PAVER database.
