PACIFIC CITY STATE AIRPORT

Figure PC-1. Airport Layout, Dimensions and Pavement Cross-Sections.
Pacific City State Airport

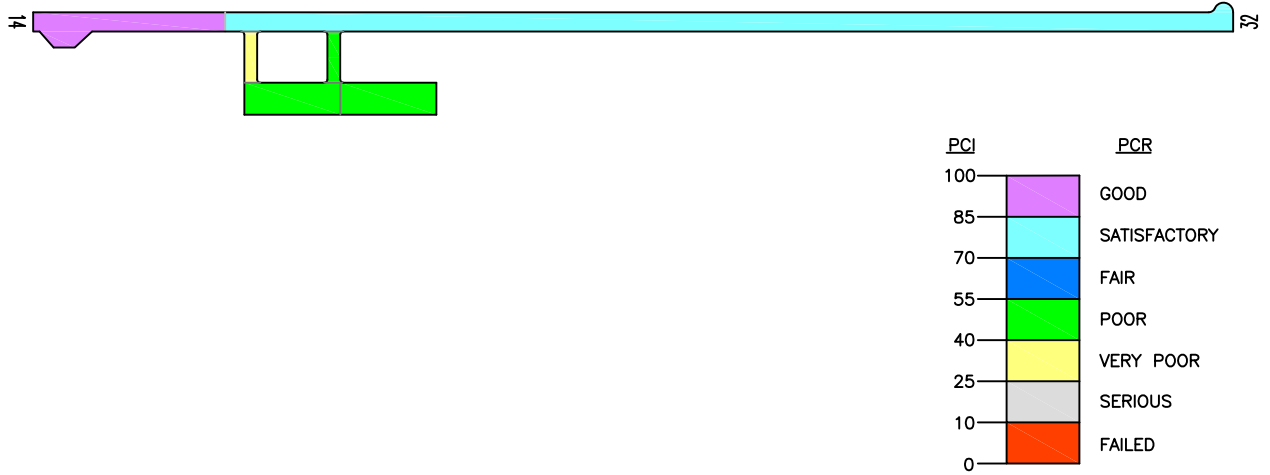
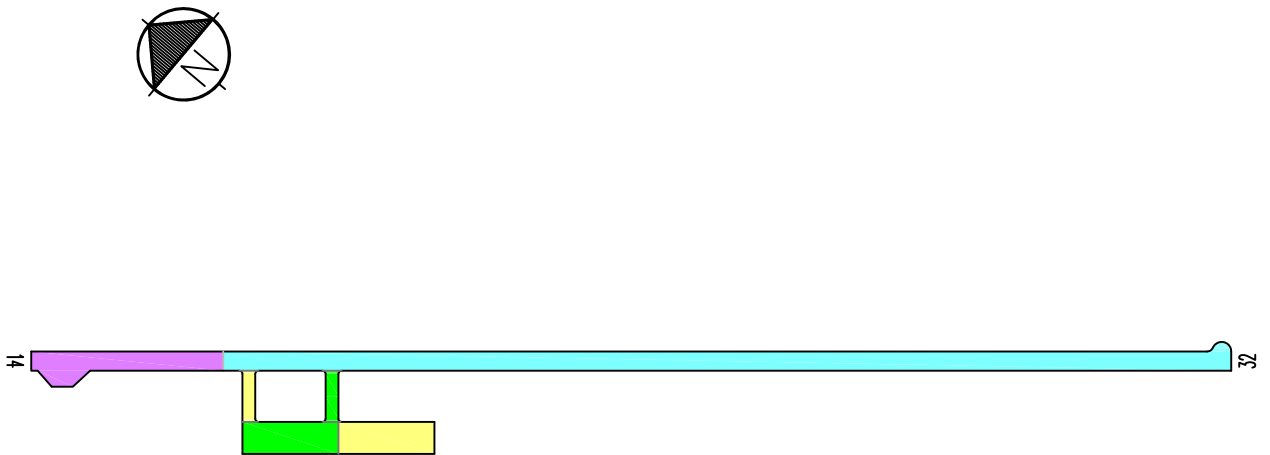
Figure PC-5. Future Pavement Condition.

A graphical representation of the projected PCIs listed in Table 1 is shown in Figure PC-5.

Predicted Condition in 2023.

Predicted Condition in 2028.
