SCAPPOOSE INDUSTRIAL AIRPARK

This report describes how your Pavement Maintenance Management Program (PMMP) was developed. Your Program was developed as part of the Oregon Continuous Aviation System Plan sponsored in part by the Oregon Department of Aviation and the Federal Aviation Administration (FAA). The information and data contained in this report ensures you comply with the requirements of FAA Grant Assurance Number 11 which states that any airport requesting federal funds for pavement improvement projects must have implemented a pavement maintenance management program.

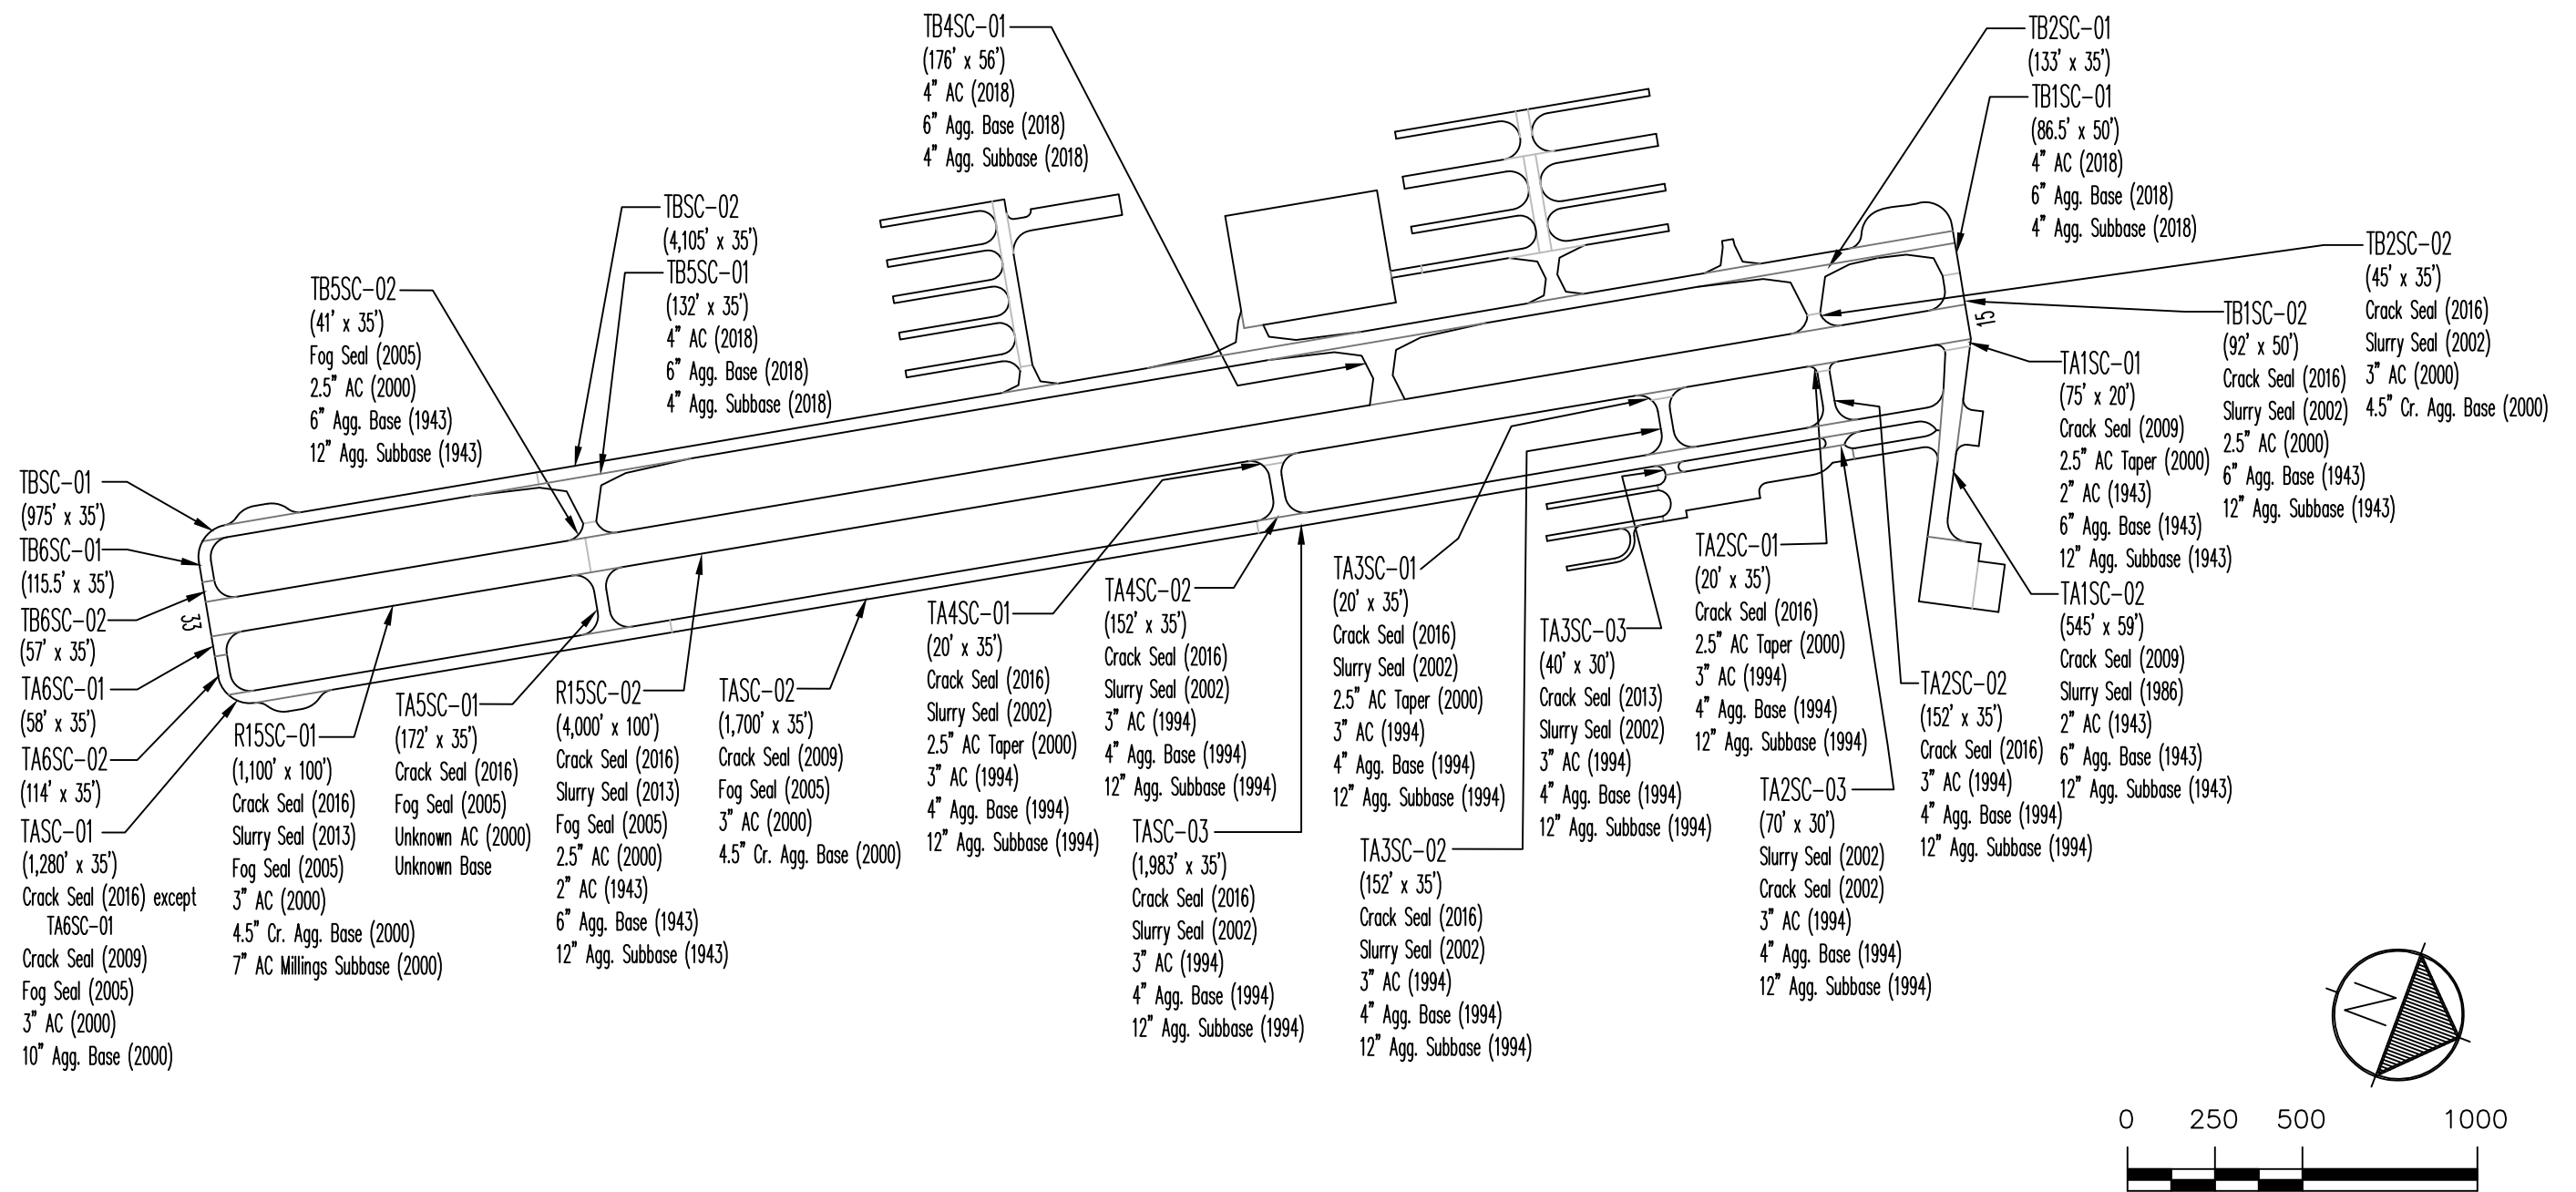
Figure SC-1A. Airport Layout, Dimensions and Pavement Cross-Sections – Runways and Taxiways.
Scappoose Industrial Airpark

To determine how your pavements were constructed and their age, a records review was conducted. Figures SC-1A and SC-1B show the records review results. These figures identify pavement boundaries, dimensions, pavement layer types, thicknesses and dates of construction. The most recent construction date for each pavement can also be found in the Section Condition Report in Appendix 2. Figures SC-1A and SC-1B and the information contained in Appendices 1, 2 and 4 ensure that your airport complies with the “pavement inventory” requirement of FAA’s PMMP guidelines.

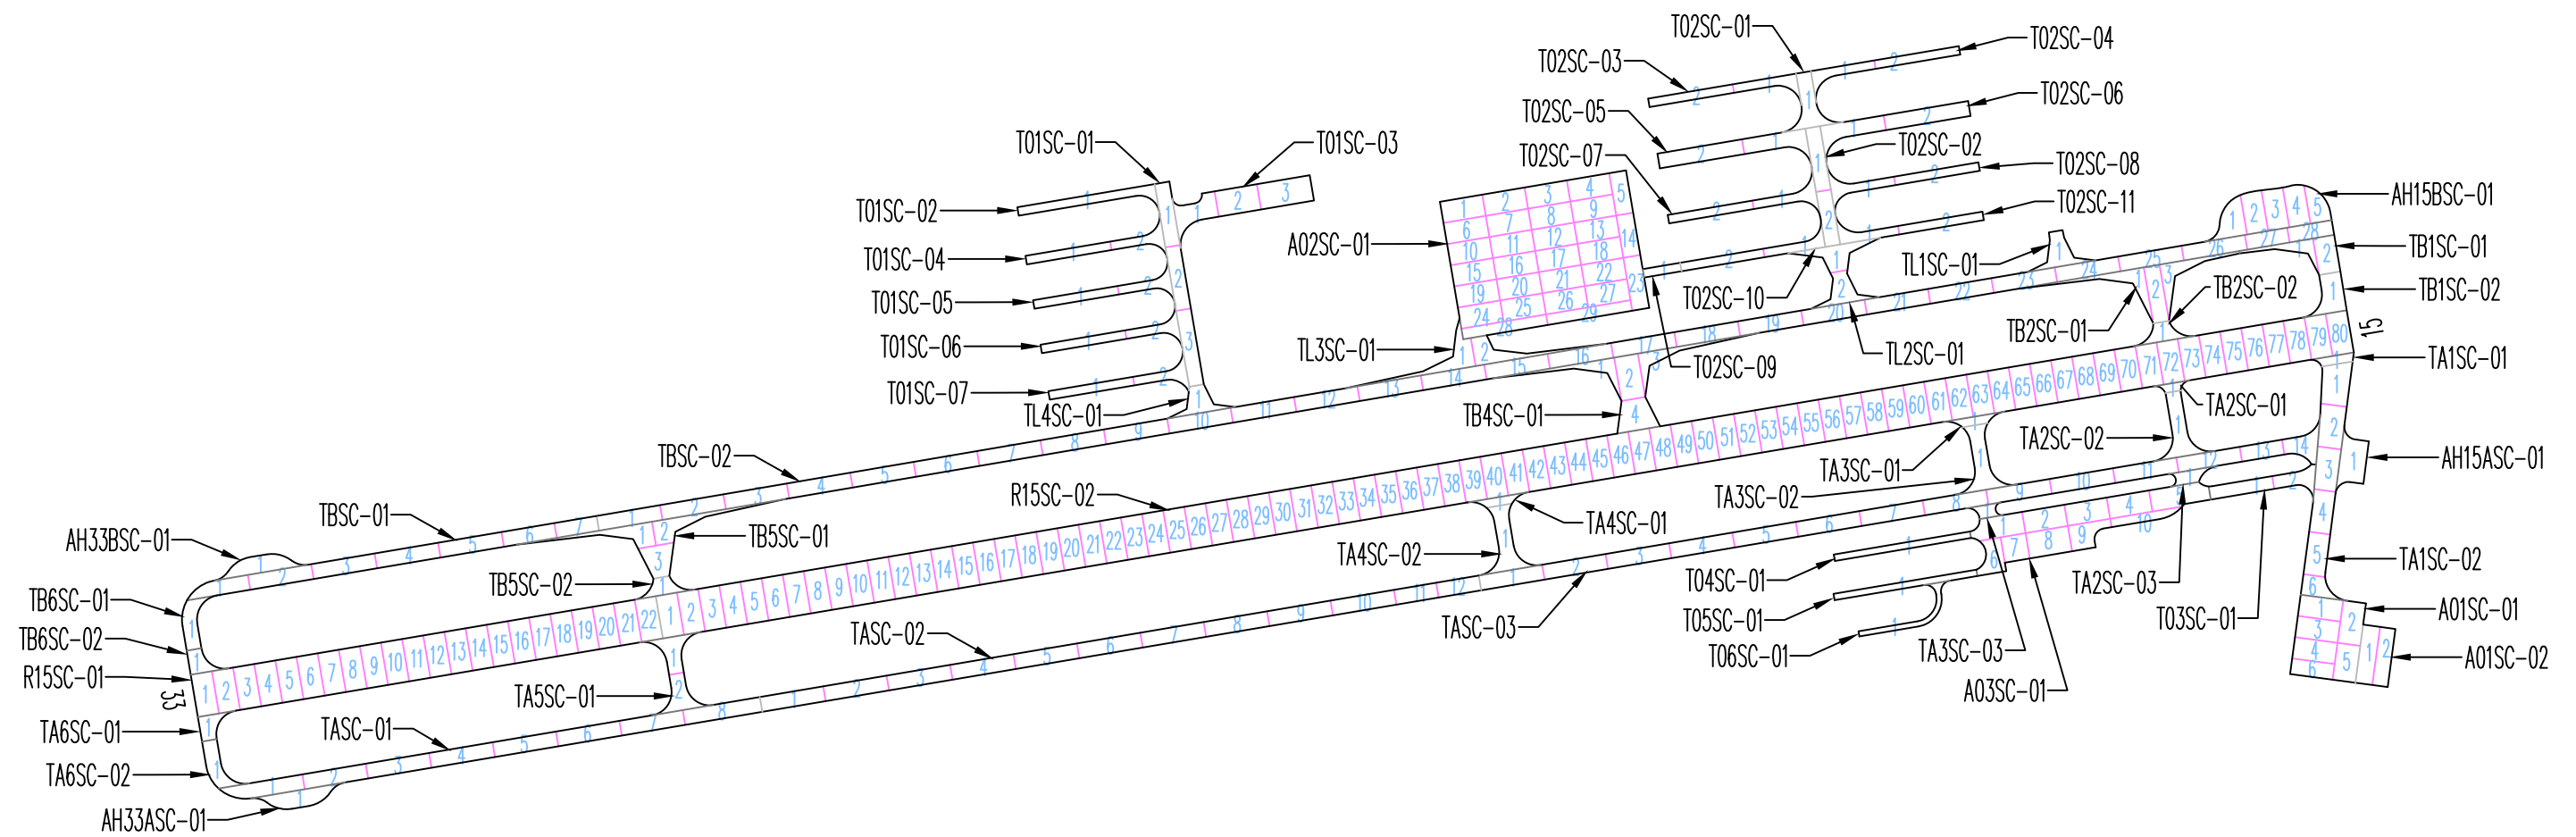
Figure SC-2. Pavement Branch, Section and Sample Unit Layout.
 Scappoose Industrial Airpark

The pavements at your airport were divided into branches, sections and sample units in accordance with the methodology outlined in the current edition of ASTM D5430, *Standard Test Method for Airport Condition Index Surveys*. The branches, sections and sample units established at your airport are shown in Figure SC-2. A Branch Condition Report showing all branches, their associated areas, and their area-weighted average condition is provided in Appendix 1. Additionally, the Appendix 2 Section Condition Report provides information used to define each branch and section in the PAVER database.
