SEASIDE MUNICIPAL AIRPORT

Figure SS-1. Airport Layout, Dimensions and Pavement Cross-Sections.
Seaside Municipal Airport

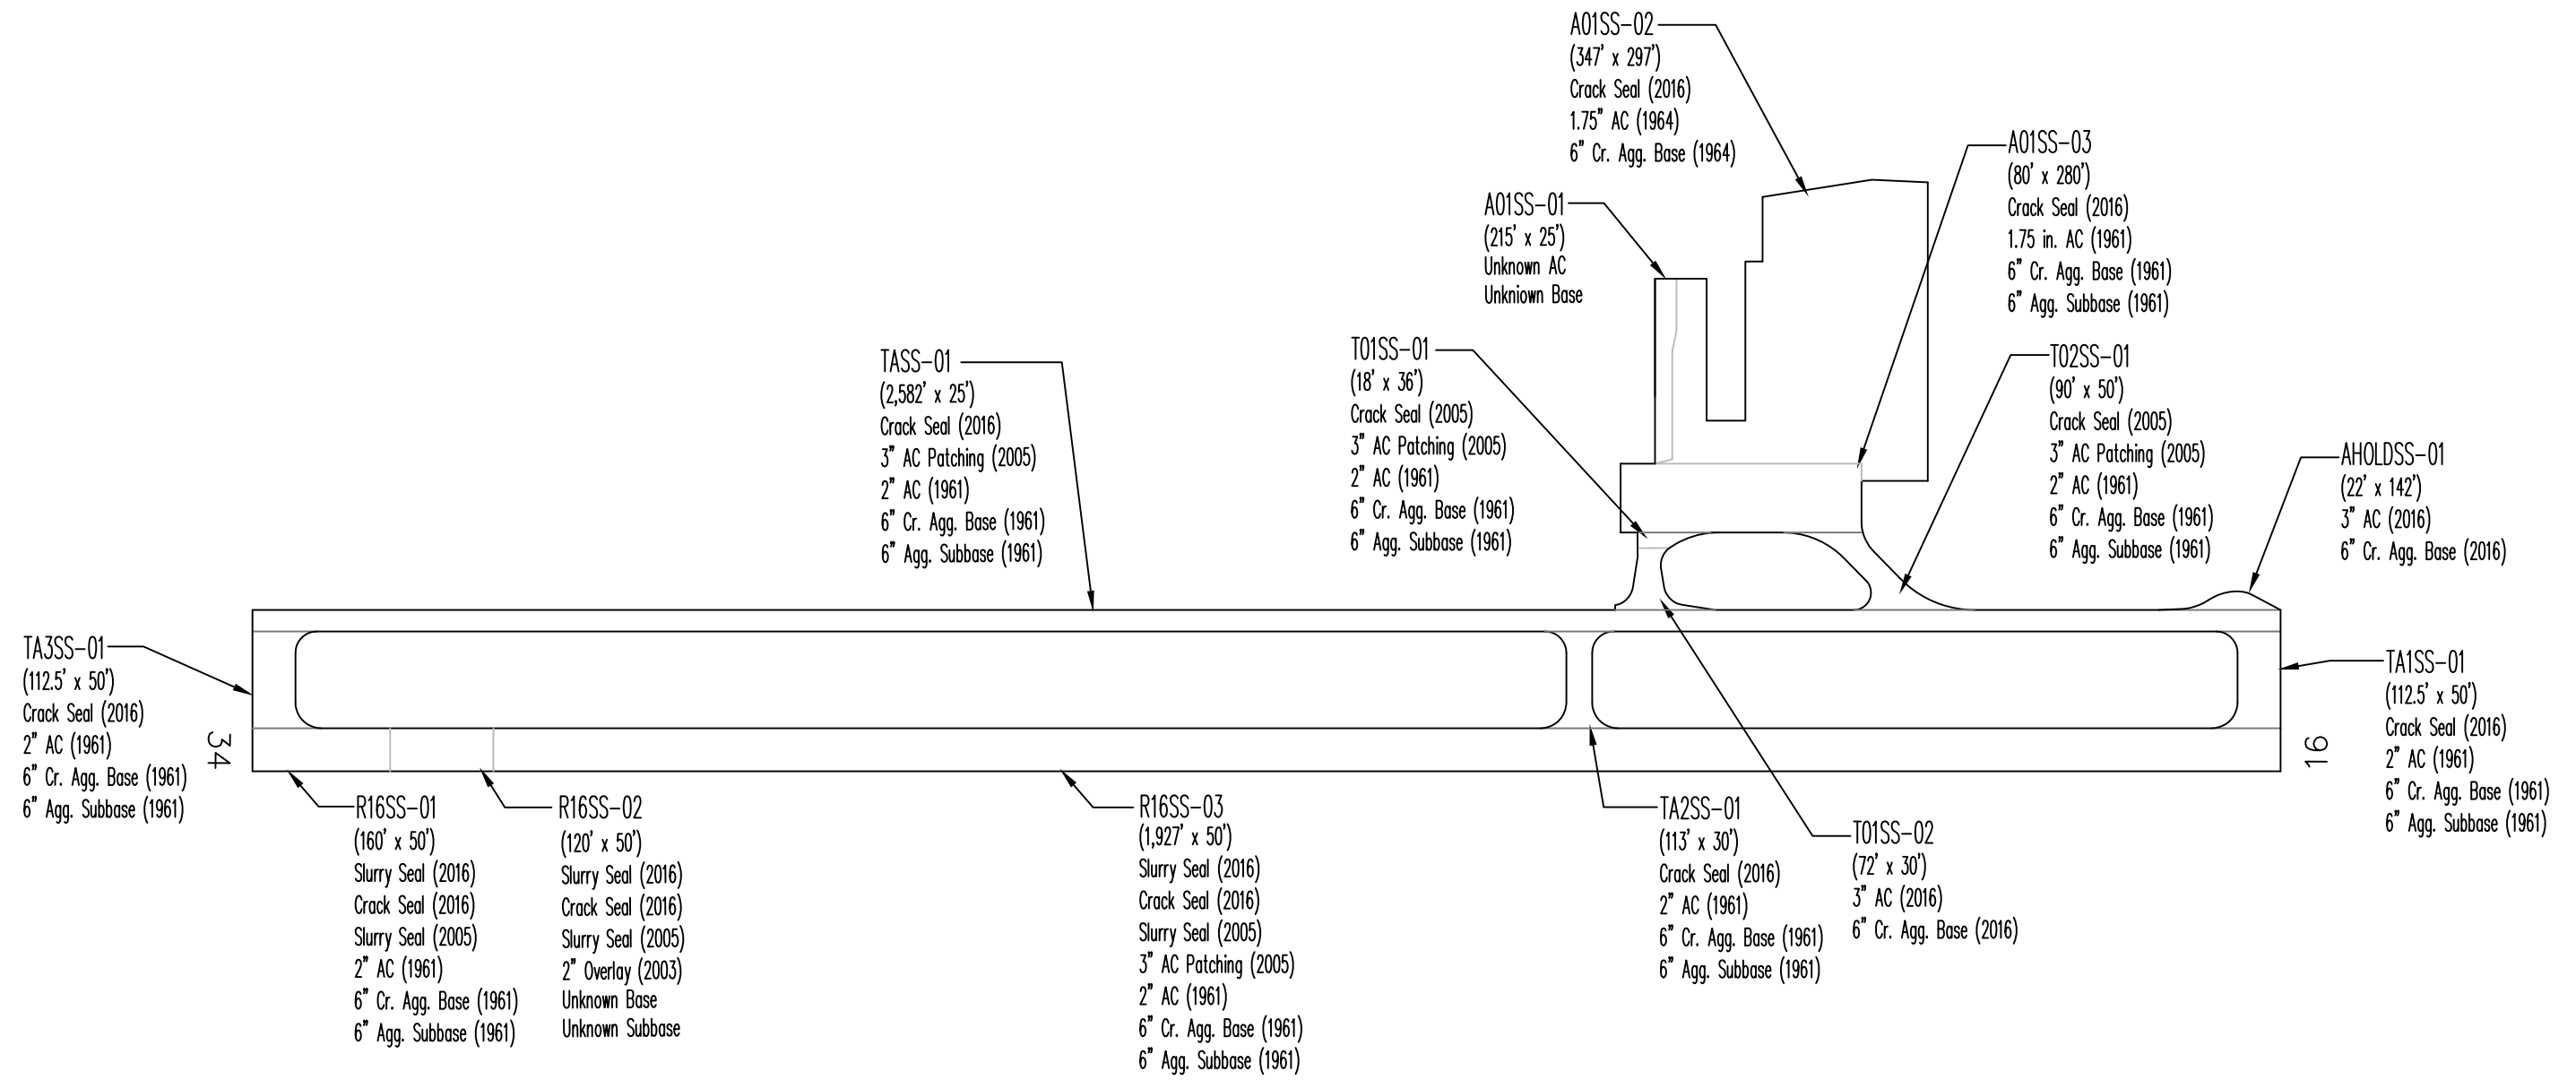
To determine how your pavements were constructed and their age, a records review was conducted. Figure SS-1 shows the records review results. This figure identifies pavement boundaries, dimensions, pavement layer types, thicknesses and dates of construction. The most recent construction date for each pavement can also be found in the Section Condition Report in Appendix 2. Figure SS-1 and the information contained in Appendices 1, 2 and 4 ensure that your airport complies with the “pavement inventory” requirement of FAA’s PMMP guidelines.

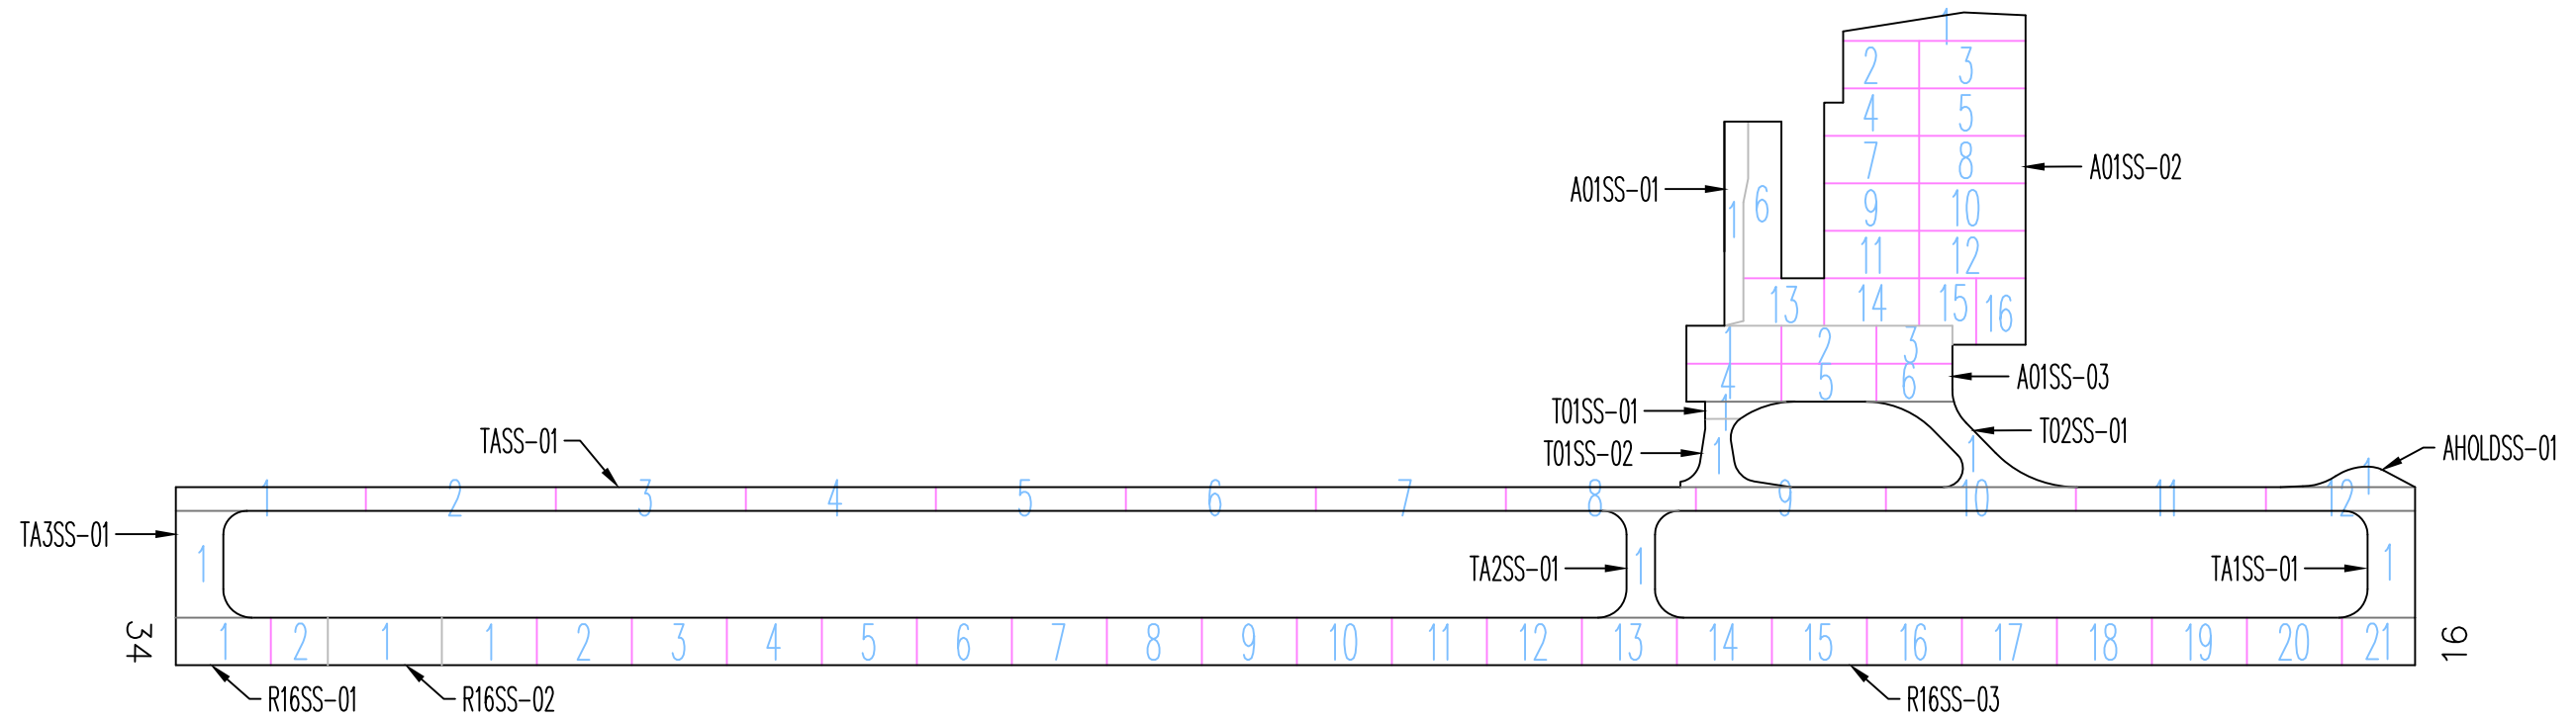
Figure SS-2. Pavement Branch, Section and Sample Unit Layout.
Seaside Municipal Airport

The pavements at your airport were divided into branches, sections and sample units in accordance with the methodology outlined in the current edition of ASTM D5430, *Standard Test Method for Airport Condition Index Surveys*. The branches, sections and sample units established at your airport are shown in Figure SS-2. A Branch Condition Report showing all branches, their associated areas, and their area-weighted average condition is provided in Appendix 1. Additionally, the Appendix 2 Section Condition Report provides information used to define each branch and section in the PAVER database.
