SPORTSMAN AIRPARK

Figure SP-1. Airport Layout, Dimensions and Pavement Cross-Sections.
Sportsman Airpark

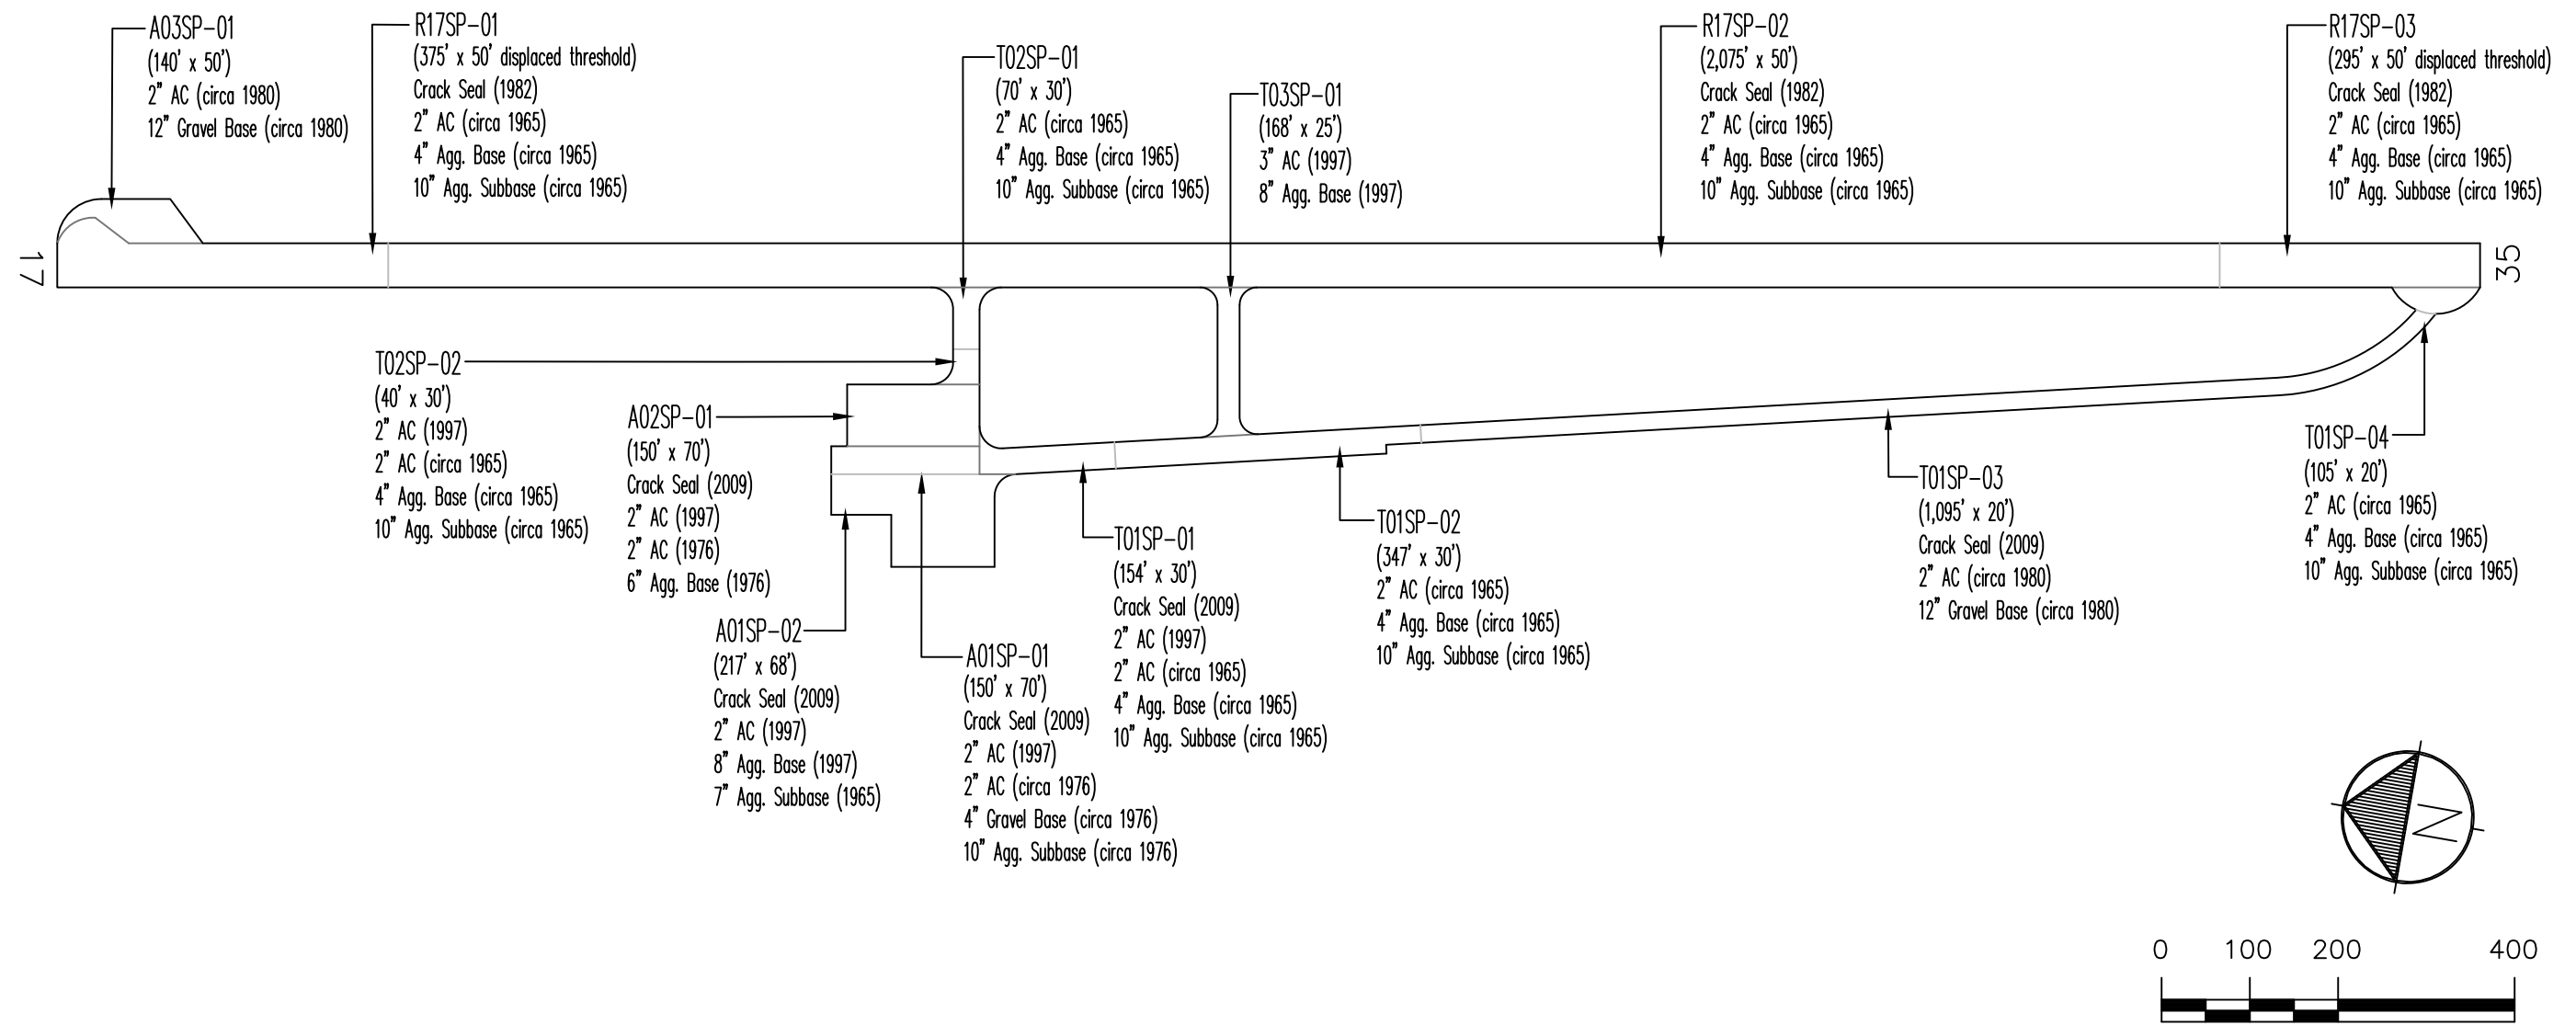
To determine how your pavements were constructed and their age, a records review was conducted. Figure SP-1 shows the records review results. This figure identifies pavement boundaries, dimensions, pavement layer types, thicknesses and dates of construction. The most recent construction date for each pavement can also be found in the Section Condition Report in Appendix 2. Figure SP-1 and the information contained in Appendices 1, 2 and 4 ensure that your airport complies with the “pavement inventory” requirement of FAA’s PMMP guidelines.

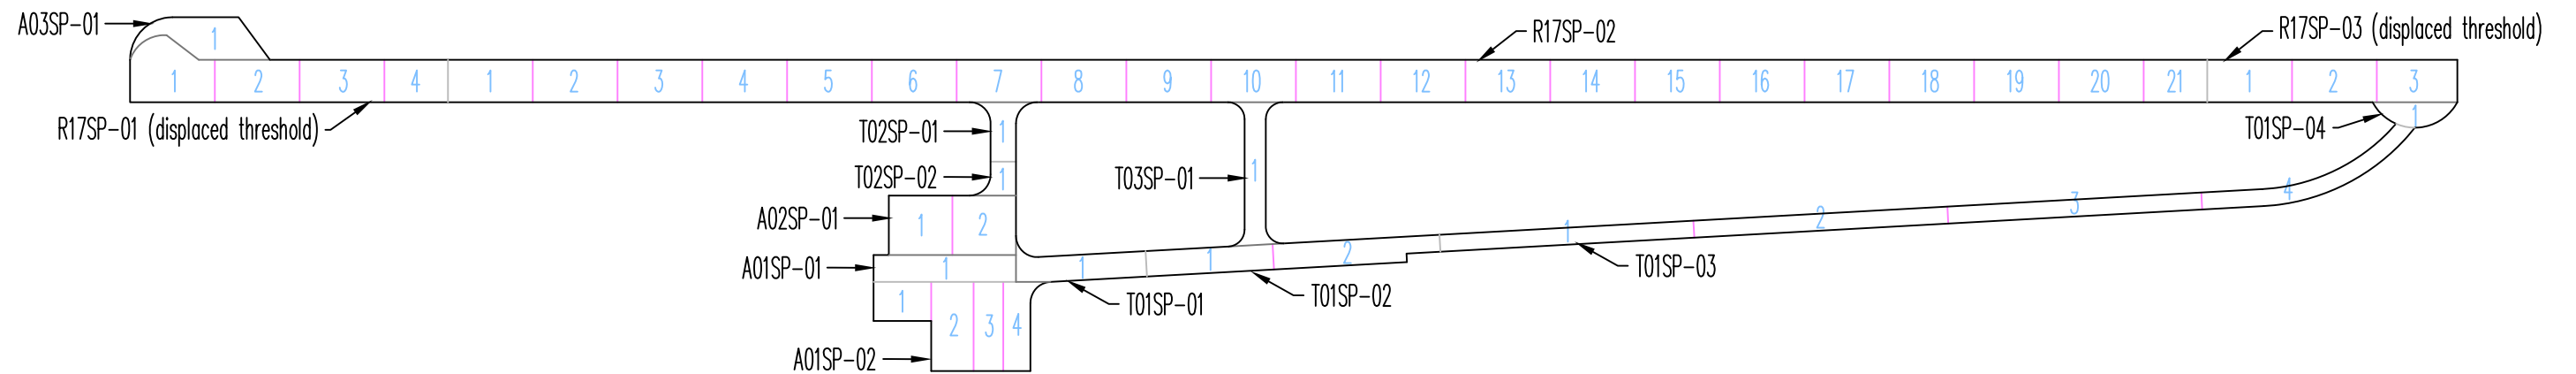
Figure SP-2. Pavement Branch, Section and Sample Unit Layout.
Sportsman Airpark

The pavements at your airport were divided into branches, sections and sample units in accordance with the methodology outlined in the current edition of ASTM D5430, *Standard Test Method for Airport Condition Index Surveys*. The branches, sections and sample units established at your airport are shown in Figure SP-2. A Branch Condition Report showing all branches, their associated areas, and their area-weighted average condition is provided in Appendix 1. Additionally, the Appendix 2 Section Condition Report provides information used to define each branch and section in the PAVER database.
