STARK'S TWIN OAKS AIRPARK

This report describes how your Pavement Maintenance Management Program (PMMP) was developed. Your Program was developed as part of the Oregon Continuous Aviation System Plan sponsored in part by the Oregon Department of Aviation and the Federal Aviation Administration (FAA). The information and data contained in this report ensures you comply with the requirements of FAA Grant Assurance Number 11 which states that any airport requesting federal funds for pavement improvement projects must have implemented a pavement maintenance management program.

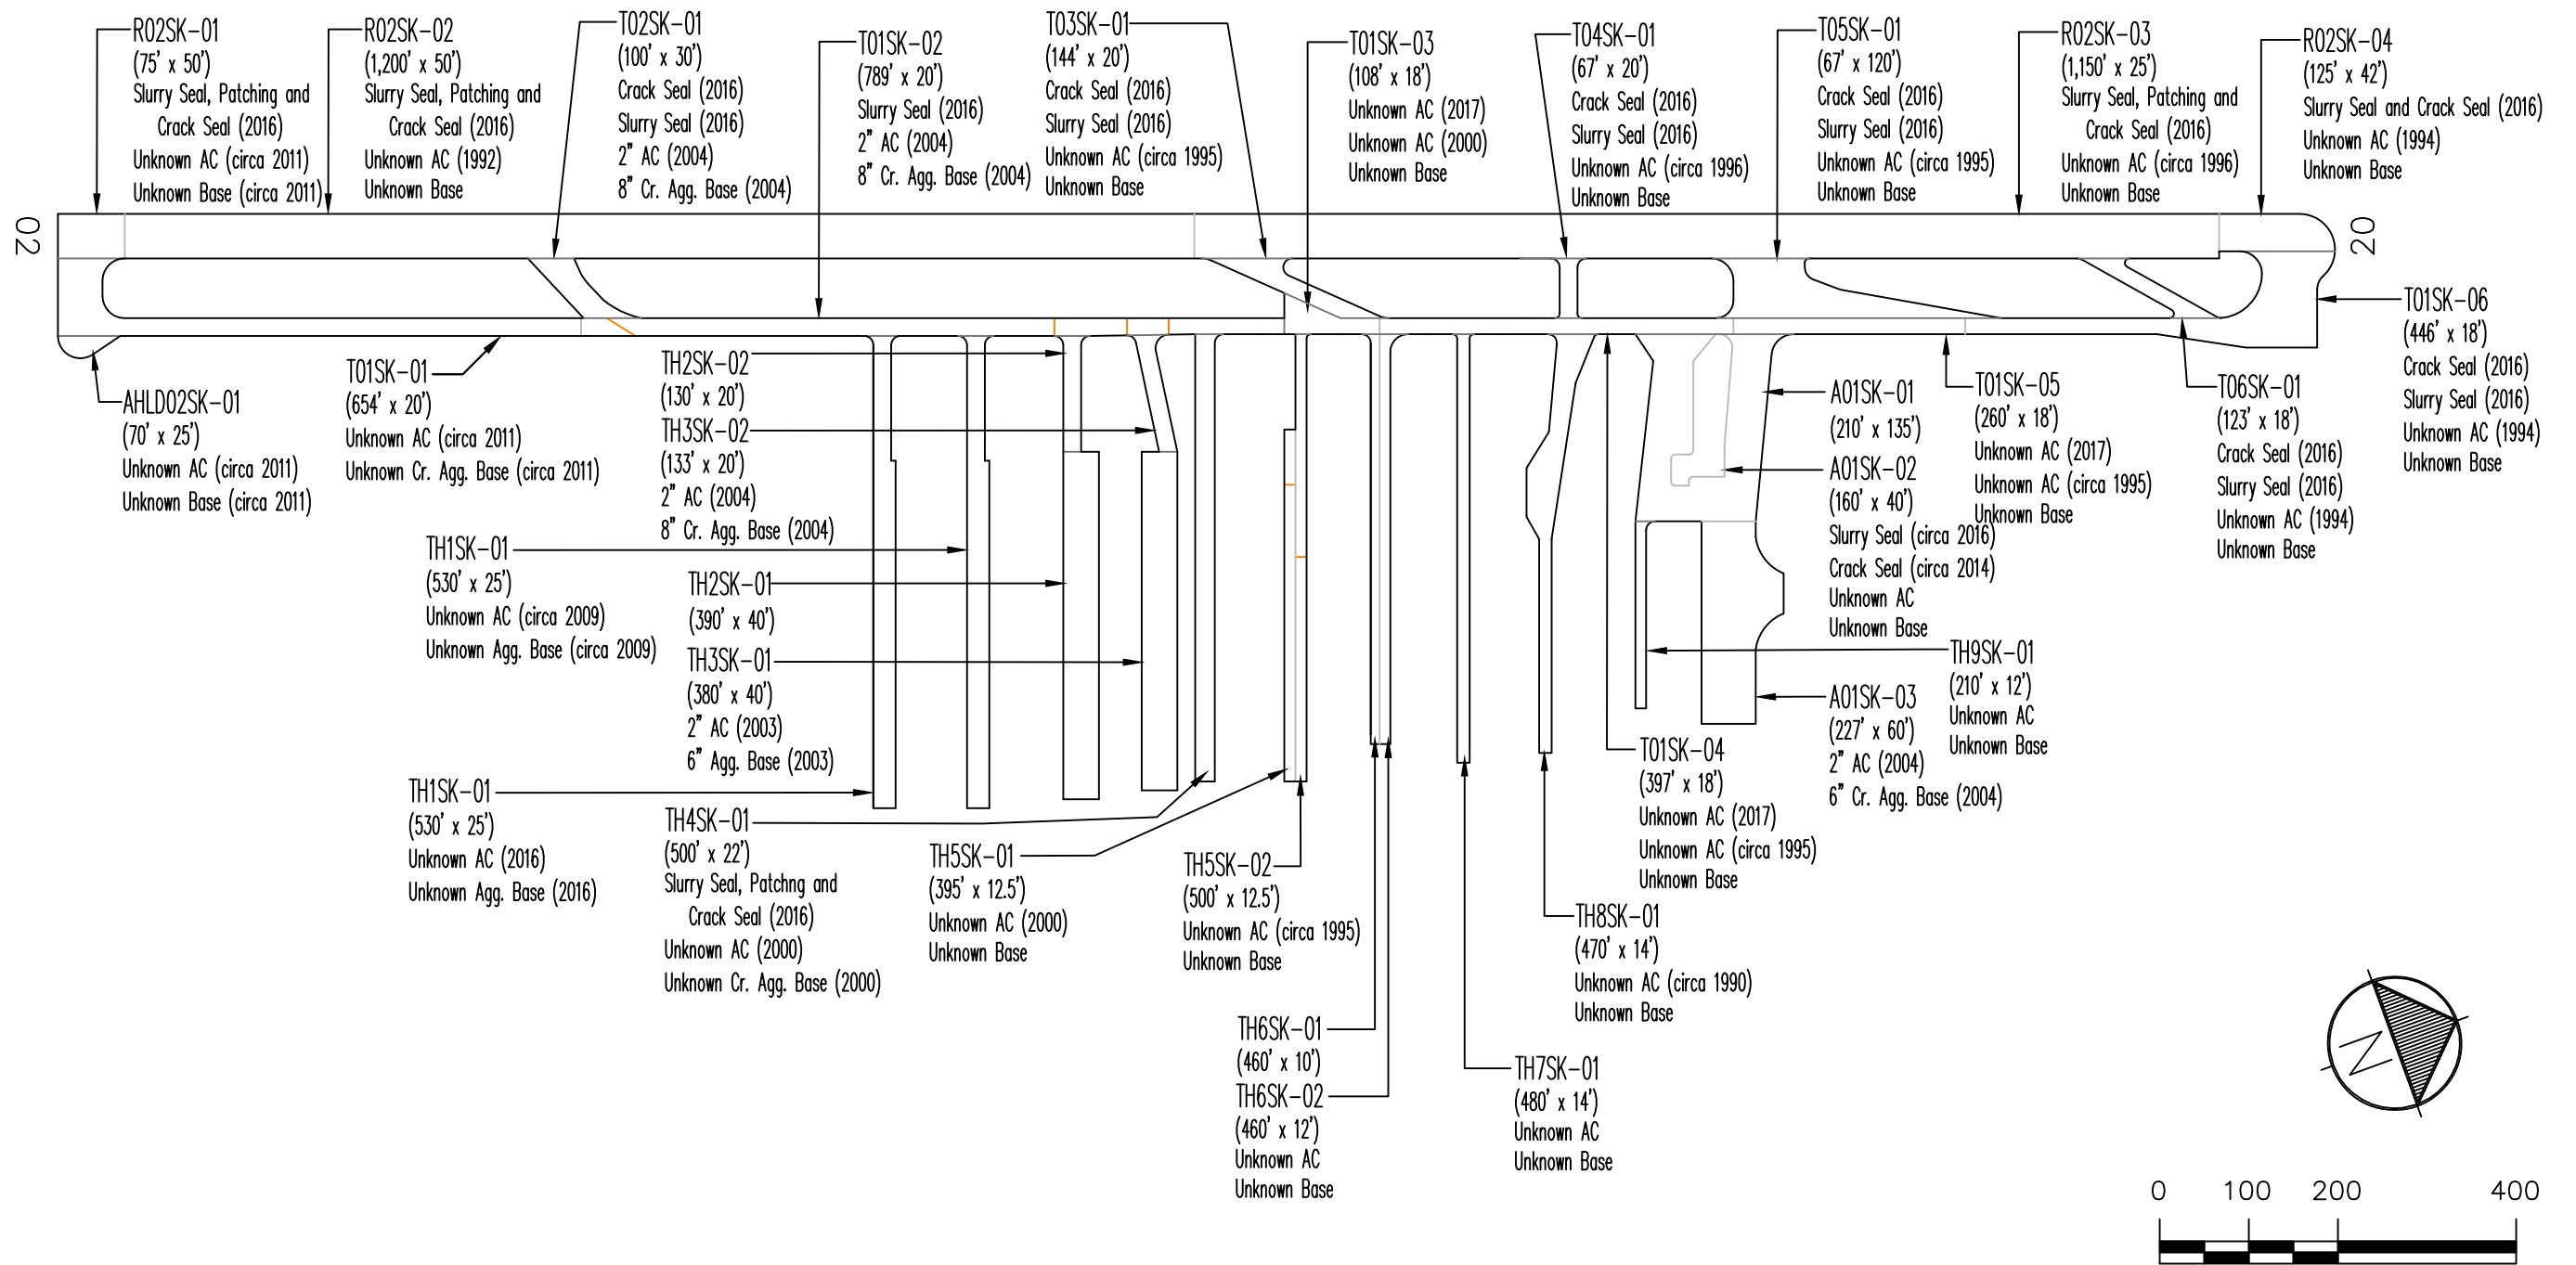
Figure SK-1. Airport Layout, Dimensions and Pavement Cross-Sections.
Stark's Twin Oaks Airpark

To determine how your pavements were constructed and their age, a records review was conducted. Figure SK-1 shows the records review results. This figure identifies pavement boundaries, dimensions, pavement layer types, thicknesses and dates of construction. The most recent construction date for each pavement can also be found in the Section Condition Report in Appendix 2. Figure SK-1 and the information contained in Appendices 1, 2 and 4 ensure that your airport complies with the “pavement inventory” requirement of FAA’s PMMP guidelines.

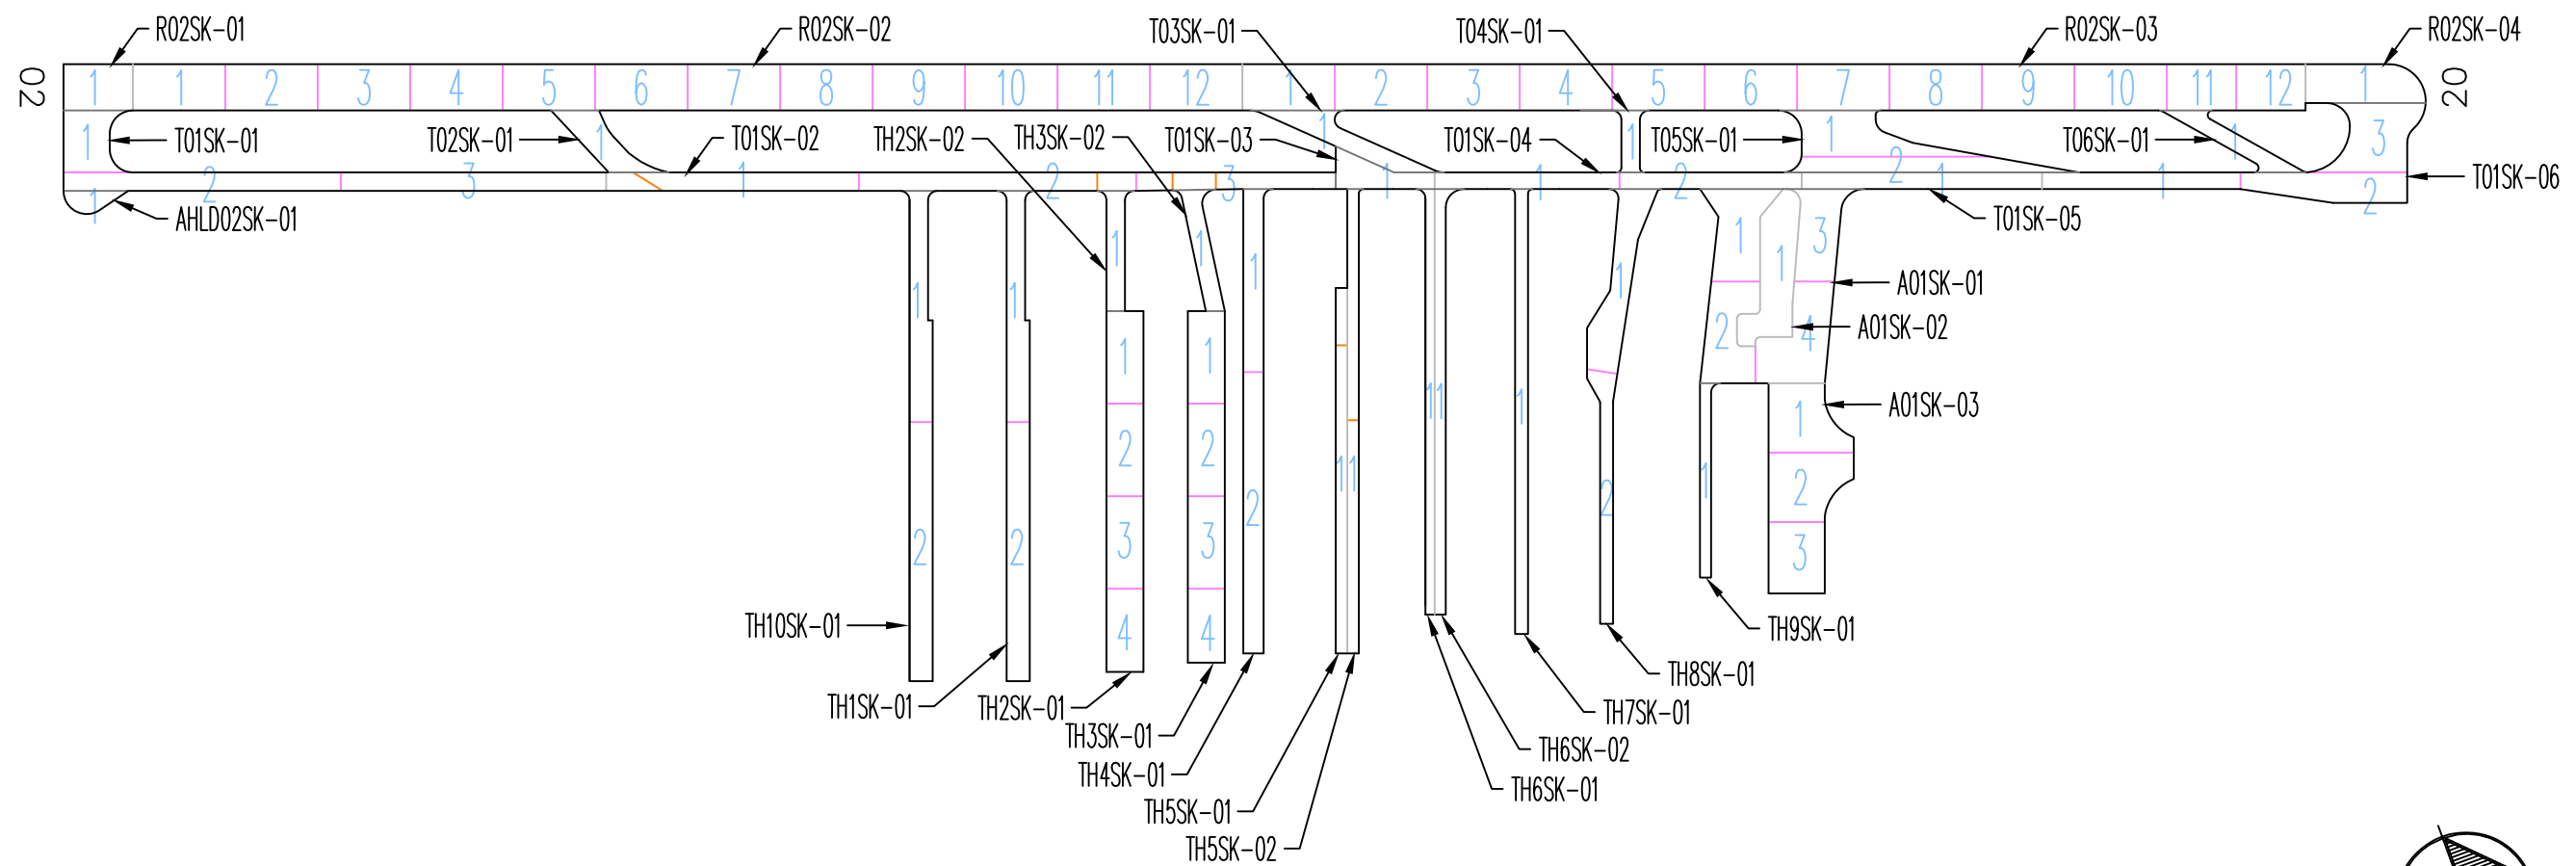
Figure SK-2. Pavement Branch, Section and Sample Unit Layout.
Stark's Twin Oaks Airpark

The pavements at your airport were divided into branches, sections and sample units in accordance with the methodology outlined in the current edition of ASTM D5430, *Standard Test Method for Airport Condition Index Surveys*. The branches, sections and sample units established at your airport are shown in Figure SK-2. A Branch Condition Report showing all branches, their associated areas, and their area-weighted average condition is provided in Appendix 1. Additionally, the Appendix 2 Section Condition Report provides information used to define each branch and section in the PAVER database.
