# PORTLAND TROUTDALE AIRPORT

This report describes how your Pavement Maintenance Management Program (PMMP) was developed. Your Program was developed as part of the Oregon Continuous Aviation System Plan sponsored in part by the Oregon Department of Aviation and the Federal Aviation Administration (FAA). The information and data contained in this report ensures you comply with the requirements of FAA Grant Assurance Number 11 which states that any airport requesting federal funds for pavement improvement projects must have implemented a pavement maintenance management program.

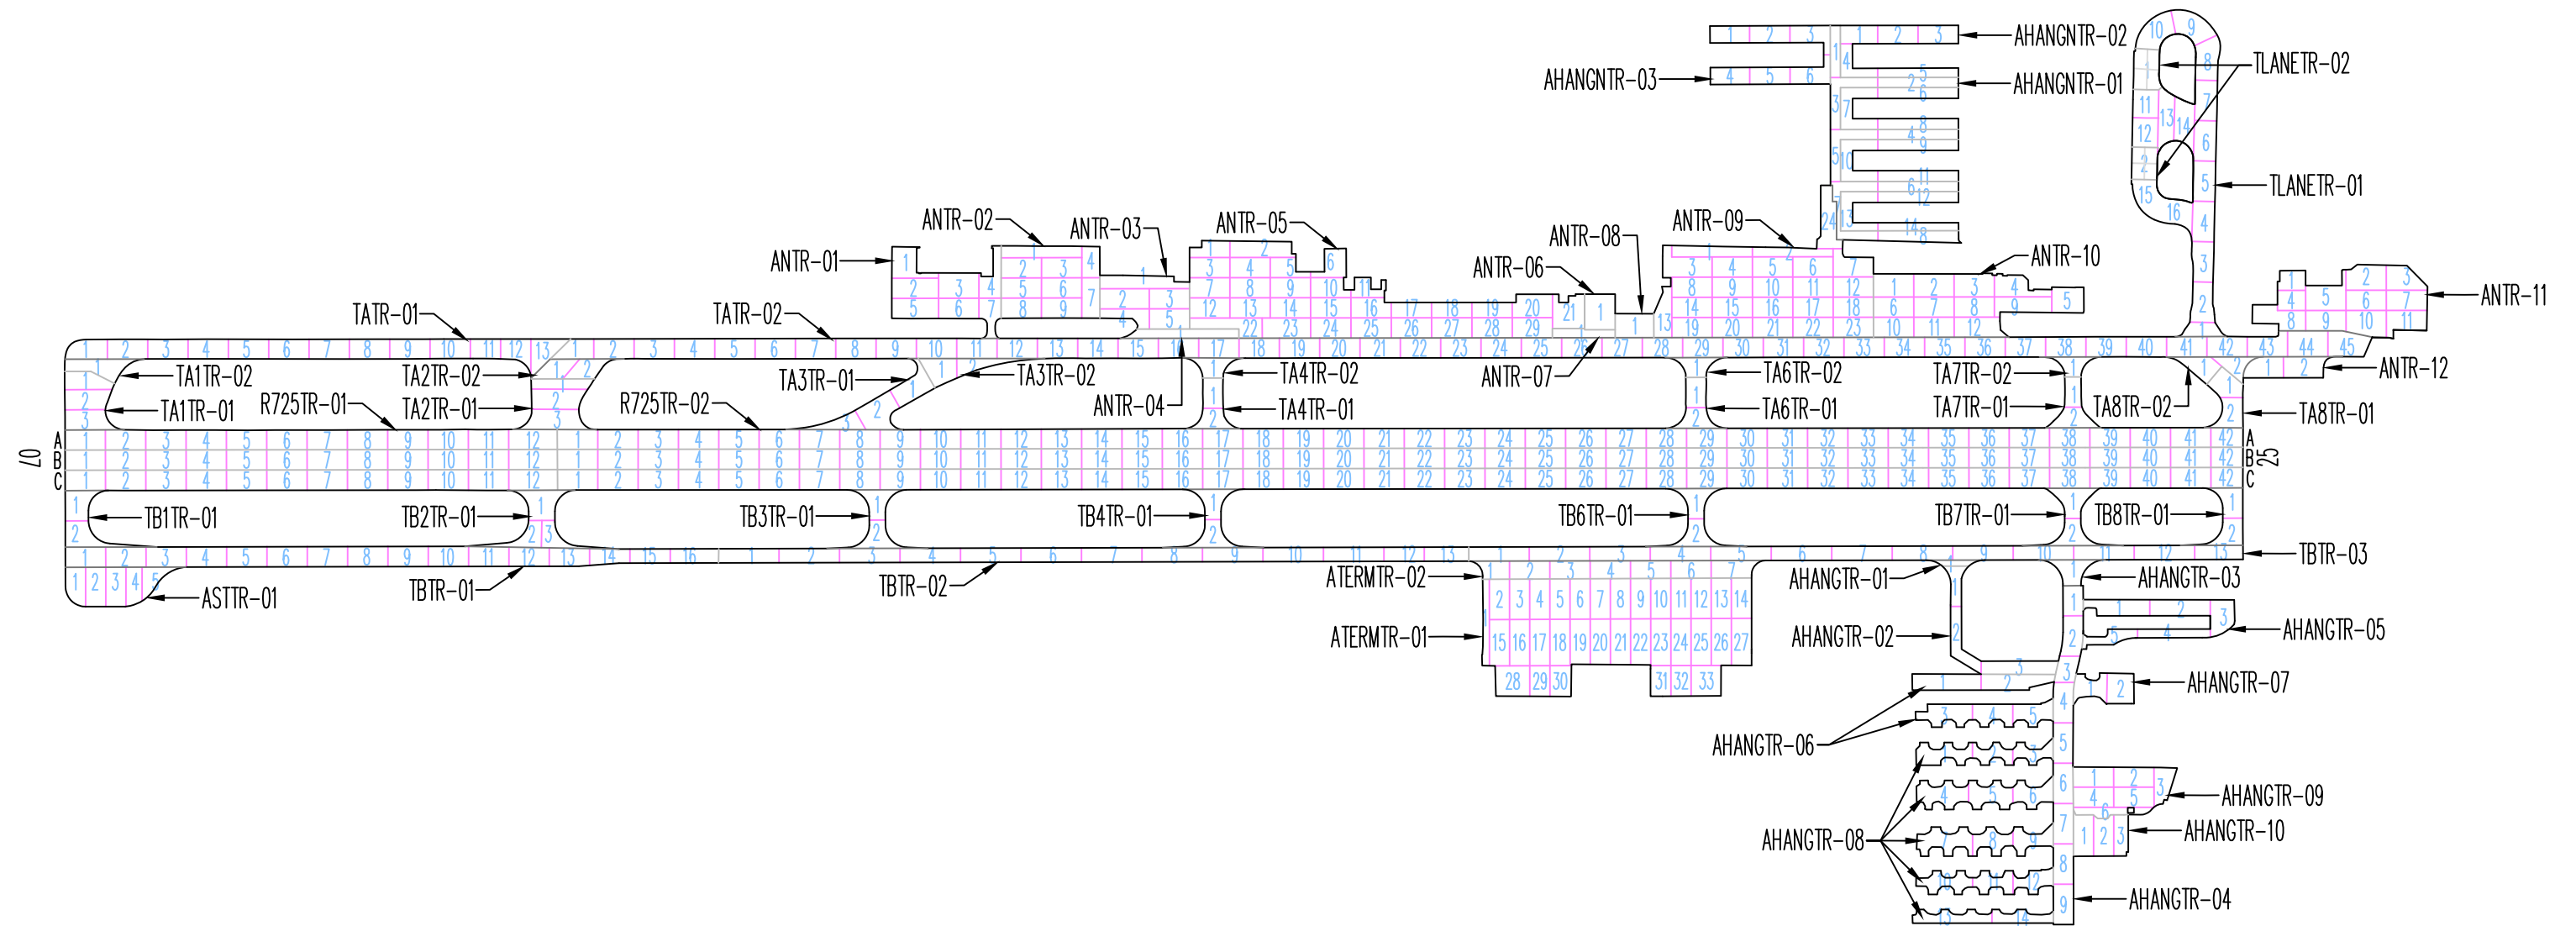
Figure TR-2. Pavement Branch, Section and Sample Unit Layout.  
Portland Troutdale Airport

The pavements at your airport were divided into branches, sections and sample units in accordance with the methodology outlined in the current edition of ASTM D5430, *Standard Test Method for Airport Condition Index Surveys*. The branches, sections and sample units established at your airport are shown in Figure TR-2. A Branch Condition Report showing all branches, their associated areas, and their area-weighted average condition is provided in Appendix 1. Additionally, the Appendix 2 Section Condition Report provides information used to define each branch and section in the PAVER database.
