VALLEY VIEW AIRPORT

Using the branch, section and sample unit divisions established, a visual condition survey was conducted at Valley View Airport in May 2018. During the inspection, pavement defects were identified and measured in accordance with the methodology outlined in ASTM D5430. This inspection ensures your airport complies with the “detailed inspection” requirement of FAA’s PMMP guidelines. After collection, the data were entered into the PAVER software for analysis. These data are reproduced in the Re-Inspection Report attached as Appendix 4.

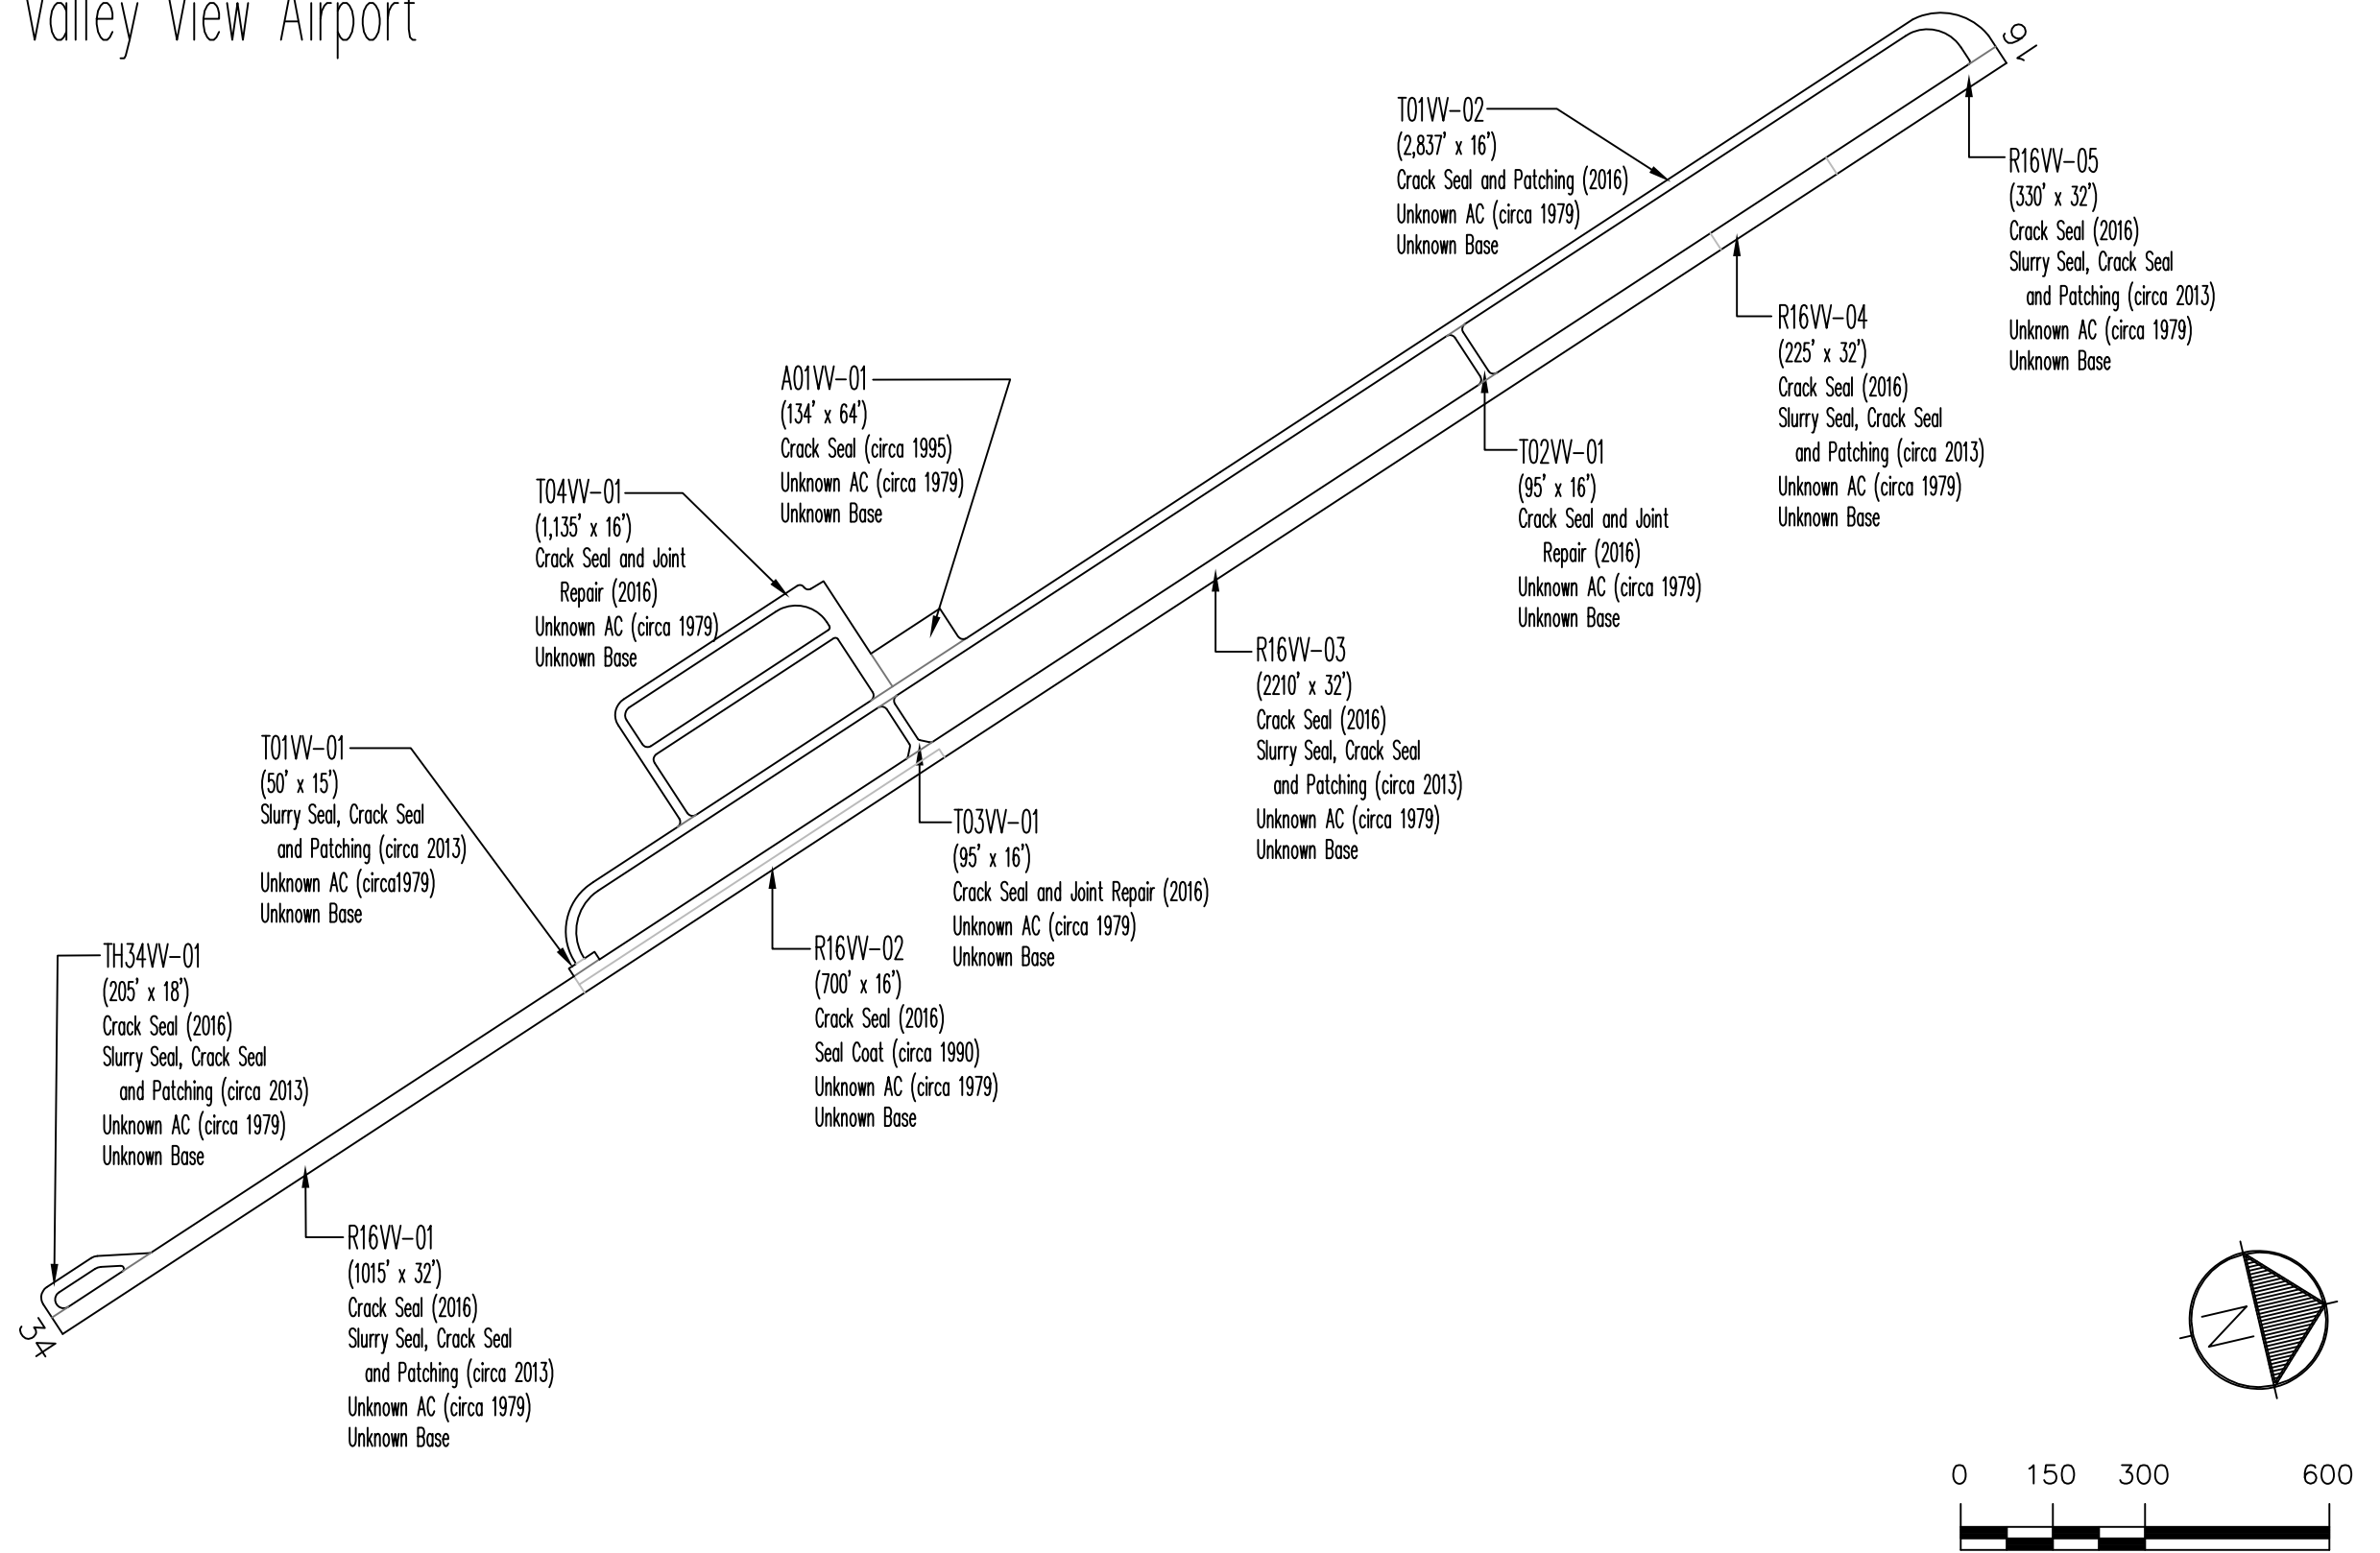
Figure W-1. Airport Layout, Dimensions and Pavement Cross-Sections.
Valley View Airport

To determine how your pavements were constructed and their age, a records review was conducted. Figure VV-1 shows the records review results. This figure identifies pavement boundaries, dimensions, pavement layer types, thicknesses and dates of construction. The most recent construction date for each pavement can also be found in the Section Condition Report in Appendix 2. Figure VV-1 and the information contained in Appendices 1, 2 and 4 ensure that your airport complies with the “pavement inventory” requirement of FAA’s PMMP guidelines.

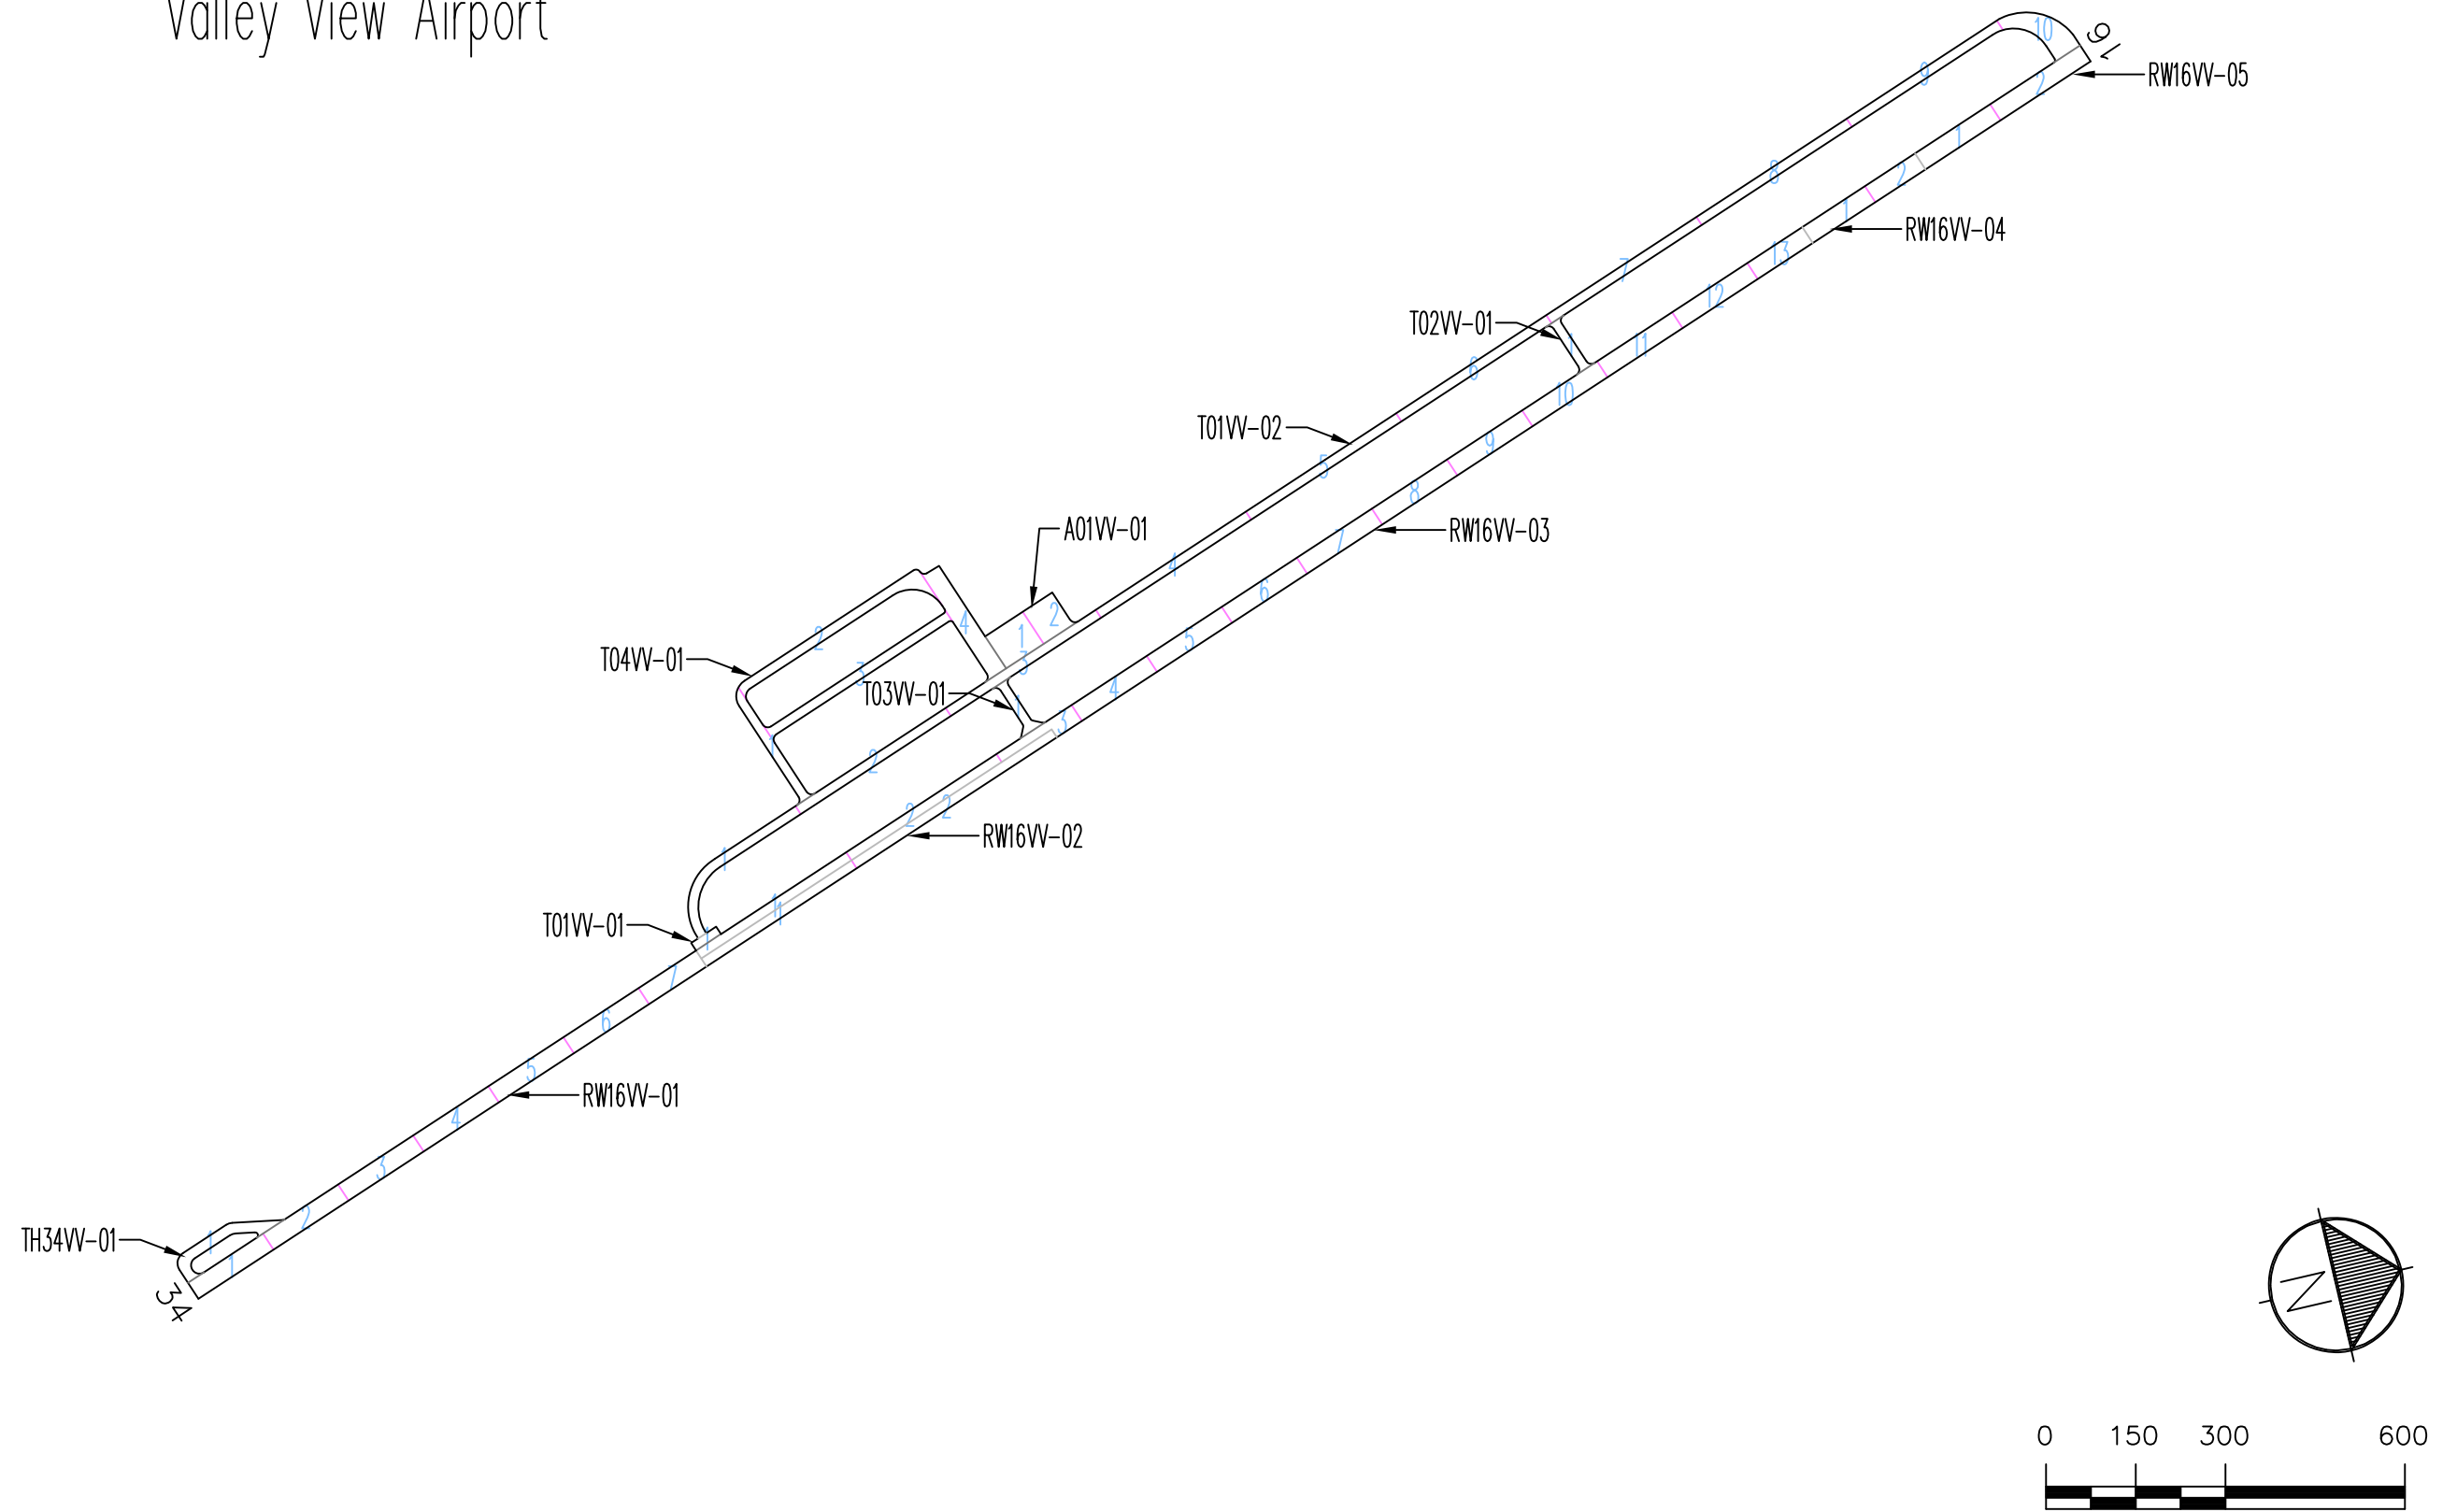
Figure VV-2. Pavement Branch, Section and Sample Unit Layout.
Valley View Airport

The pavements at your airport were divided into branches, sections and sample units in accordance with the methodology outlined in the current edition of ASTM D5430, *Standard Test Method for Airport Condition Index Surveys*. The branches, sections and sample units established at your airport are shown in Figure VV-2. A Branch Condition Report showing all branches, their associated areas, and their area-weighted average condition is provided in Appendix 1. Additionally, the Appendix 2 Section Condition Report provides information used to define each branch and section in the PAVER database.
