BROOKINGS AIRPORT

Using the branch, section and sample unit divisions established, a visual condition survey was conducted at Brookings Airport in May 2019. During the inspection, pavement defects were identified and measured in accordance with the methodology outlined in ASTM D5430. This inspection ensures your airport complies with the “detailed inspection” requirement of FAA’s PMMP guidelines. After collection, the data were entered into the PAVER software for analysis. These data are reproduced in the Re-Inspection Report attached as Appendix 4.

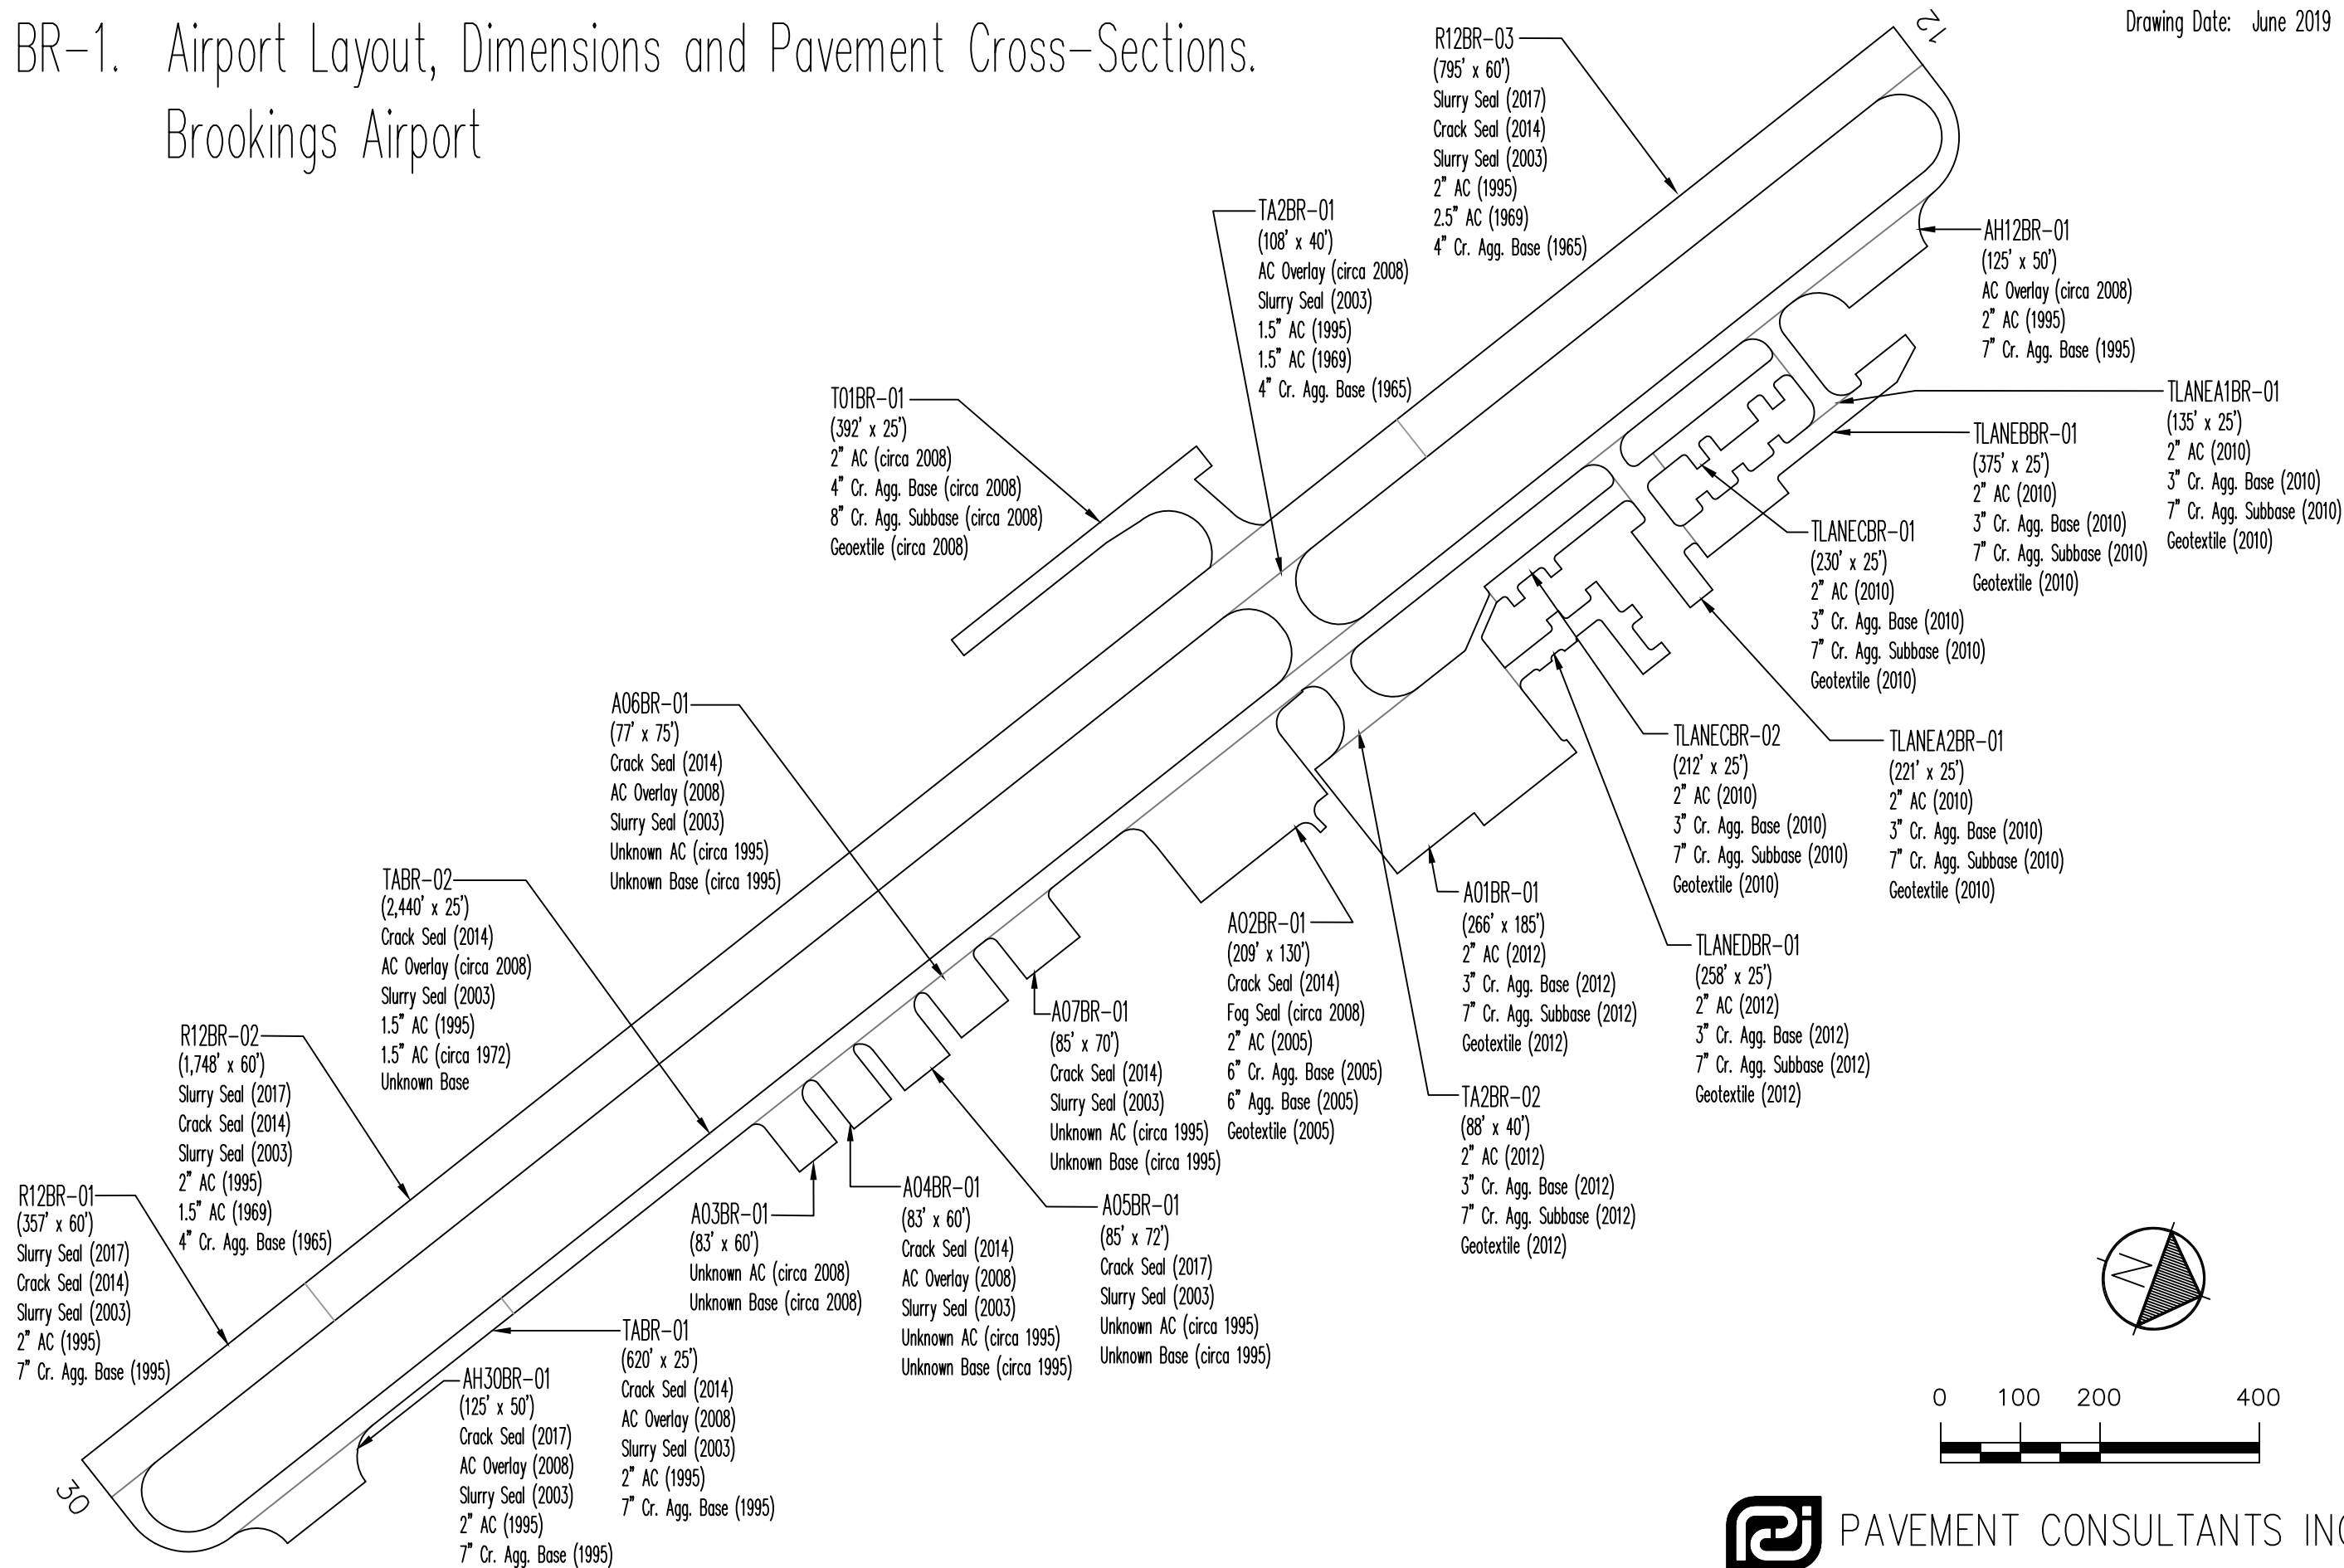
Figure BR-1. Airport Layout, Dimensions and Pavement Cross-Sections.
Brookings Airport

To determine how your pavements were constructed and their age, a records review was conducted. Figure BR-1 shows the records review results. This figure identifies pavement boundaries, dimensions, pavement layer types, thicknesses and dates of construction. The most recent construction date for each pavement can also be found in the Section Condition Report in Appendix 2. Figure BR-1 and the information contained in Appendices 1, 2 and 4 ensure that your airport complies with the “pavement inventory” requirement of FAA’s PMMP guidelines.

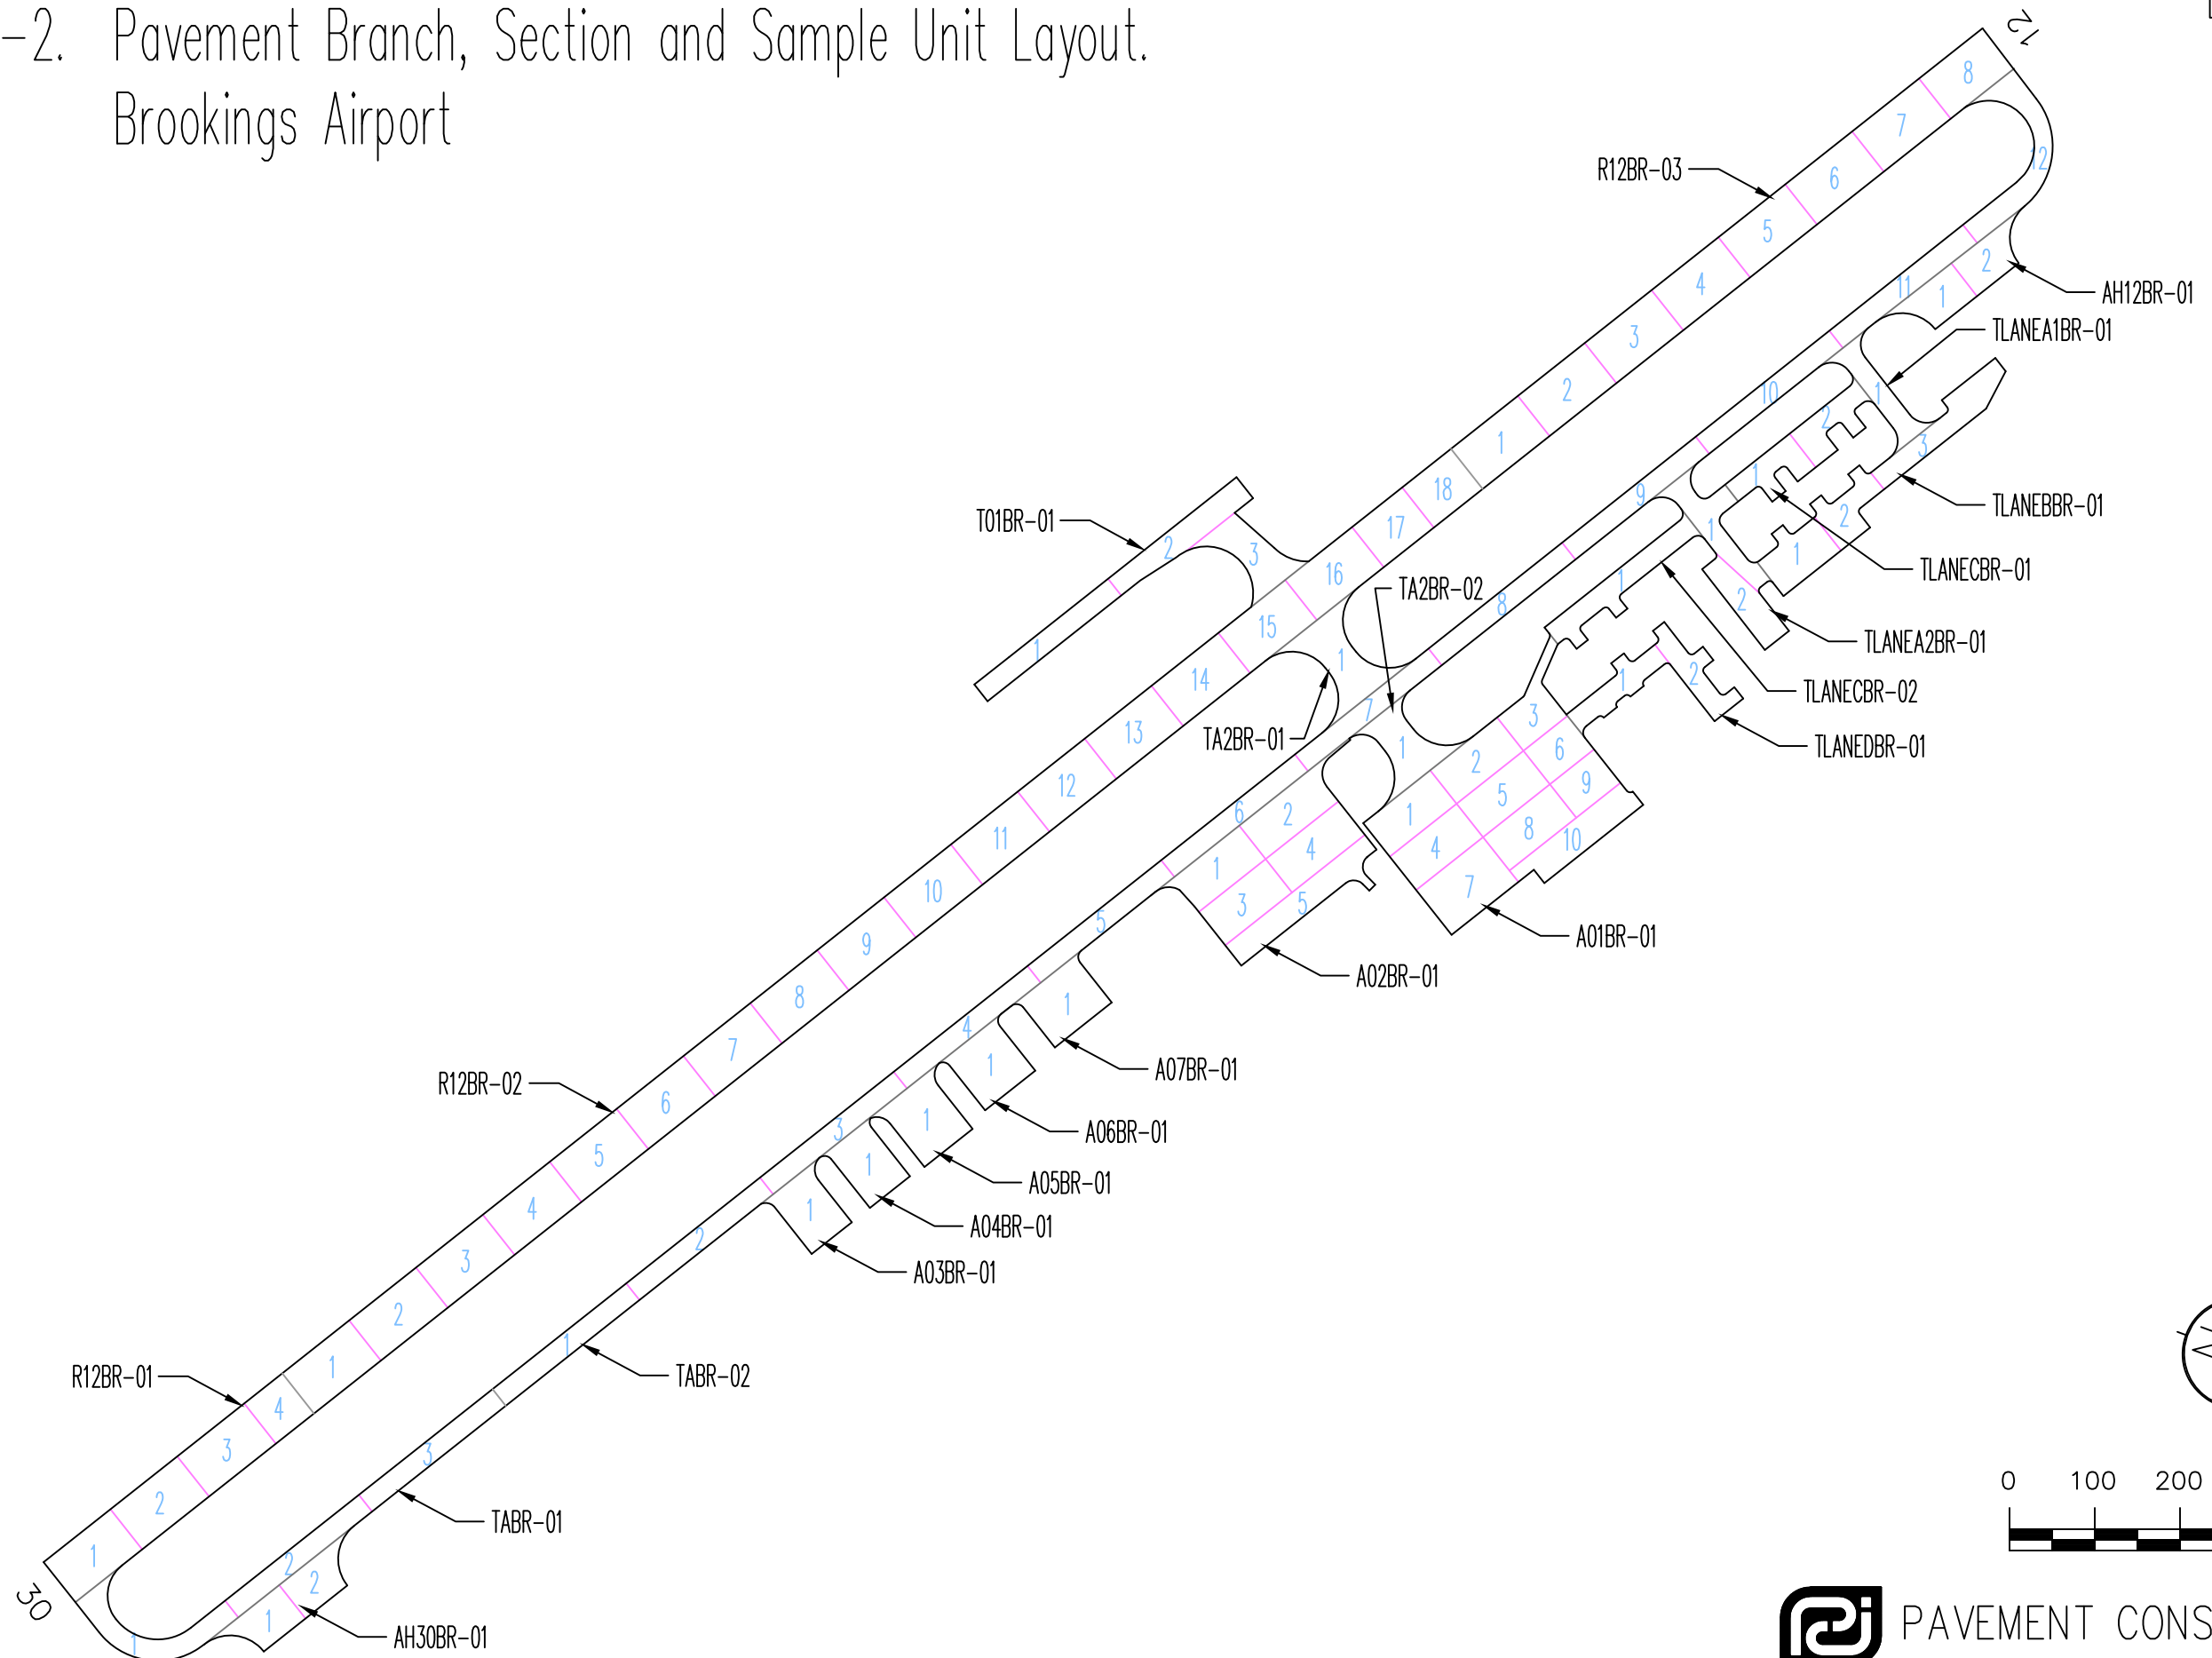
Figure BR-2. Pavement Branch, Section and Sample Unit Layout.
Brookings Airport

The pavements at your airport were divided into branches, sections and sample units in accordance with the methodology outlined in the current edition of ASTM D5430, *Standard Test Method for Airport Condition Index Surveys*. The branches, sections and sample units established at your airport are shown in Figure BR-2. A Branch Condition Report showing all branches, their associated areas, and their area-weighted average condition is provided in Appendix 1. Additionally, the Appendix 2 Section Condition Report provides information used to define each branch and section in the PAVER database.
