CHRISTMAS VALLEY AIRPORT

This report describes how your Pavement Maintenance Management Program (PMMP) was developed. Your Program was developed as part of the Oregon Continuous Aviation System Plan sponsored in part by the Oregon Department of Aviation and the Federal Aviation Administration (FAA). The information and data contained in this report ensures you comply with the requirements of FAA Grant Assurance Number 11 which states that any airport requesting federal funds for pavement improvement projects must have implemented a pavement maintenance management program.

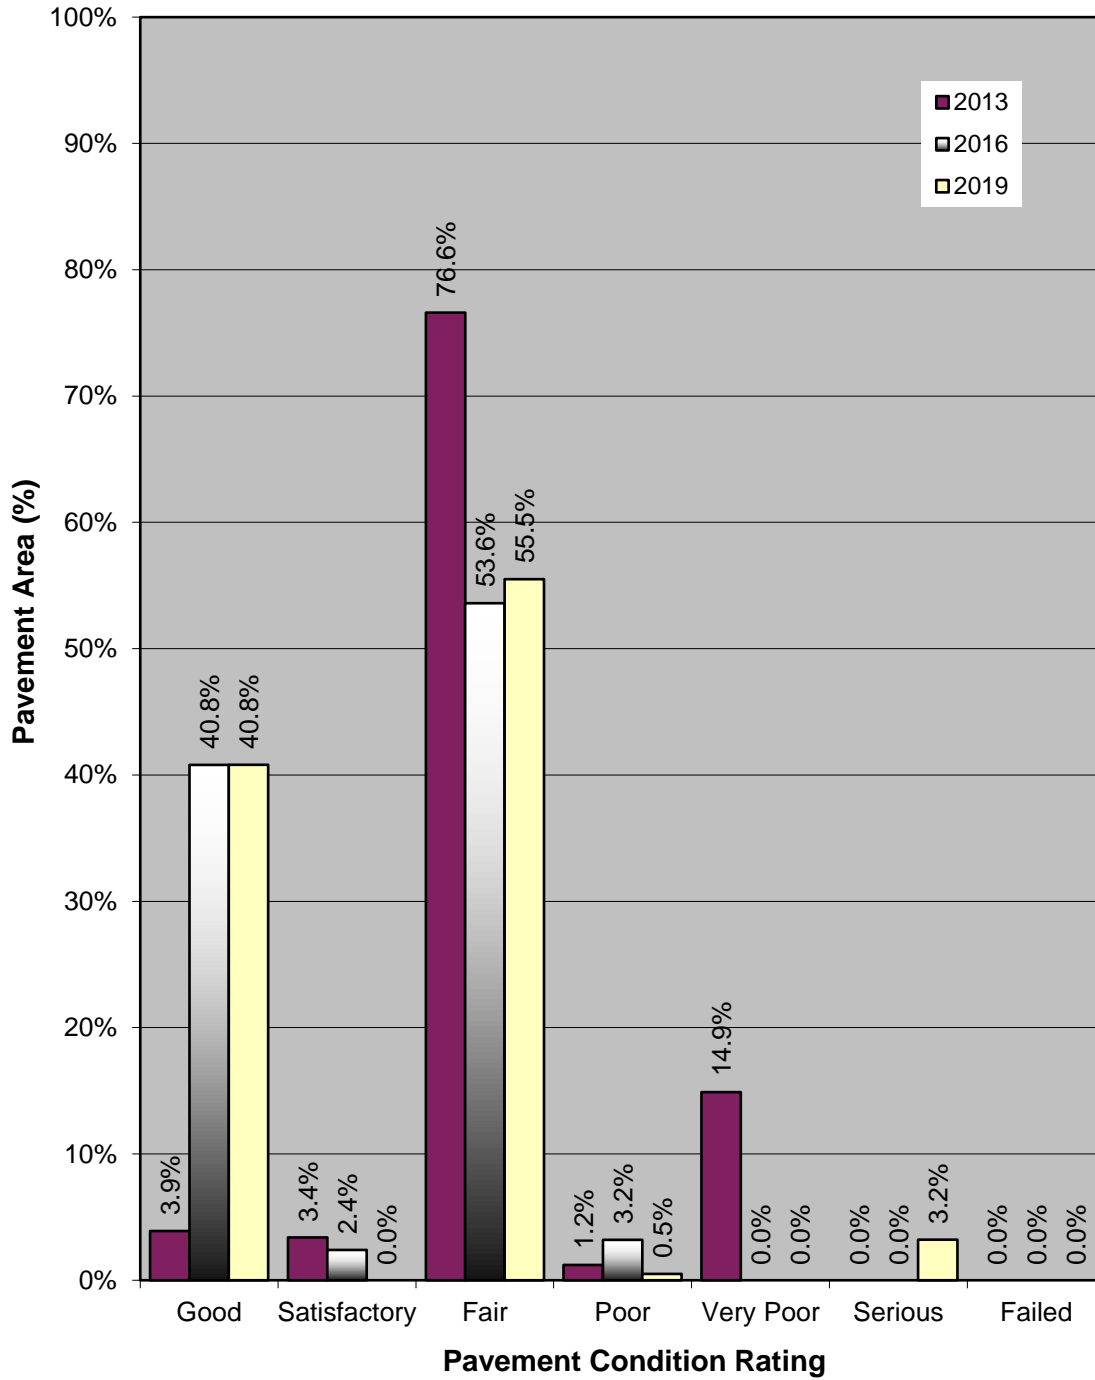
**Figure CV-4. Pavement Condition Distribution
Christmas Valley Airport**

Section PCIs at Christmas Valley Airport range from a low of 20 (a PCR of “Serious”) to a high of 98 (a PCR of “Good”). The area-weighted average PCI for all airport pavements is 74, corresponding to an overall PCR of “Satisfactory”. Figure CV-4 shows how much pavement area is associated with each Pavement Condition Rating category and also shows pavement condition distribution from the inspections conducted in 2013 and 2016.
