CRESWELL HOBBY FIELD

This report describes how your Pavement Maintenance Management Program (PMMP) was developed. Your Program was developed as part of the Oregon Continuous Aviation System Plan sponsored in part by the Oregon Department of Aviation and the Federal Aviation Administration (FAA). The information and data contained in this report ensures you comply with the requirements of FAA Grant Assurance Number 11 which states that any airport requesting federal funds for pavement improvement projects must have implemented a pavement maintenance management program.

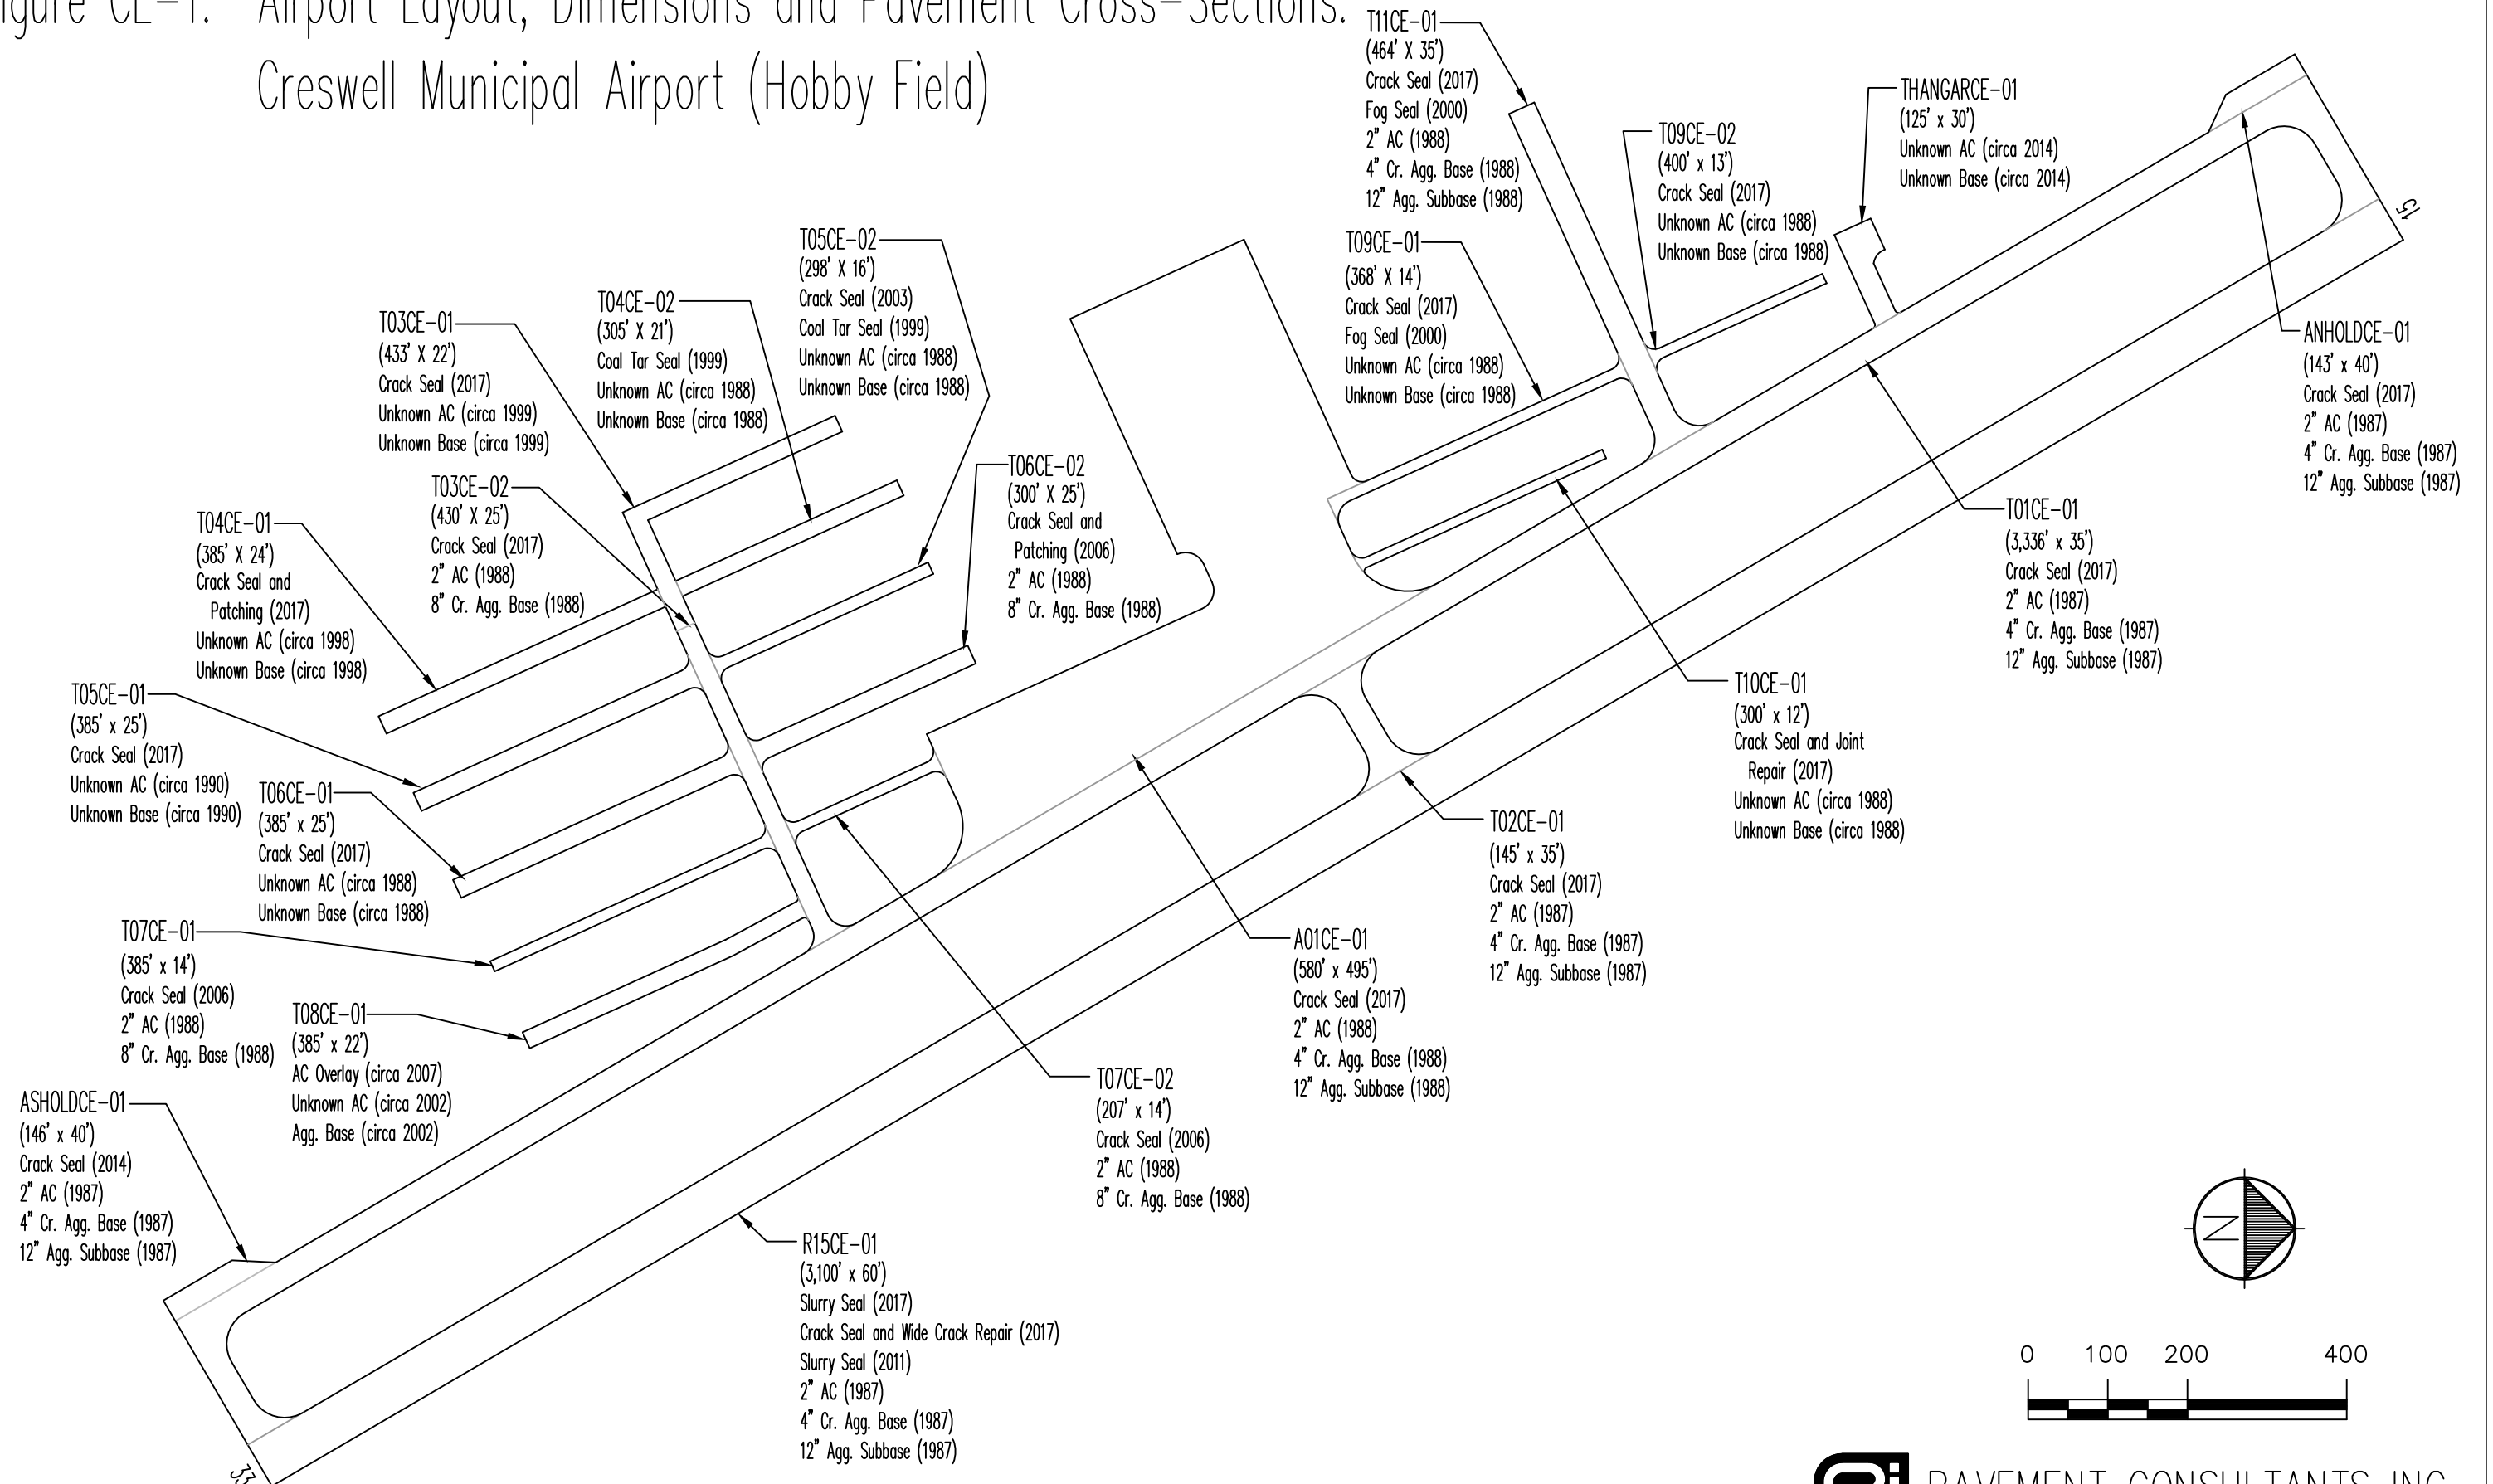
Figure CE-1. Airport Layout, Dimensions and Pavement Cross-Sections. Creswell Municipal Airport (Hobby Field)

To determine how your pavements were constructed and their age, a records review was conducted. Figure CE-1 shows the records review results. This figure identifies pavement boundaries, dimensions, pavement layer types, thicknesses and dates of construction. The most recent construction date for each pavement can also be found in the Section Condition Report in Appendix 2. Figure CE-1 and the information contained in Appendices 1, 2 and 4 ensure that your airport complies with the “pavement inventory” requirement of FAA’s PMMP guidelines.

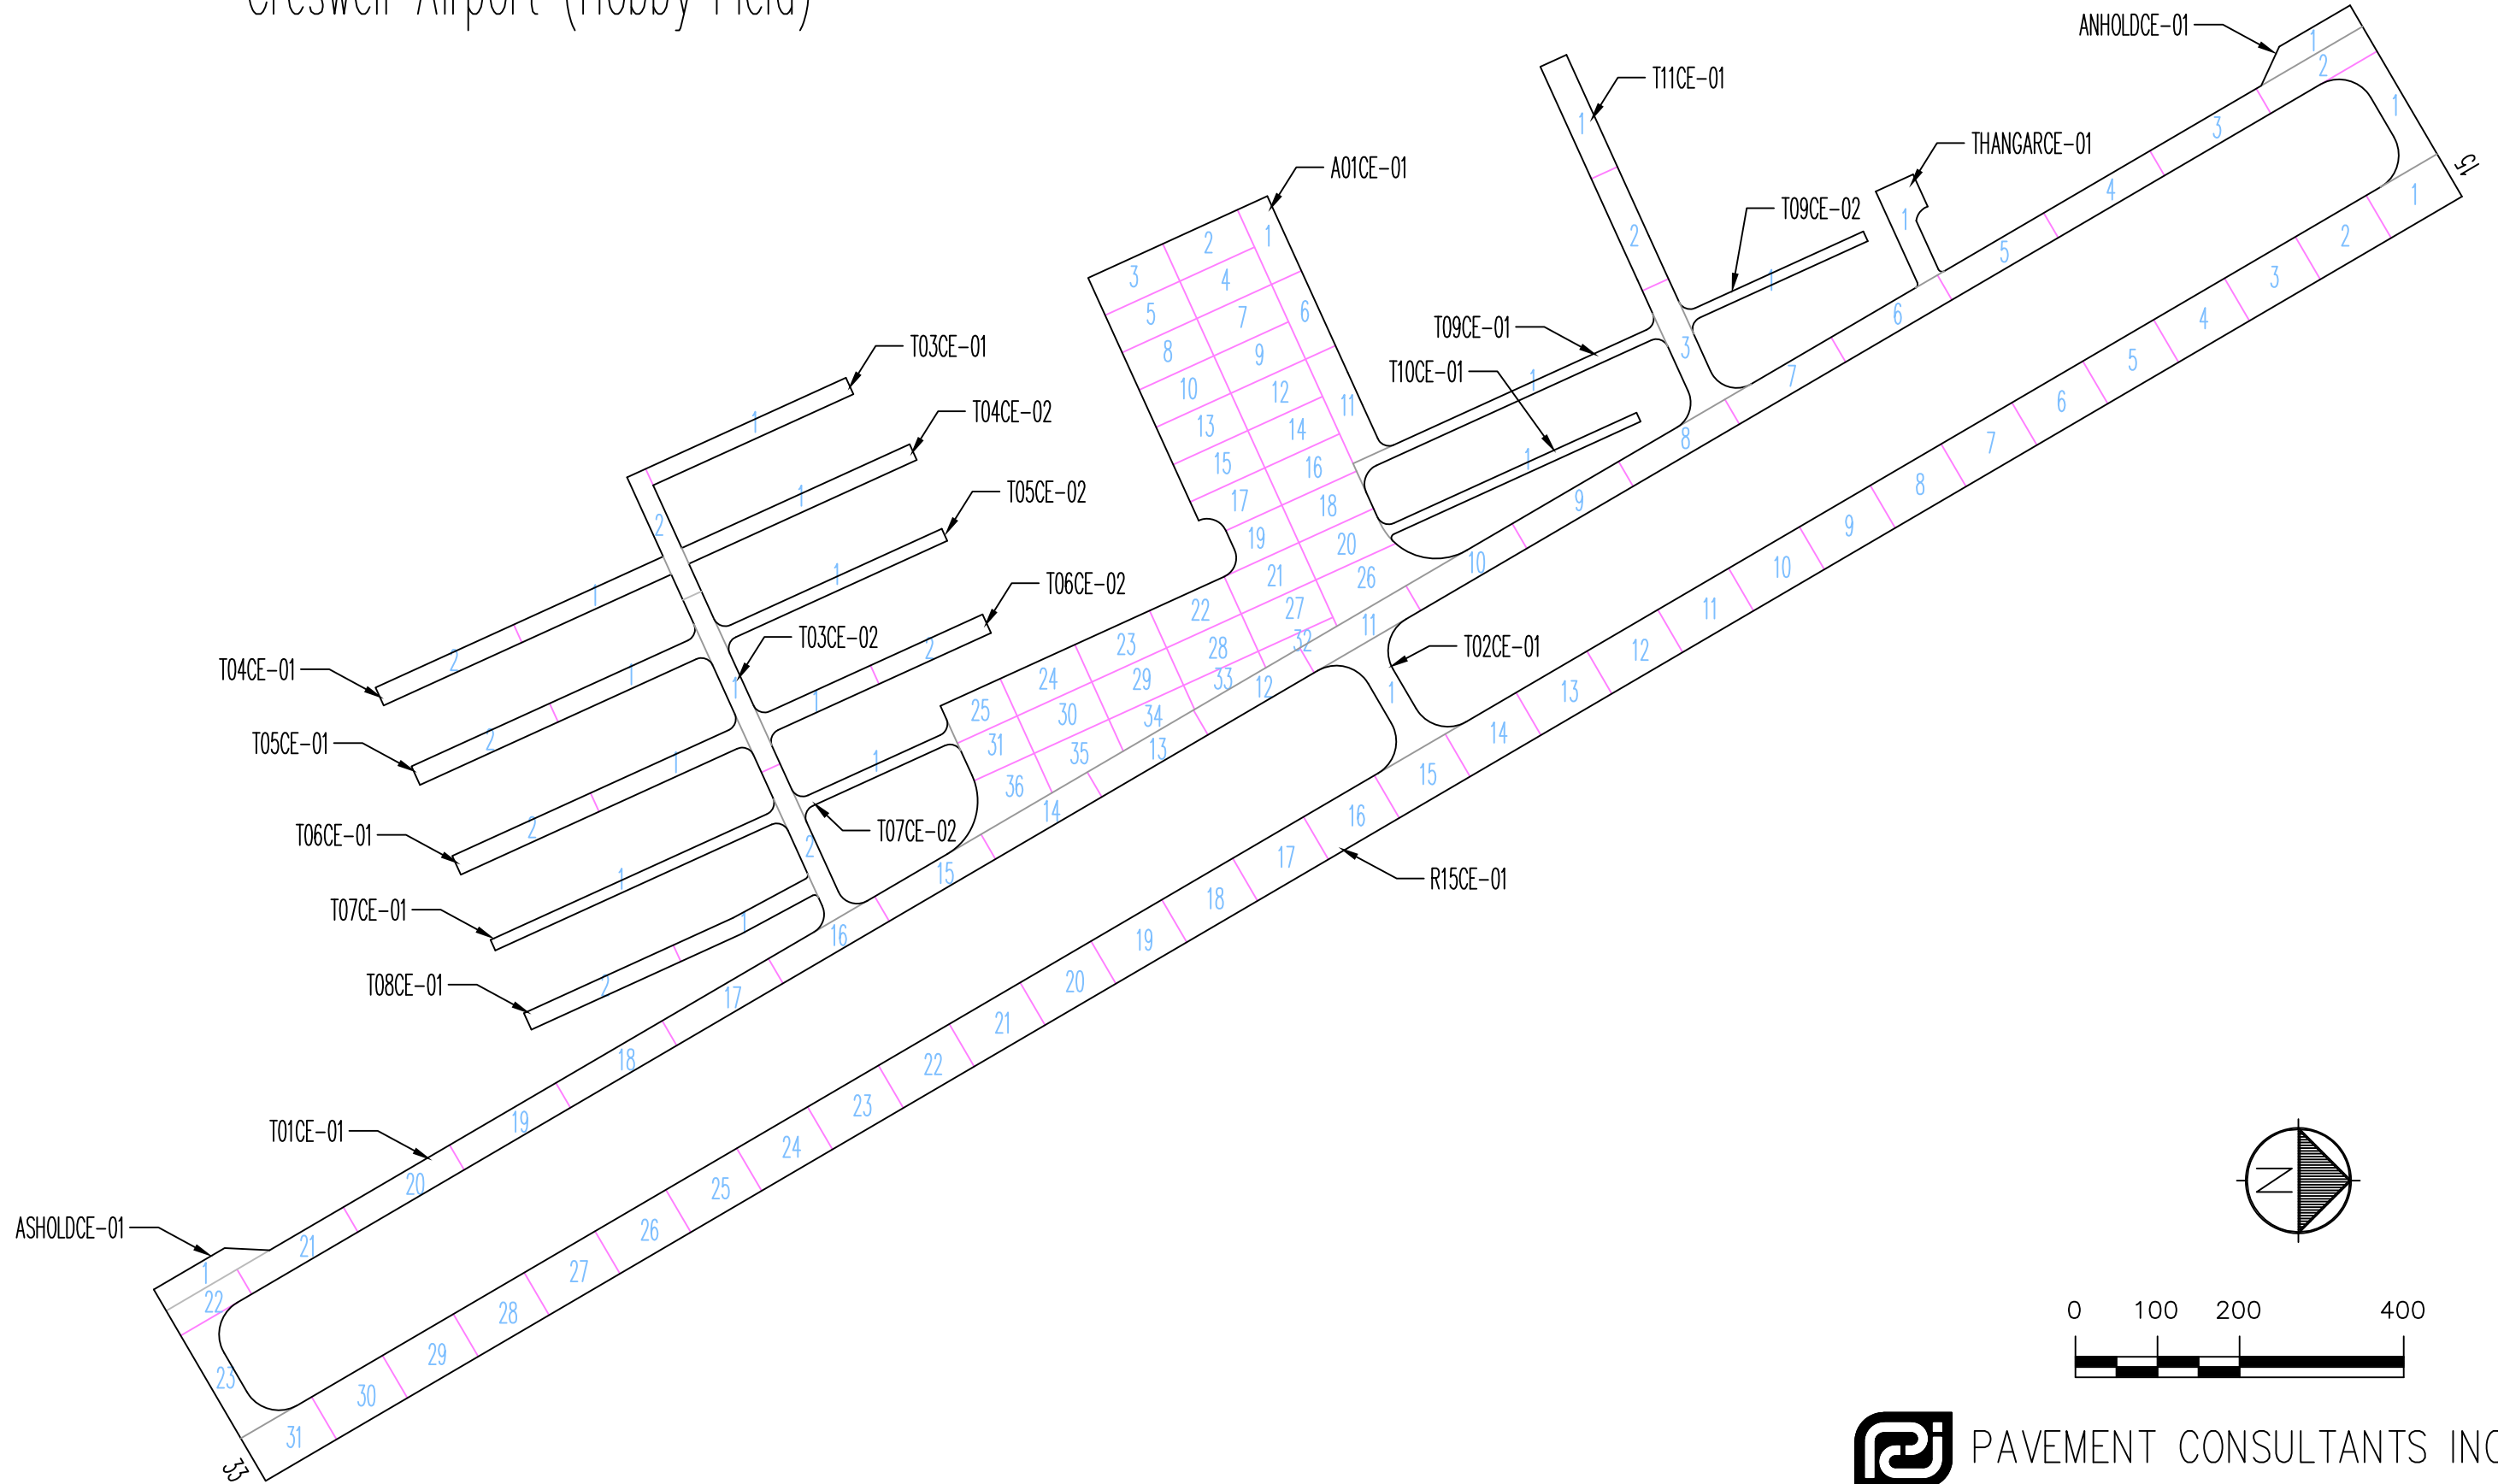
Figure CE-2. Pavement Branch, Section and Sample Unit Layout.
Creswell Airport (Hobby Field)

The pavements at your airport were divided into branches, sections and sample units in accordance with the methodology outlined in the current edition of ASTM D5430, *Standard Test Method for Airport Condition Index Surveys*. The branches, sections and sample units established at your airport are shown in Figure CE-2. A Branch Condition Report showing all branches, their associated areas, and their area-weighted average condition is provided in Appendix 1. Additionally, the Appendix 2 Section Condition Report provides information used to define each branch and section in the PAVER database.
