# FLORENCE MUNICIPAL AIRPORT

Figure FL-1. Airport Layout, Dimensions and Pavement Cross-Sections.  
 Florence Municipal Airport

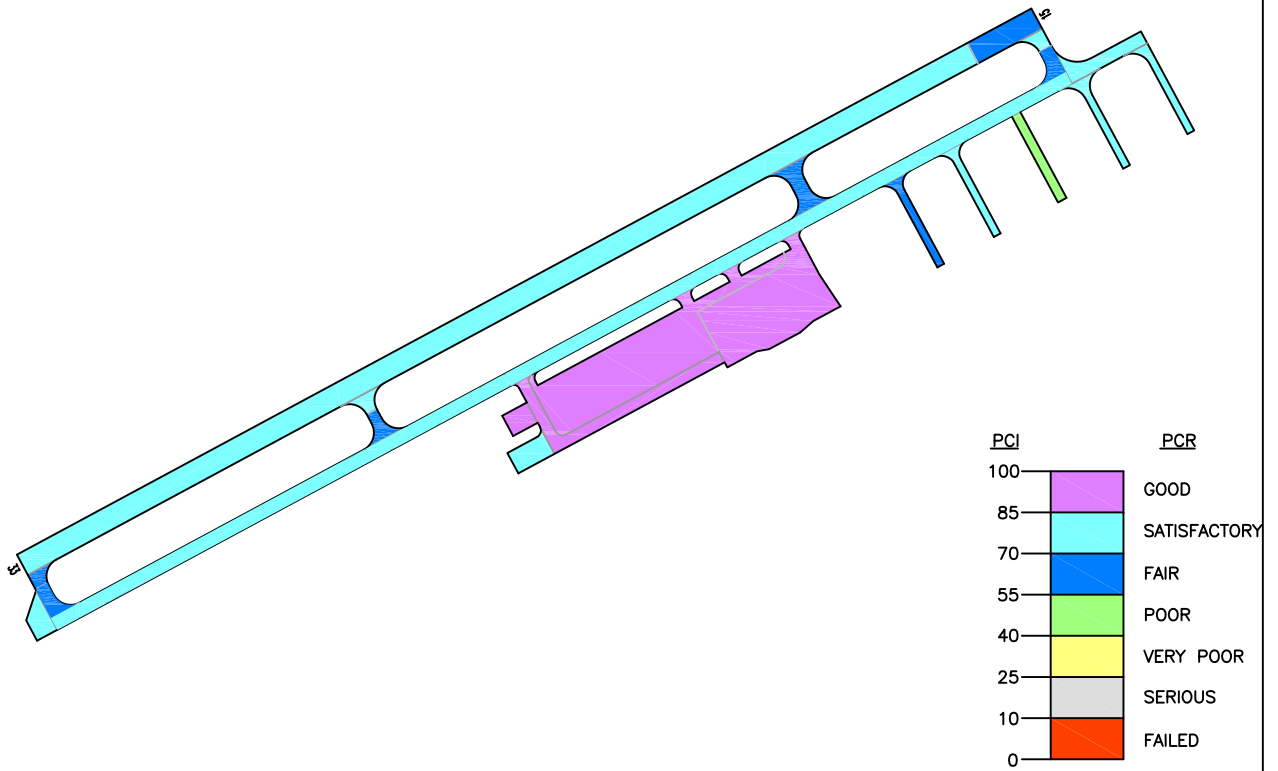
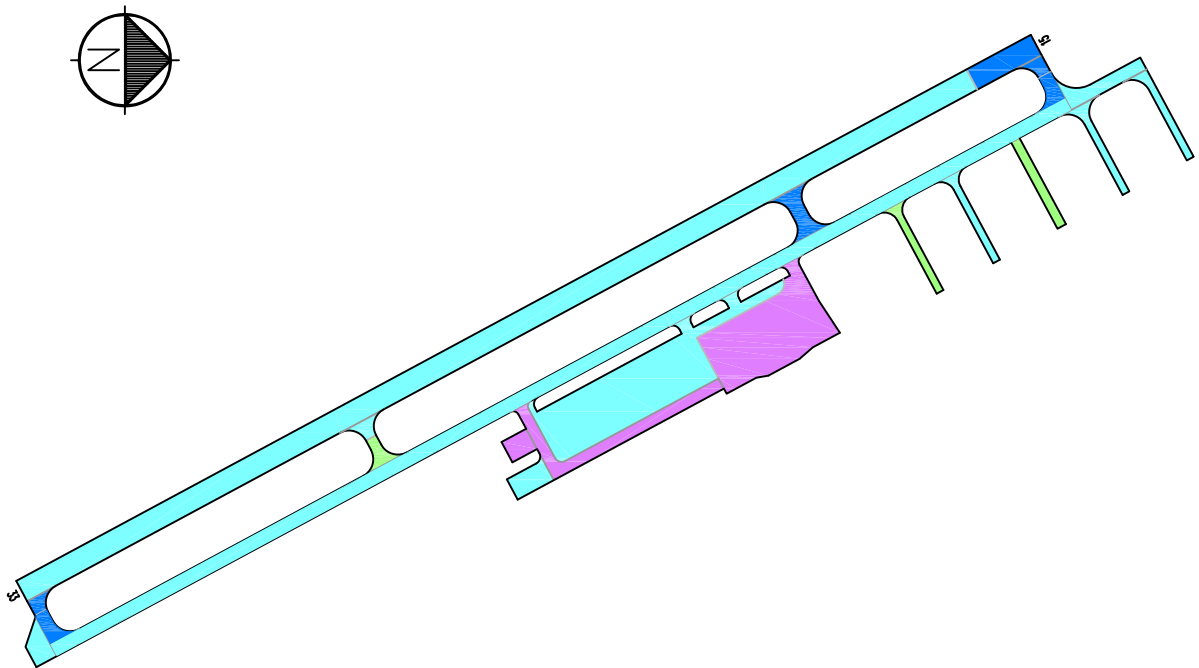
Figure FL-5. Future Pavement Condition.

A graphical representation of the projected PCIs listed in Table 1 is shown in Figure FL-5.
