PROSPECT STATE AIRPORT

This report describes how your Pavement Maintenance Management Program (PMMP) was developed. Your Program was developed as part of the Oregon Continuous Aviation System Plan sponsored in part by the Oregon Department of Aviation and the Federal Aviation Administration (FAA). The information and data contained in this report ensures you comply with the requirements of FAA Grant Assurance Number 11 which states that any airport requesting federal funds for pavement improvement projects must have implemented a pavement maintenance management program.

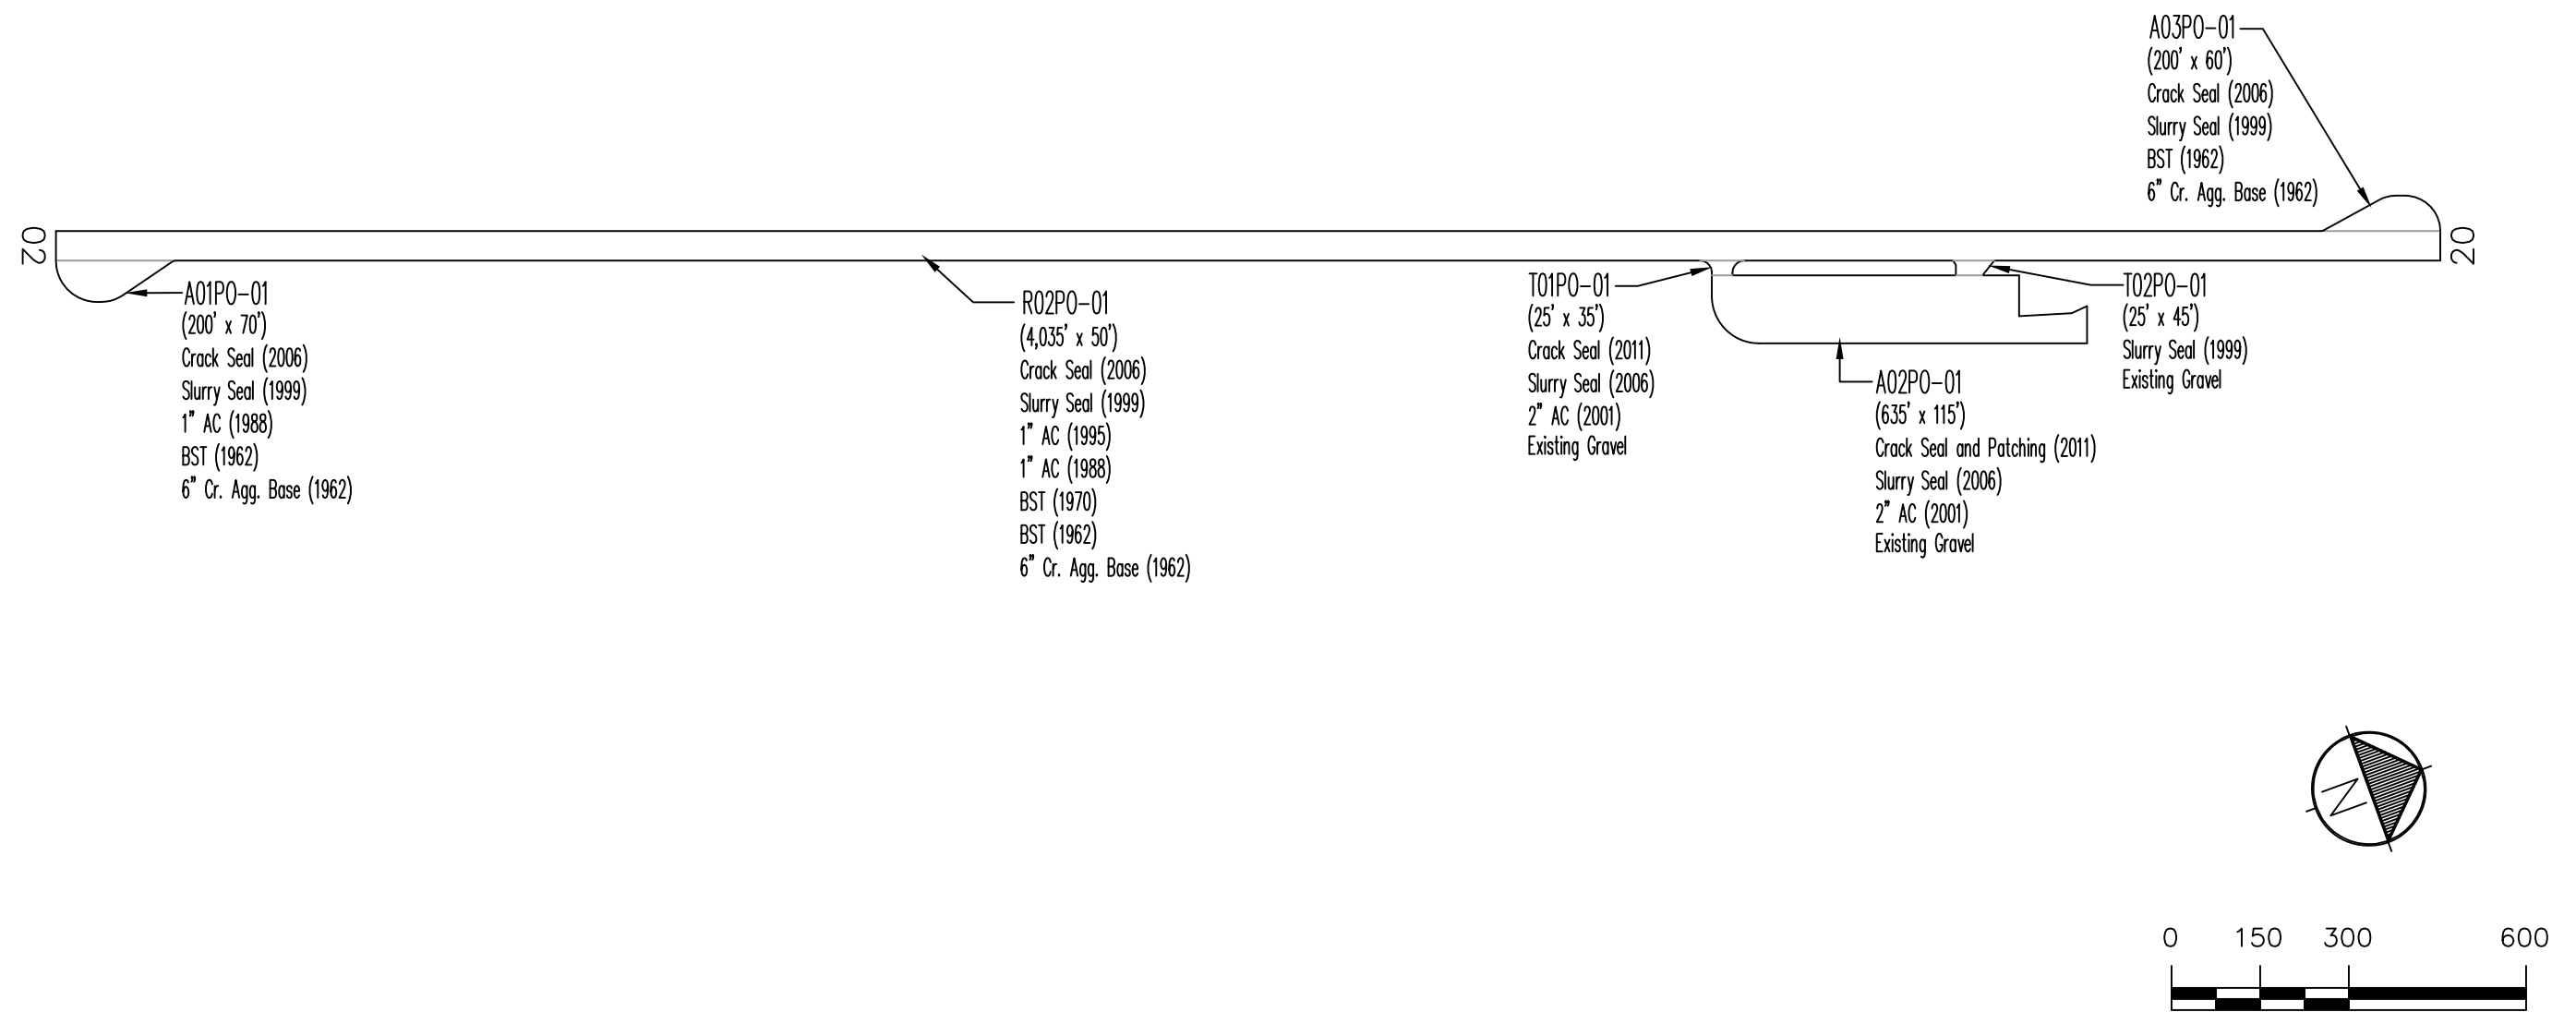
Figure PO-1. Airport Layout, Dimensions and Pavement Cross-Sections.
Prospect State Airport

To determine how your pavements were constructed and their age, a records review was conducted. Figure PO-1 shows the records review results. This figure identifies pavement boundaries, dimensions, pavement layer types, thicknesses and dates of construction. The most recent construction date for each pavement can also be found in the Section Condition Report in Appendix 2. Figure PO-1 and the information contained in Appendices 1, 2 and 4 ensure that your airport complies with the “pavement inventory” requirement of FAA’s PMMP guidelines.

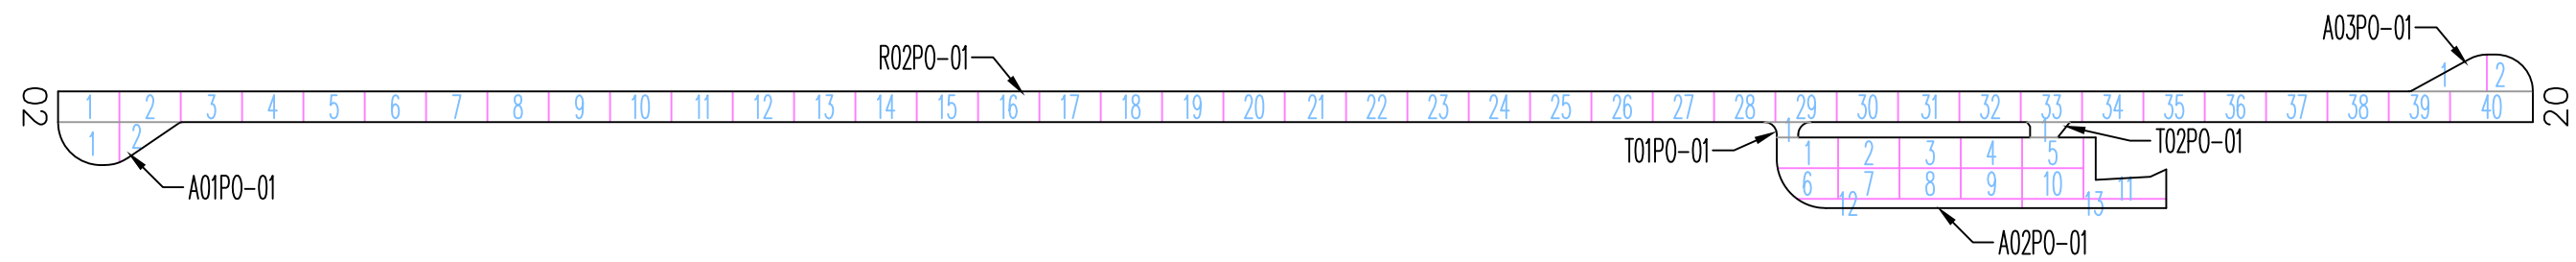
Figure PO-2. Pavement Branch, Section and Sample Unit Layout.
Prospect State Airport

The pavements at your airport were divided into branches, sections and sample units in accordance with the methodology outlined in the current edition of ASTM D5430, *Standard Test Method for Airport Condition Index Surveys*. The branches, sections and sample units established at your airport are shown in Figure PO-2. A Branch Condition Report showing all branches, their associated areas, and their area-weighted average condition is provided in Appendix 1. Additionally, the Appendix 2 Section Condition Report provides information used to define each branch and section in the PAVER database.
