# ATTACHMENT A LPCS AIR CASTING EMISSIONS MEMO

To:	Kenzie Billings	Date:	December 14, 2021
From:	Brian Eagle	Project No.:	8006.58.01
RE:	PCC Structurals LPC Steel Air Casting Emissi	ons

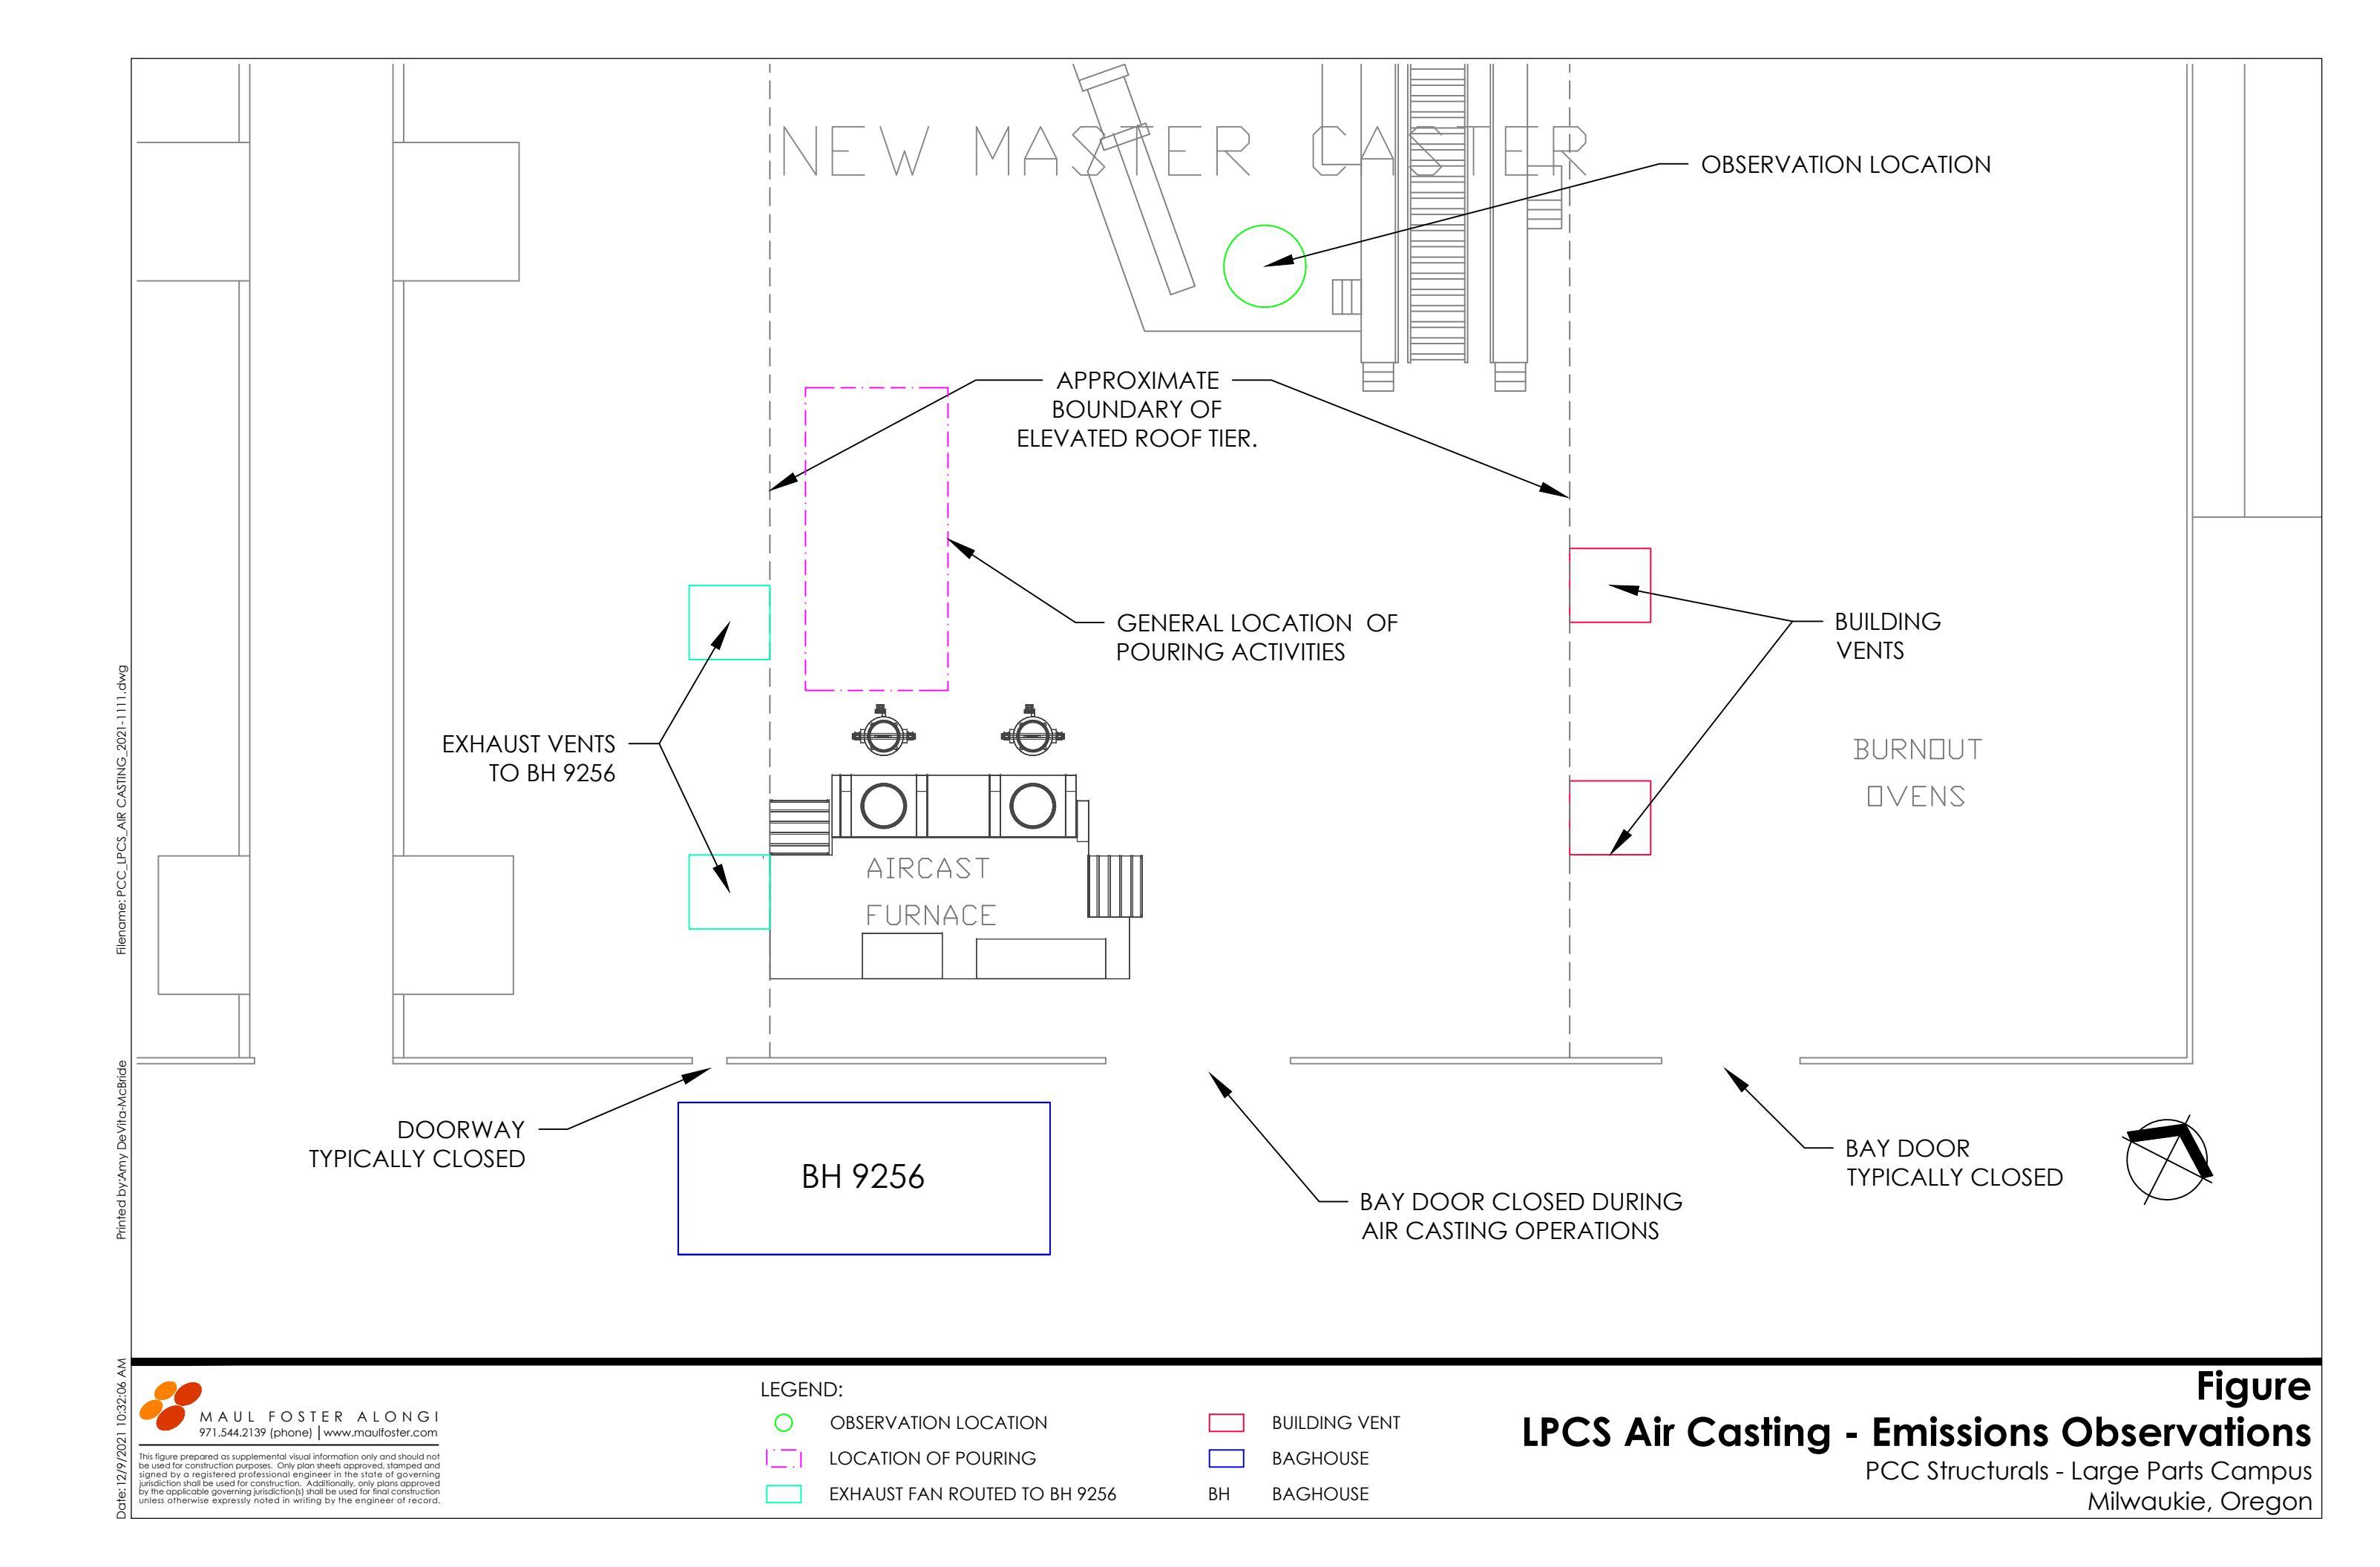
Visible emissions generated by the air casting activities rose rapidly to roof level, due to the thermal buoyancy of the emissions. Once at roof level, the visible emissions dispersed in the upper portion of the building but remained concentrated on the western side of building near the vents to the baghouse. In contrast, the eastern side of the building remained visibly clear of smoke. The observed behavior of the visible emissions was expected given the size of the baghouse, which is rated at 80,000 cubic feet per minute. Images 1 and 2 in the photograph log, which were captured only seconds apart, show the visible emissions generated from casting activities and the concentration of the emissions in the western portion of the building.

Image 1: Smoke rising, southwestern-facing view.
