STATE DEPARTMENT OF GEOLOGY AND MINERAL INDUSTRIES

CATLOW VALLEY CREVICE

N. S. Wagner*

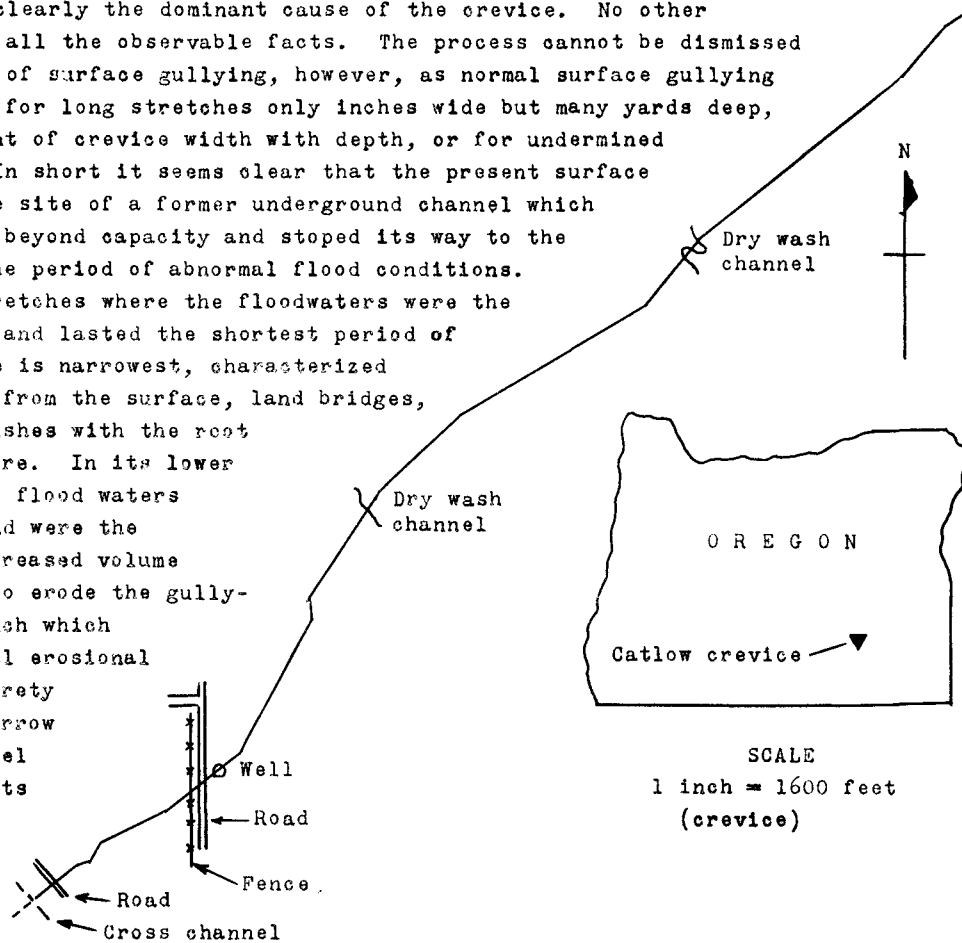
Sketch Map of Catlow Valley Crevice

The crevice is located about a mile southeast of the Miller ranch and extends for a paced distance of somewhat in excess of 2 miles along a general northeast course. These relationships are indicated on the accompanying sketch. The area traversed represents valley bottom land which is essentially flat. This is made up of clays and silts with occasional interbedded lenses of sands and fine gravels. No information is available concerning the thickness of these sediments but the valley as a whole is underlain by basaltic lavas of Tertiary age.

along the line indicated on the accompanying sketch as a cross-fracture. Many of these holes were no larger than gopher holes, but at one which couldn't be approached nearer than 50 feet without wading, the water entered in such amounts, and with such velocity, that it could be distinctly heard from a considerable distance.
