Monroe RFPD

Building Type		County	
Fire - RFPD		Benton	
Street			
26764 Bellfountain Rd			
City	State	Zip	
Monroe	OR	97456	
Latitude		Longitude	
44.36502		123.35584	
Tracking Code		Inspection Date	
RVS in 2006		6/27/2006

FEMA 154 Rapid Visual Screening Score Card

Rapid Visual Screening - Senate Bill #2 - Seismic Needs Assessment
Oregon Department of Geology and Mineral Industries

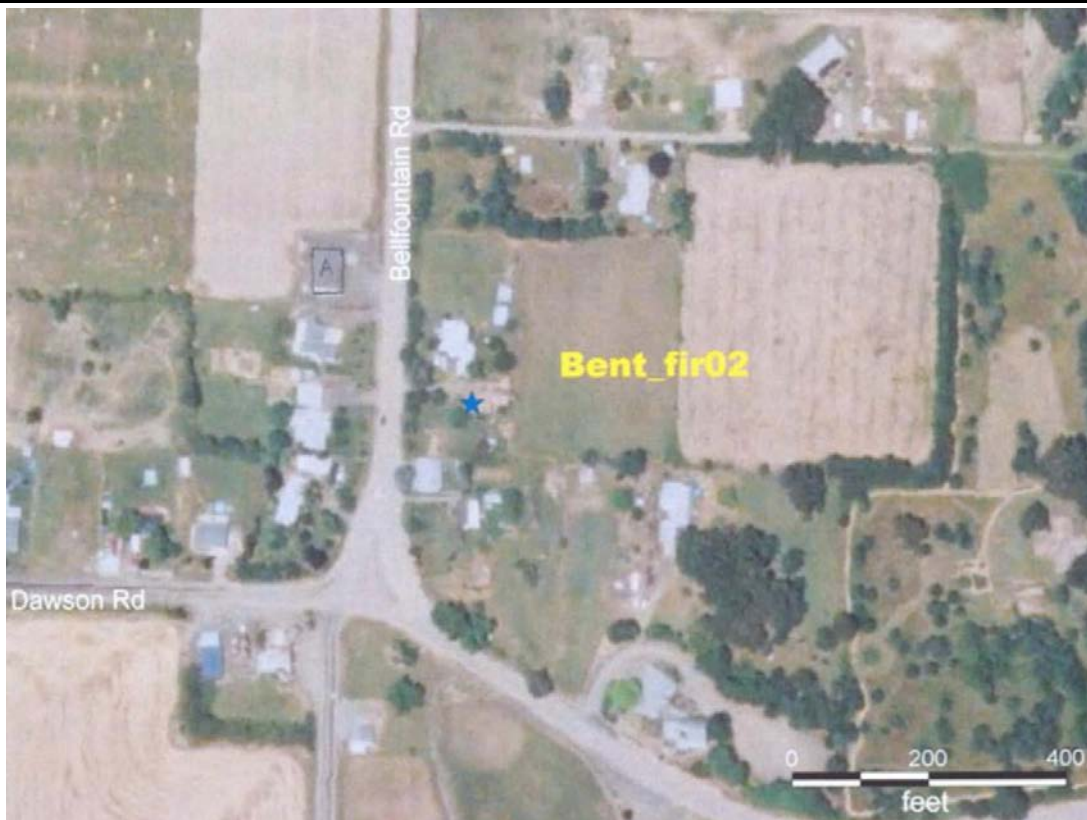
Type	Basic Score	Vert Irreg	Plan Irreg	Pre-Code	Post-Bench	Soil C	Soil D	Soil E	RVS Score
Primary	S3	3.2	0	-0.5	0	0	0	0	0	2.7
Secondary		0	0	0	0	0	0	0	0	0
Tertiary		0	0	0	0	0	0	0	0	0

FEMA-154 Collapse Potential

Low (<1%)
