# Corvallis Fire Station #3

Bent\_fir04A

## FEMA 154 Rapid Visual Screening Score Card

Rapid Visual Screening - Senate Bill #2 - Seismic Needs Assessment  
Oregon Department of Geology and Mineral Industries

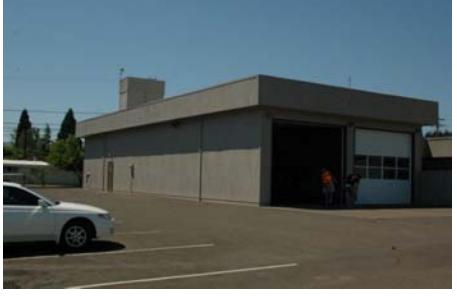
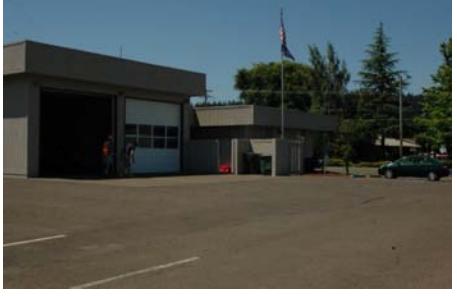
N	General Site out-of-plane lateral system	S	Primary Structural Type
E	Vertical Irregularity Primary	E	Vertical Irregularity Primary
