Monroe RFPD

Building Type		County	
Fire - RFPD		Benton	
Street			
680 Commercial St			
City	State	Zip	
Monroe	OR	97456	
Latitude		Longitude	
44.31462		123.30033	
Tracking Code		Inspection Date	
RVS in 2006		6/27/2006

FEMA 154 Rapid Visual Screening Score Card

Rapid Visual Screening - Senate Bill #2 - Seismic Needs Assessment
Oregon Department of Geology and Mineral Industries

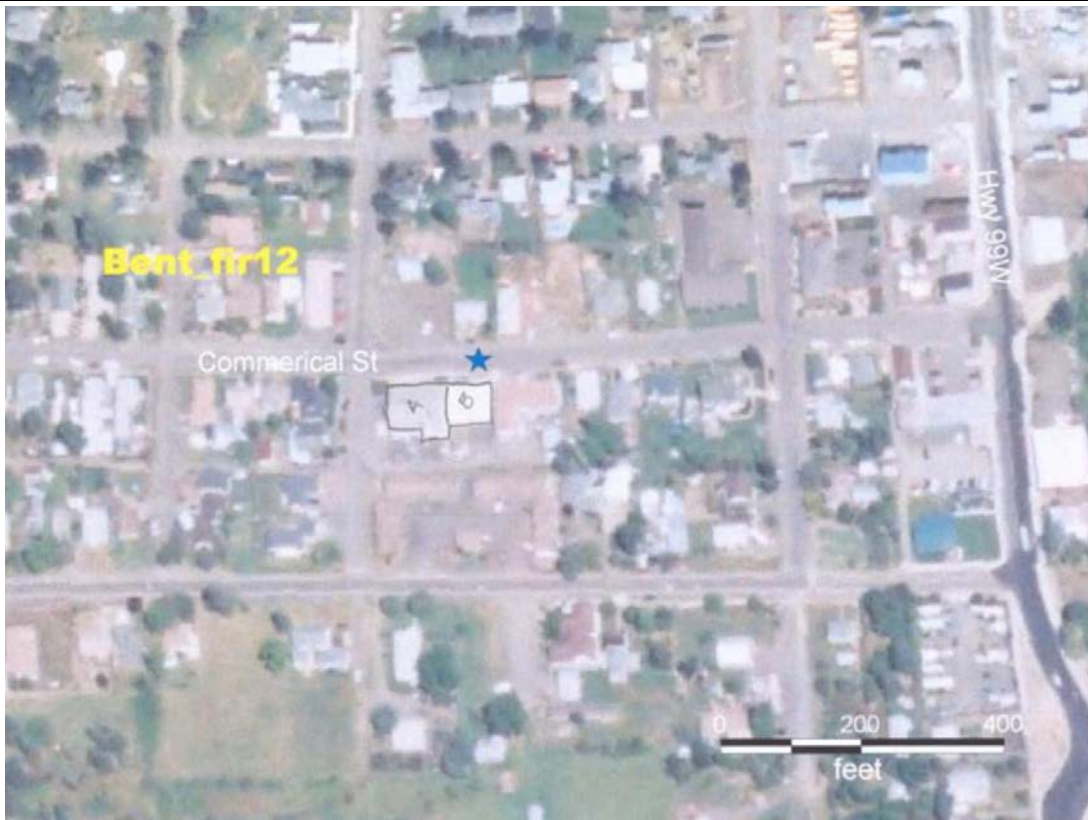
Type	Basic Score	Vert Irreg	Plan Irreg	Pre-Code	Post-Bench	Soil C	Soil D	Soil E	RVS Score
Primary	S3	3.2	0	0	0	0	-0.4	0	0	2.8
Secondary		0	0	0	0	0	0	0	0	0
Tertiary		0	0	0	0	0	0	0	0	0

FEMA-154 Collapse Potential

Low (<1%)

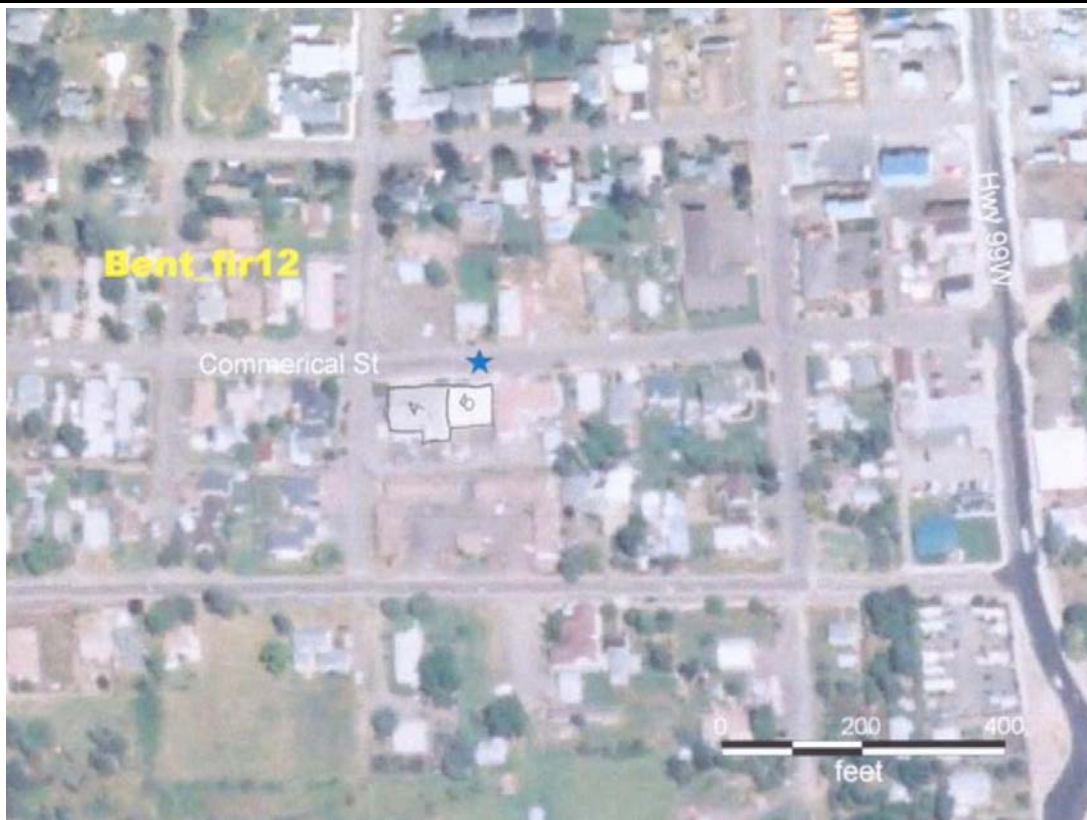
Type	Basic Score	Vert Irreg	Plan Irreg	Pre-Code	Post-Bench	Soil C	Soil D	Soil E	RVS Score
Primary	URM	1.8	-1	-0.5	-0.2	0	-0.4	0	0	-0.3
Secondary		0	0	0	0	0	0	0	0	0
Tertiary		0	0	0	0	0	0	0	0	0

FEMA-154 Collapse Potential

Very High (100%)

Falling Hazards	Poor Conditions
None	Cracks
None	Poor Masonry
None	None
