| EOC-Public Safety Answering P | Benton | |
| 200 Cascade Hall | | |
| RVS in 2006 | | 6/26/2006 |

## FEMA 154 Rapid Visual Screening Score Card

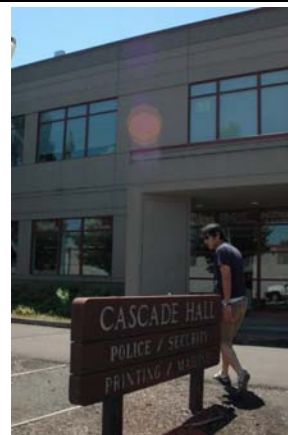
Seismicity Zone: High

| | Type | Basic Score | Vert Irreg | Plan Irreg | Pre-Code | Post-Bench | Soil C | Soil D | Soil E | RVS Score |
| Primary | S2 | 3 | -1.5 | -0.5 | 0 | 0 | 0 | -0.6 | 0 | 0.4 |

High (&gt;10%)
