# Mt Pleasant Elementary School

Oregon City SD 62

## FEMA 154 Rapid Visual Screening Score Card

Rapid Visual Screening - Senate Bill #2 - Seismic Needs Assessment  
Oregon Department of Geology and Mineral Industries

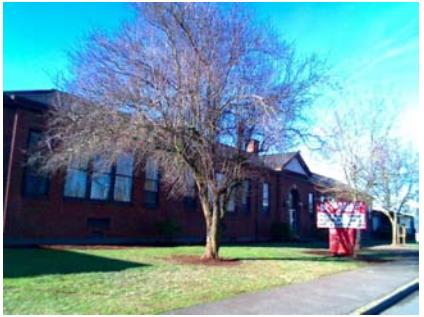
| E | Elevation View | E | Vertical Irregularity Secondary |

| Reentrant Corners: E Shaped | | Steps in Elevation View: 2 to 3 Changes | |

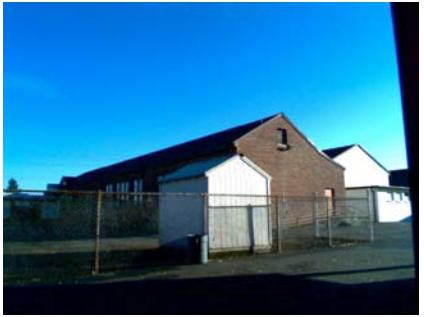
| NW | Vertical Irregularity Secondary | SW | Vertical Irregularity Primary |

| Reentrant Corners: Other (Adjacent Build/Entity) | | Steps in Elevation View: Single Change (Adjacent Building/Entity) | |

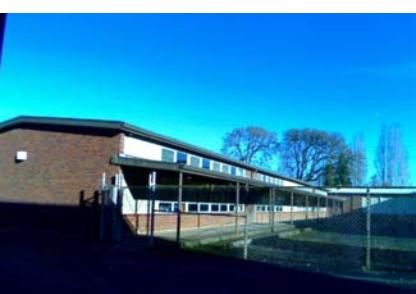
| SW Plan Irregularity Secondary | | NW Plan Irregularity Primary | |

| Reentrant Corners: L Shaped | | None | |

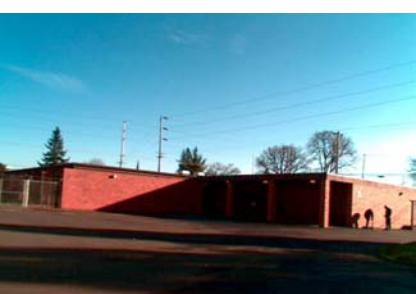
| Lateral-Force-Resistance in One Direction Only | | Steps in Elevation View: Single Change (Adjacent Building/Entity) | |
