Ogden Middle School

Oregon City SD 62

FEMA 154 Rapid Visual Screening Score Card

Rapid Visual Screening - Senate Bill #2 - Seismic Needs Assessment
Oregon Department of Geology and Mineral Industries

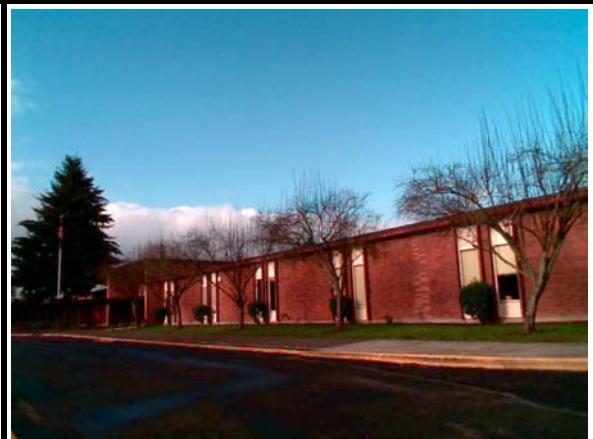
Clac_sch50A

Type	Basic Score	Vert Irreg	Plan Irreg	Pre-Code	Post-Bench	Soil C	Soil D	Soil E	RVS Score
Primary	RM1	2.8	-1	-0.5	0	0	-0.4	0	0	0.9
Secondary		0	0	0	0	0	0	0	0	0
Tertiary		0	0	0	0	0	0	0	0	0

Final Type	Final Score
RM1	0.9

High (>10%)

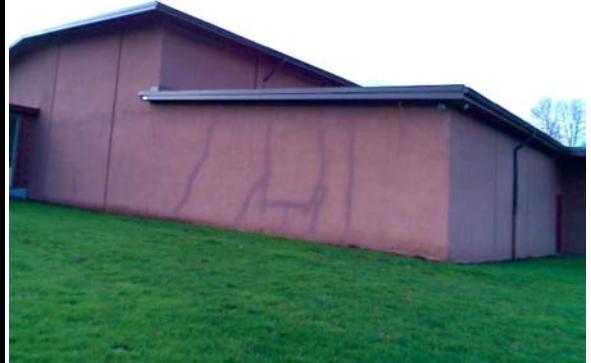
Clac_sch50B

Enrollment	Year Built (Field Verified)	Year Built (Alt. Source)	Est. Decade Built
663	1966	1965	1960
Total Area (square ft)	Number of Stories	Basement	Pounding Potential
100370	1	No	No
Plan Irregularities		Vertical Irregularities	
Reentrant Corners: Other		Steps in Elevation View: 2 to 3 Changes	
Reentrant Corners: Other (Adjacent Build/Entity)		Steps in Elevation View: Single Change (Adjacent Building/Entity)	
Out of Plane Lateral-Force-Resistance Elements		None	
Falling Hazards		Poor Conditions	
Other: Ornamental Hazard Over Exit		Cracks	
Unreinforced Chimneys		None	
None		None
