# Lewelling Elementary School

Clac\_sch88A

## FEMA 154 Rapid Visual Screening Score Card

Rapid Visual Screening - Senate Bill #2 - Seismic Needs Assessment  
Oregon Department of Geology and Mineral Industries

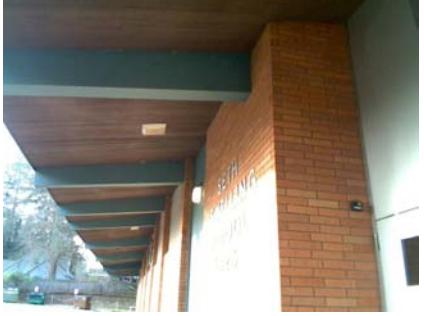
| Enrollment | Year Built (Field Verified) | Year Built (Alt. Source) | Est. Decade Built |
|---|--|---|---|
| S Field Verified Year Built<br>1963<br>also interior brick wall | S Primary Structural Type | S General Site<br>looking from part 1 to 2 and 3. | |

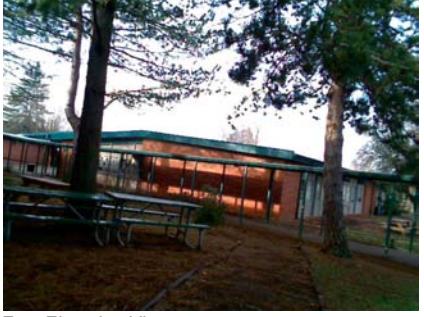
| Enrollment | Year Built (Field Verified) | Year Built (Alt. Source) | Est. Decade Built |
|---|--|---|---|
| SW Plan Irregularity Primary<br>pi and vi on 2 are typical. | S Falling Hazard<br>canopies | SE Elevation View<br>part 4 | |

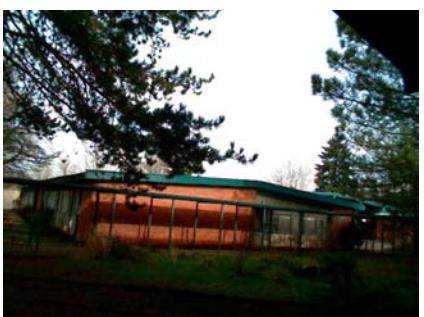
| Enrollment | Year Built (Field Verified) | Year Built (Alt. Source) | Est. Decade Built |
|---|--|---|---|
| SW Elevation View<br>part 3 | SE Elevation View<br>part 5 | NW Elevation View<br>back of part 1 | |
