# Knappa Svensen RFPD

Knappa Fire District

## FEMA 154 Rapid Visual Screening Score Card

Rapid Visual Screening - Senate Bill #2 - Seismic Needs Assessment  
Oregon Department of Geology and Mineral Industries

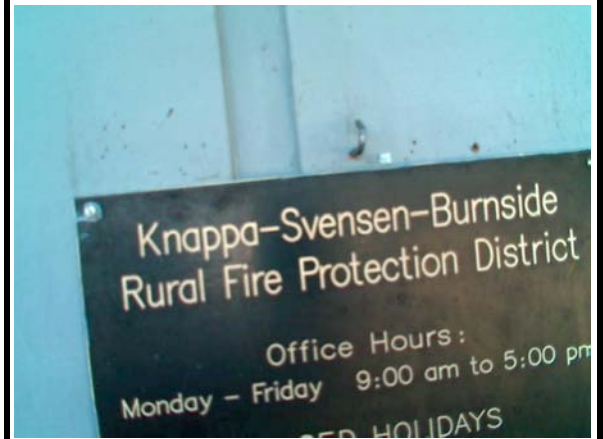
| | Type | Basic Score | Vert Irreg | Plan Irreg | Pre-Code | Post-Bench | Soil C | Soil D | Soil E | RVS Score |
|---|---|---|---|---|---|---|---|---|---|---|
| Primary | W2 | 3.8 | 0 | -0.5 | 0 | 2.4 | -0.4 | 0 | 0 | 5.3 |

5.3

Low (<1%)
