Scappoose RFPD

Colu_fir09A

Building Type Fire - RFPD	County Columbia	
Street 52751 Columbia River Hwy		
City Scappoose	State OR	Zip 97056
Latitude 45.76138	Longitude 122.87908	
Tracking Code RVS in 2006	Inspection Date 9/21/2006

FEMA 154 Rapid Visual Screening Score Card

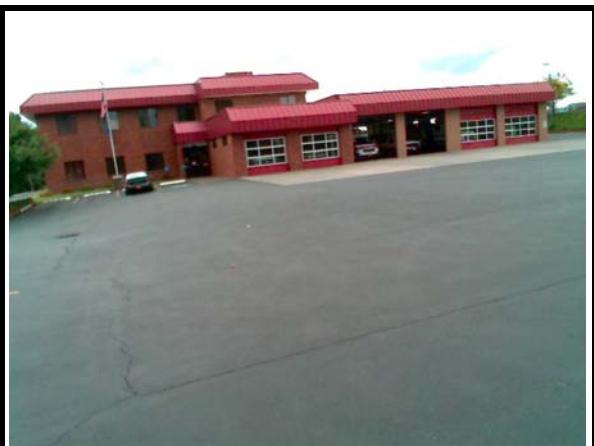
Seismicity Zone: High

Type	Basic Score	Vert Irreg	Plan Irreg	Pre-Code	Post-Bench	Soil C	Soil D	Soil E	RVS Score
Primary	RM1	2.8	-1	-0.5	0	0	0	0	0	1.3
Secondary		0	0	0	0	0	0	0	0	0
Tertiary		0	0	0	0	0	0	0	0	0

Final Type	Final Score
RM1	1.3

Moderate (>1%)

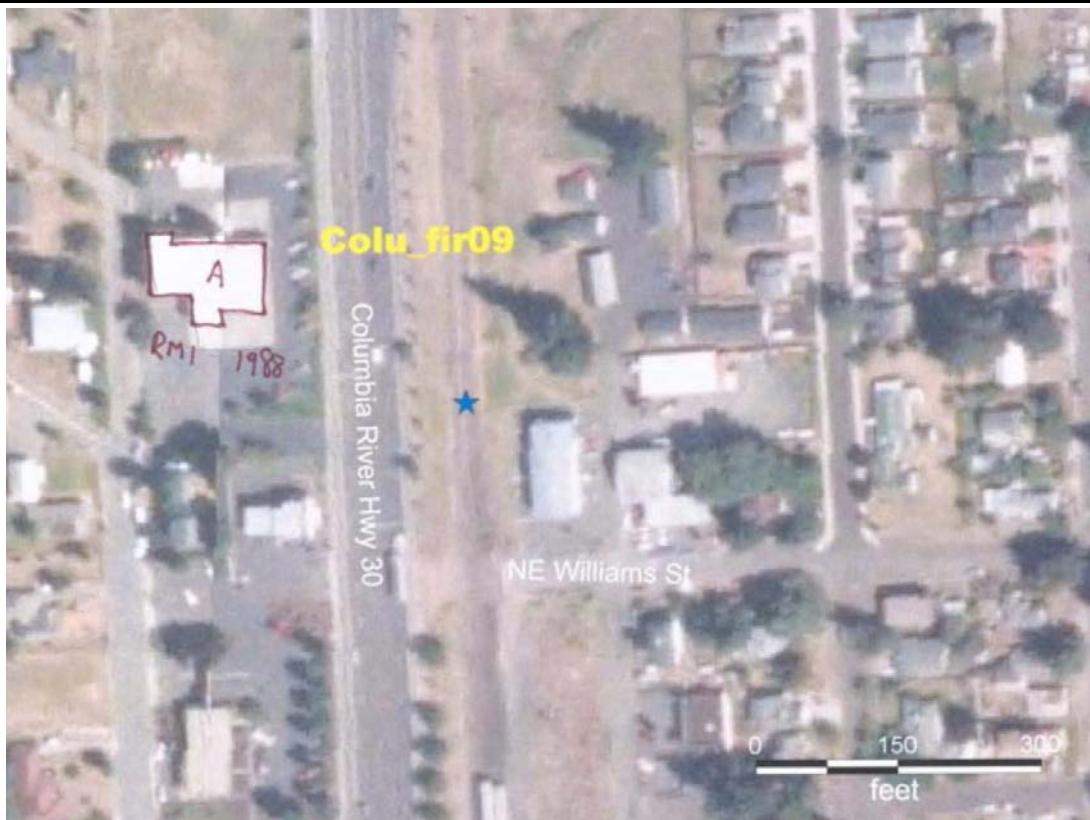
Enrollment	Year Built (Field Verified)	Year Built (Alt. Source)	Est. Decade Built		
	1988	1988	1980		
Total Area (square ft)	Number of Stories	Basement	Pounding Potential		
	2	No	No		
Plan Irregularities		Vertical Irregularities			
Reentrant Corners: Other		Steps in Elevation View: 2 to 3 Changes			
Lateral-Force-Resistance in One Direction Only		None			
None		None			
Falling Hazards		Poor Conditions			
None		None			
None		None			
None		None
