Eden Hall

Southwest Oregon CC

FEMA 154 Rapid Visual Screening Score Card

Rapid Visual Screening - Senate Bill #2 - Seismic Needs Assessment
Oregon Department of Geology and Mineral Industries

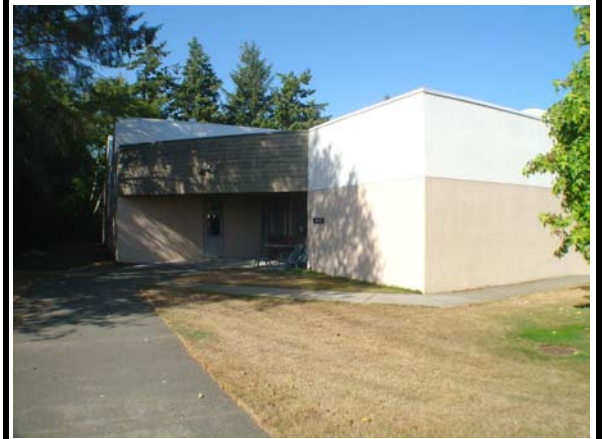
Seismicity Zone: Very High

Type	Basic Score	Vert Irreg	Plan Irreg	Pre-Code	Post-Bench	Soil C	Soil D	Soil E	RVS Score
Primary	C2	2.8	-1	-0.5	0	0	0	-0.6	0	0.7
Secondary		0	0	0	0	0	0	0	0	0
Tertiary		0	0	0	0	0	0	0	0	0

0.7

High (>10%)
