# Bandon RFPD

Coos\_fir09A

Building Type Fire - RFPD	County Coos	
Street 555 Hwy 1010		
City Bandon	State OR	Zip 97411
Latitude 43.11717	Longitude 124.41381	
Tracking Code RVS in 2006	Inspection Date 8/10/2006

Rapid Visual Screening - Senate Bill #2 - Seismic Needs Assessment  
Oregon Department of Geology and Mineral Industries

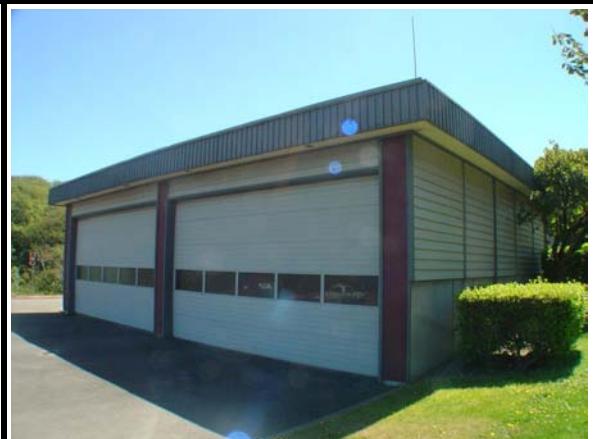
Type	Basic Score	Vert Irreg	Plan Irreg	Pre-Code	Post-Bench	Soil C	Soil D	Soil E	RVS Score
Primary	W1	4.4	0	-0.5	0	0	0	0	0	3.9
Secondary		0	0	0	0	0	0	0	0	0
Tertiary		0	0	0	0	0	0	0	0	0

Final Type	Final Score
W1	3.9

Low (<1%)
