Lakeside RFPD

Coos_fir15A

Rapid Visual Screening - Senate Bill #2 - Seismic Needs Assessment
Oregon Department of Geology and Mineral Industries

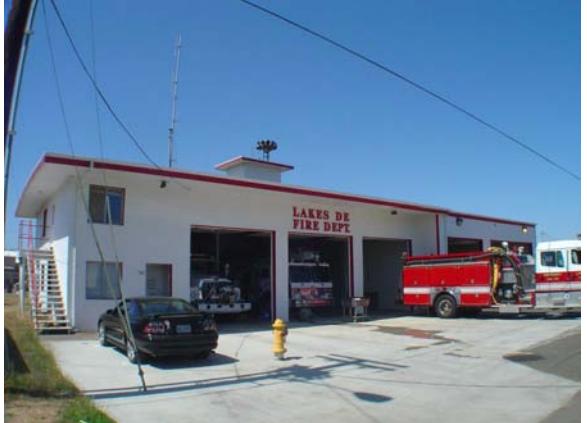
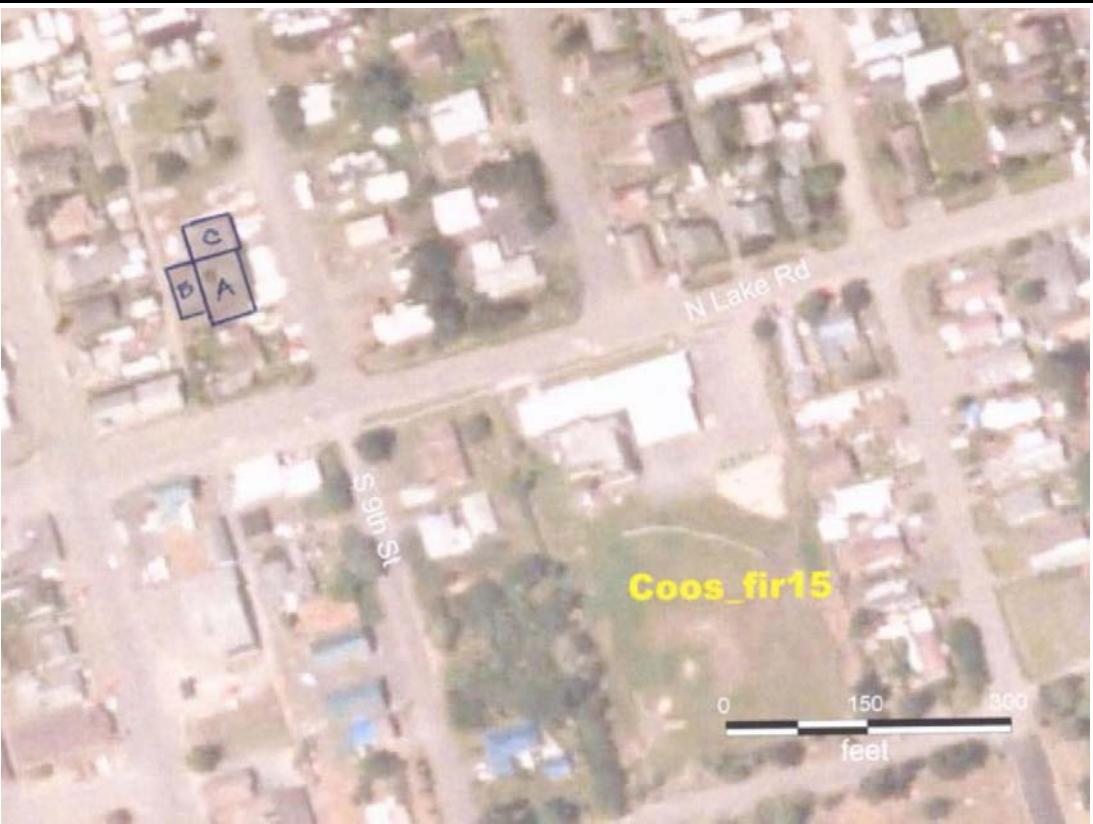
Final RVS Score

Final Type RM1	Final Score 1.7
-------------------	--------------------

FEMA-154 Collapse Potential

Moderate (>1%)

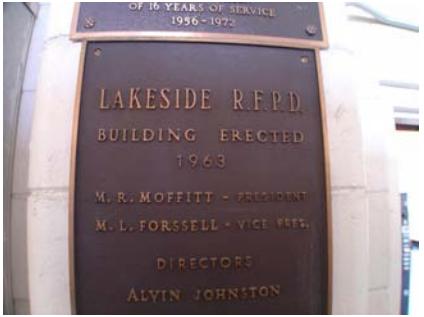
<p>OF 10 YEARS OF SERVICE 1956-1972</p> <p>LAKESIDE R.F.P.D. BUILDING ERECTED 1963</p> <p>M. R. MOFFITT - PRESIDENT M. L. FORSELL - VICE PRES.</p> <p>DIRECTORS ALVIN JOHNSTON</p>

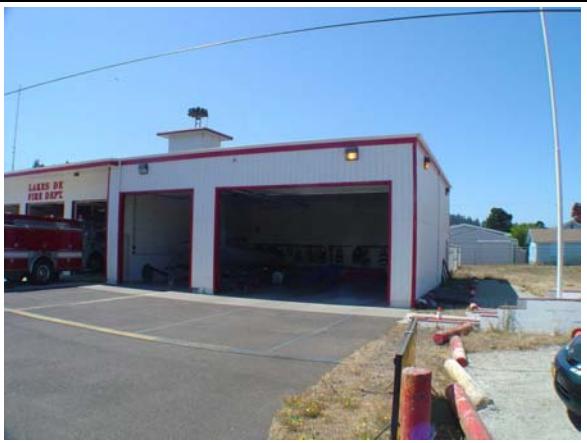
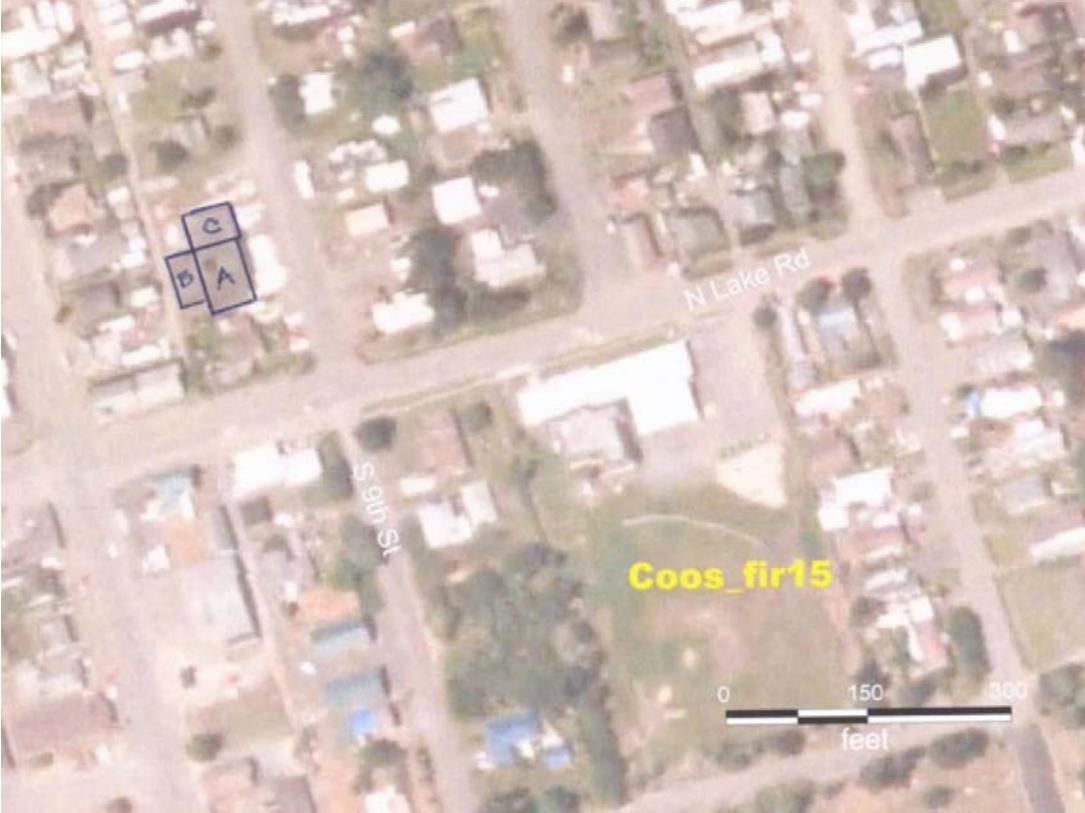
Final RVS Score

Final Type W1	Final Score 6.3
------------------	--------------------

FEMA-154 Collapse Potential

Low (<1%)
