Myrtle Point Fire

Coos_fir16A

Rapid Visual Screening - Senate Bill #2 - Seismic Needs Assessment
Oregon Department of Geology and Mineral Industries

Coos_fir16B

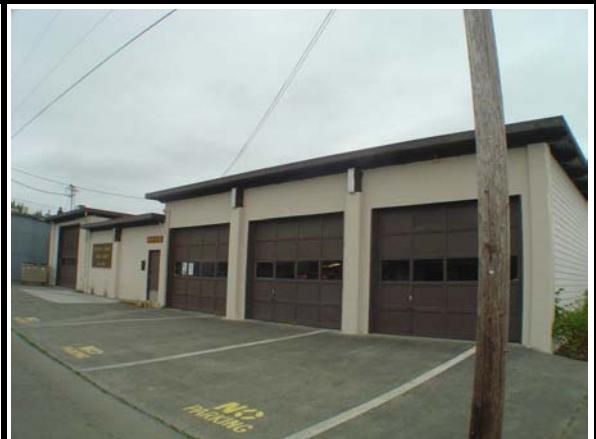
Seismicity Zone: Very High

Type	Basic Score	Vert Irreg	Plan Irreg	Pre-Code	Post-Bench	Soil C	Soil D	Soil E	RVS Score
Primary	RM1	2.8	-1	-0.5	0	0	-0.4	0	0	0.9
Secondary		0	0	0	0	0	0	0	0	0
Tertiary		0	0	0	0	0	0	0	0	0

Final Type	Final Score
RM1	0.9

High (>10%)

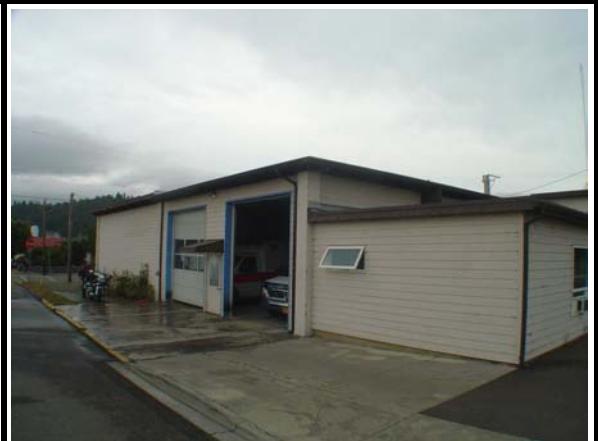
Seismicity Zone: Very High

Type	Basic Score	Vert Irreg	Plan Irreg	Pre-Code	Post-Bench	Soil C	Soil D	Soil E	RVS Score
Primary	W1	4.4	-2.5	-0.5	0	2.4	0	0	0	3.8
Secondary		0	0	0	0	0	0	0	0	0
Tertiary		0	0	0	0	0	0	0	0	0

Final Type	Final Score
W1	3.8

Low (<1%)
